20th May 2020

our ref LD17068
your ref

31 Daleham Gardens, London NW3 5BU
Structural Damage arising from Fire on 21st November 2017

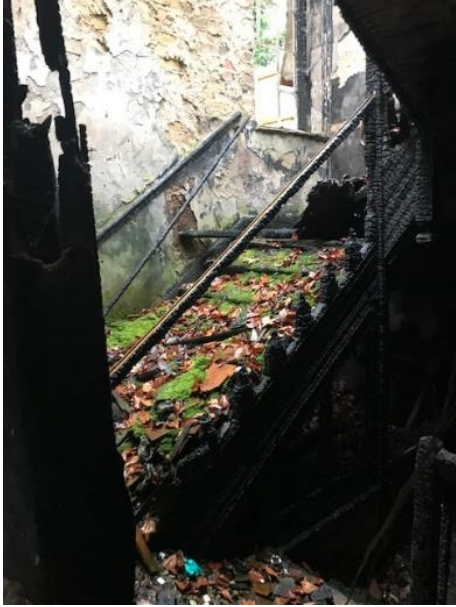
When we visited on 12th December 2019, it was evident from the main entrance door beneath the scaffold that intruders had entered the building. I observed evidence of the original fire debris in the main hall being disturbed and possessions from the flats that was formerly not present being scattered around. Of more concern was the presence of fresh masonry rubble and debris in the central hall.

This fresh debris is evidence of the inevitable deterioration of the roofless shell over the past two years. Whilst parts of the external surface of the masonry shell appear little affected, the main interior structure is all but destroyed. It is almost impossible to conceive of a practical means of safe working to remove and then replace the lost internal timber and damaged masonry structure and so reinstate the required lateral stability to the external brick envelope.

Interior View Taken Dec 2019

There is no feasible prospect either on grounds of cost nor safety by which the above ground elements of the building could be retained and repaired. The building is dangerous and I recommend demolition as soon as possible.

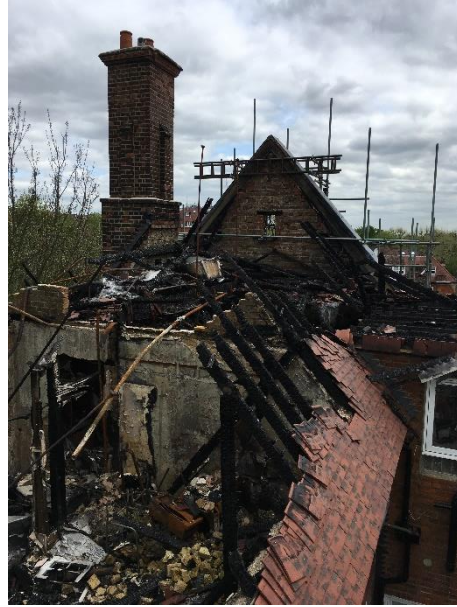
The scope of damage in the non-original rear extension is impossible to access. All we know from looking through the ground floor windows is the extensive smoke and water damage caused by firefighting activities. In contrast, before it was removed, the high-level access scaffold afforded a clear view of the internal structure of main body of the four-storey building. Here the roof was completely lost, the exposed internal timber structure below has either collapsed, is severely charred or otherwise rendered unsalvageable by the fire-fighting activities. Our inspections through ground floor windows and tentative view from the front door reveal similar severe charring of all the first and second fix timber structure further down the building. See photographs below.

High Level View Taken April 2019
