**Structural Proposals to infill
existing Door openings**

42 Bedford Square

Date: **2nd October 2019**

Project Ref: **3306/5463**

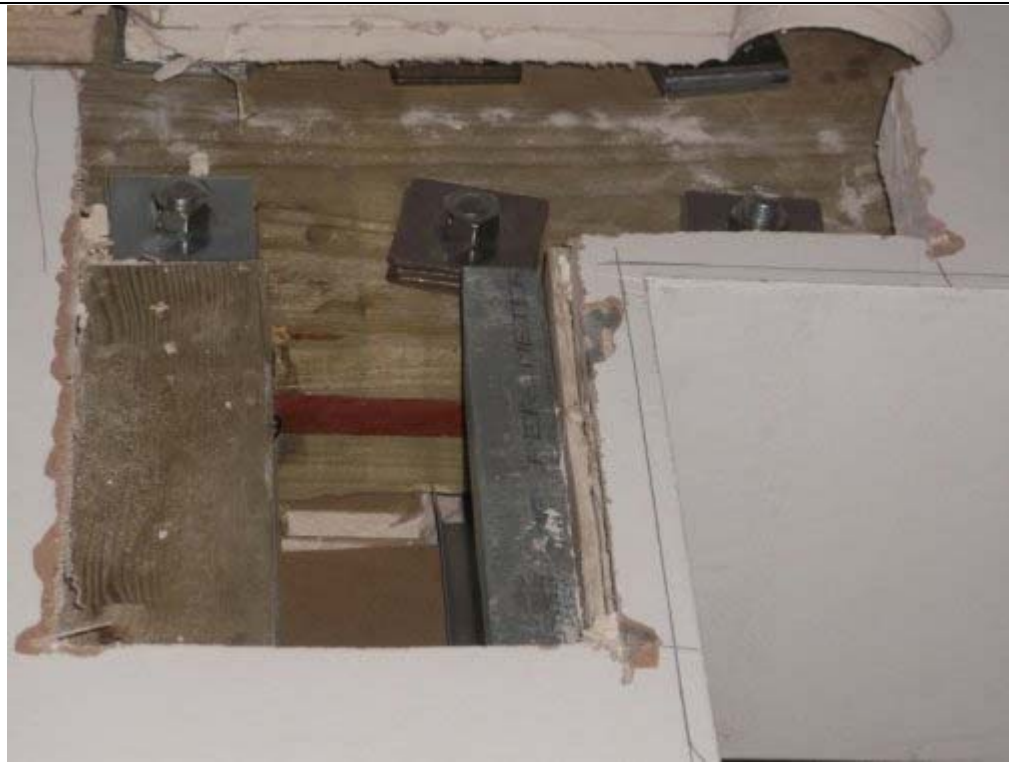
PHOTOGRAPH No. 331

- 1.1 Our examination of the BDP drawings and our examination on site lead us to believe that it will not present major structural problems adopting the door arrangements as set out on the BDP drawing. The BDP drawings show the new door will be contained within the current opening.
- 1.2 As part of the previous renovations a flitch beam comprising 219mm x 72mm outer timbers and a center steel plate of 219mm x 12mm was installed. Please refer to photograph 333 which shows the existing opening and photograph 331 which shows a detail of the flitch beam arrangement.

The present flitch beam will be more than structurally adequate to transfer the loads onto the adjacent framing stud work.

- 1.3 We recommend that the existing flitch beam arrangement remains in place and that the new side and top panels are built of structural timber. We suggest that the studs should be 169mm x 47mm at 400mm centers with 169mm x 47mm noggins at 600mm centers. The door side studs should be 72mm thick by 169mm to provide a robust fixing for future doors.

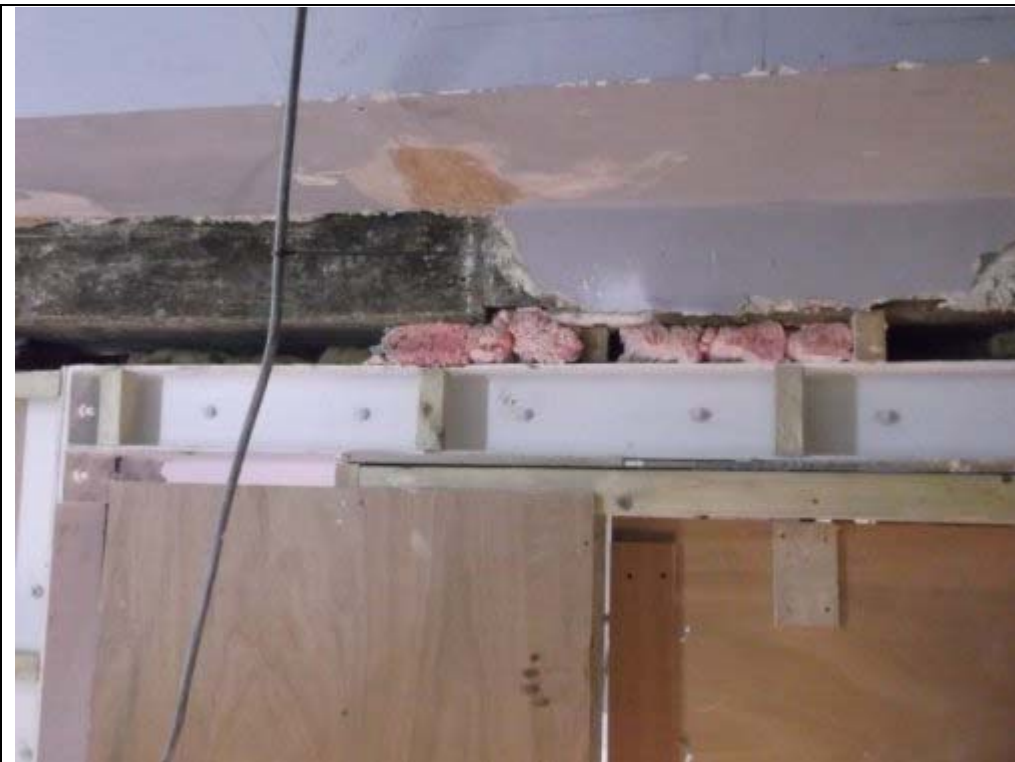
PHOTOGRAPH No. 328

- 2.1. Present Situation is that door opening No.2 was previously enlarged and the enlarged opening was reinforced with twin 152 x 152 x 30kgs per metre UC sections all around. This has resulted in twin stanchions and twin lintel beams which form a portal goal post arrangement. This work was well done and has created a robustly supported opening. See photograph No 328 and 336 which show the steel sections.

- 2.4. We strongly recommend that the goal posts of twin 152 x 152 x 30kgs per metre remain in position and that the door is moved 50 – 75mm to the left (the left when standing in the hall, see BDP drawing No.002) this will avoid any future risk to the building. We further recommend that infills are carried out using 294mm x 47mm studs and 294mm x 47mm noggins at 600mm centers. We suggest that ply liner boards be placed around the existing steel goal posts off 25mm x 294mm and these ply sheets are screwed to the UC sections using 8mm self-tapping screws in pairs at 400 centers all around this opening. This will ensure a robust fixing for any new studwork and will ensure a structurally robust fixing for all future doors.

- 2.5. We recommend that the lintels over the new door be 145mm deep x 72mm x 4 number so that the full wall thickness is supported.

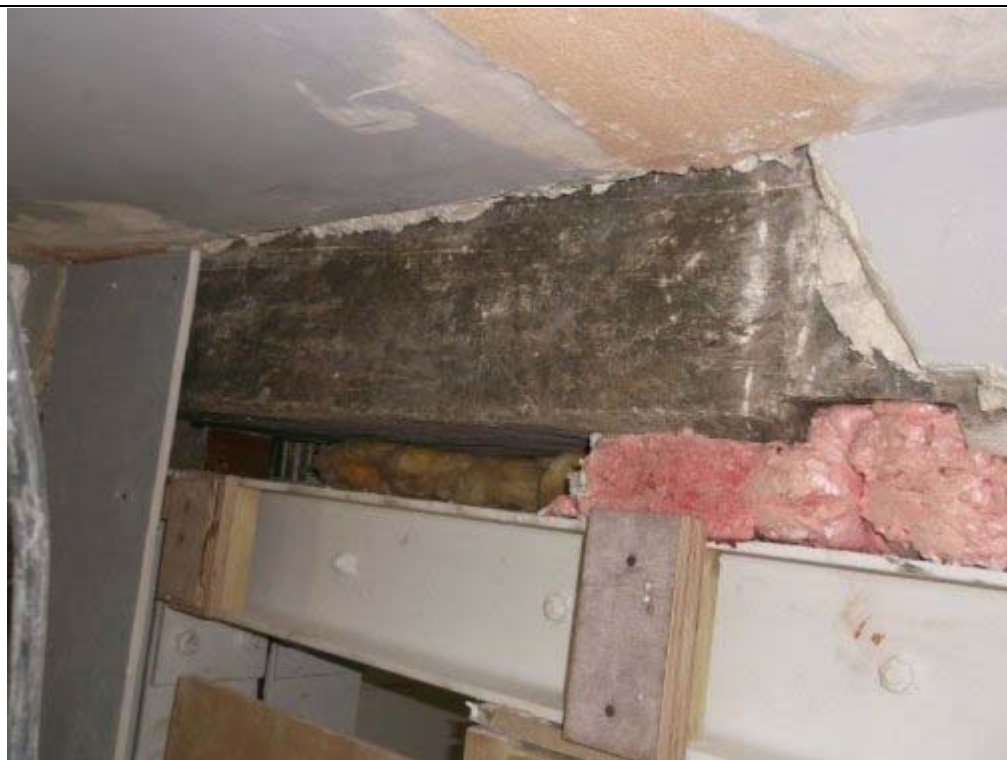
PHOTOGRAPH No. 336

- 2.3. There also exists a large timber post which is approximately 300mm x 300mm (see photograph No. 336) and this extends for the full height from floor to ceiling at this level. At present, we do not fully understand its structural purpose, however we are in no doubt that the original constructors of this building would not have inserted such a timber member had it not had a structural reason to be there. We strongly advise that this timber should not be moved or in any way interfered with.

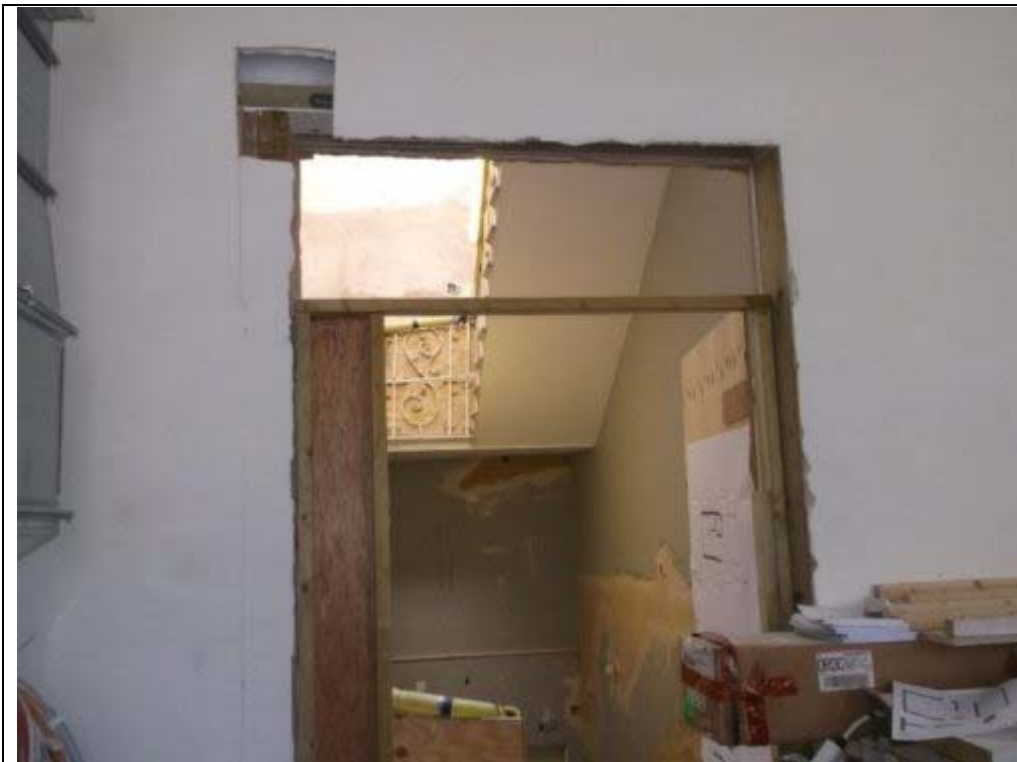
PHOTOGRAPH No. 337

- 3.1. This door is within the stair core. Prior to investigation works we expected this door to have Georgian brick masonry each side and over the door. Our investigation reveals that this door surround appears to have been altered significantly in the historic past, as we found (left and right sides assumes one is standing in the stair well).

- 3.2. Our proposal is to infill the righthand side with new 225mm brickwork which will be toothed into the existing Georgian brick. We propose to leave the existing 203 UC in place as to remove this will be dangerous and of little benefit. The steel beam lintel removal, will require significant temporary works and bearing in mind the loose nature of the existing brick work this would present a significant risk to builders and indeed the building should it be removed.
- 3.3. We recommend that the space over the door up to the lintel soffit is infilled with 219x47 studs and noggin. We also recommend that a 150mmx 219mm is installed to ensure no cracks will occur at the junction of the UC and the studwork. Filling this space with masonry will require the lintel to be bolted to the existing timber post which is an undesirable arrangement.

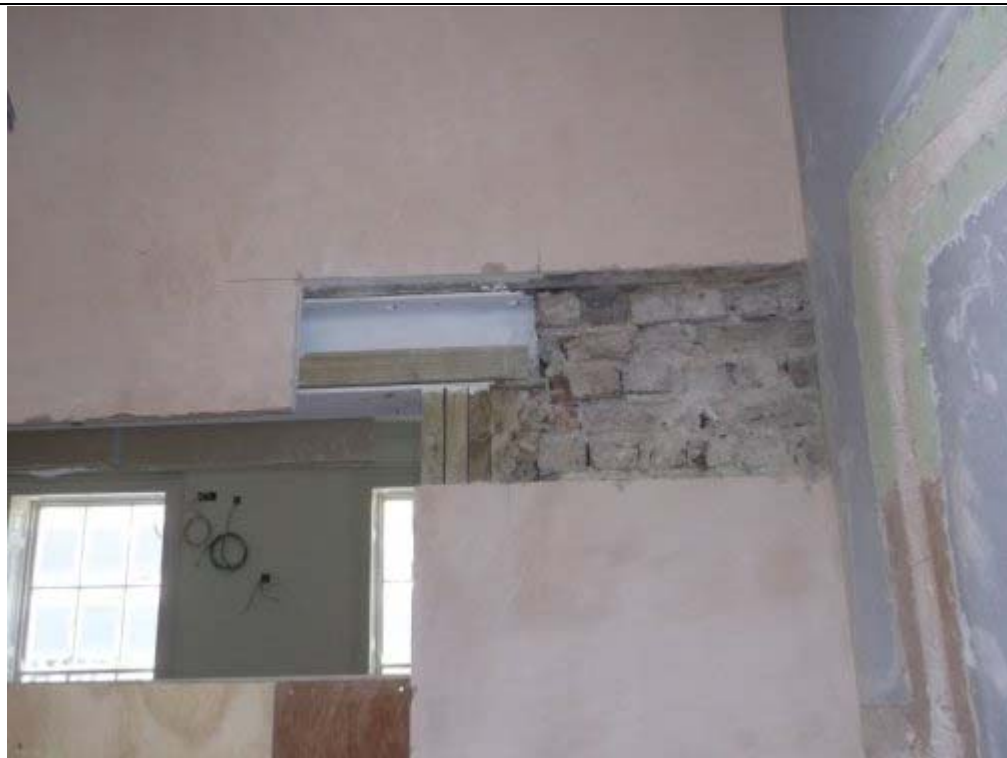
PHOTOGRAPH 349

- Loose Georgian brick masonry on the right side (assumes standing on stair landing) which has been trimmed with 3 side timbers of 47mmx219mm which support a 203x203 UC over door lintel, which has only 100mm bearing on the brickwork. See photograph 349. Please note the left side structure was exposed later and is shown in other photographs.

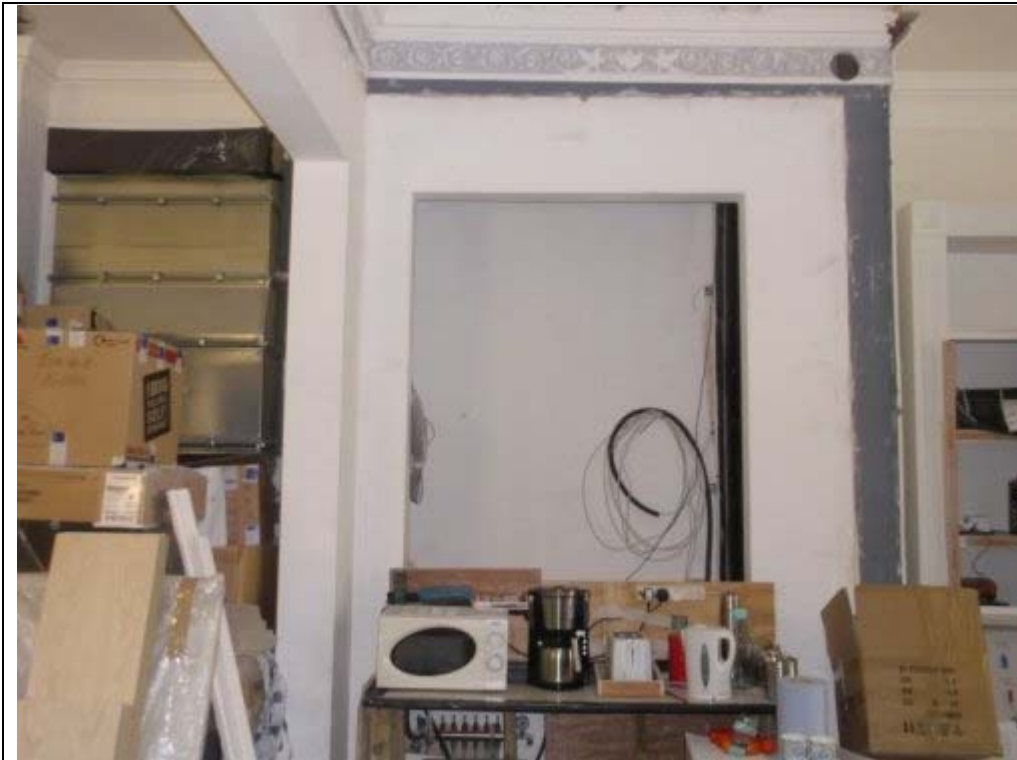
PHOTOGRAPH 350

- 5.1. This is a door that leads to a former cupboard which has now been converted into a service duct. The present proposal is to move this opening approximately 50 to 75mm to the right (when standing in the main room facing the door).
- 5.2. We proposed to move the door 50 – 75mm and the resulting infill is infilled with studs and noggins of 120mm x 47mm with 120mm deep x 97mm timber lintels, studs are to be at 400 centers and noggins at 600 centers.
- 5.3. We recommend that the door be moved marginally to avoid unnecessary disruption to the structure of the building.

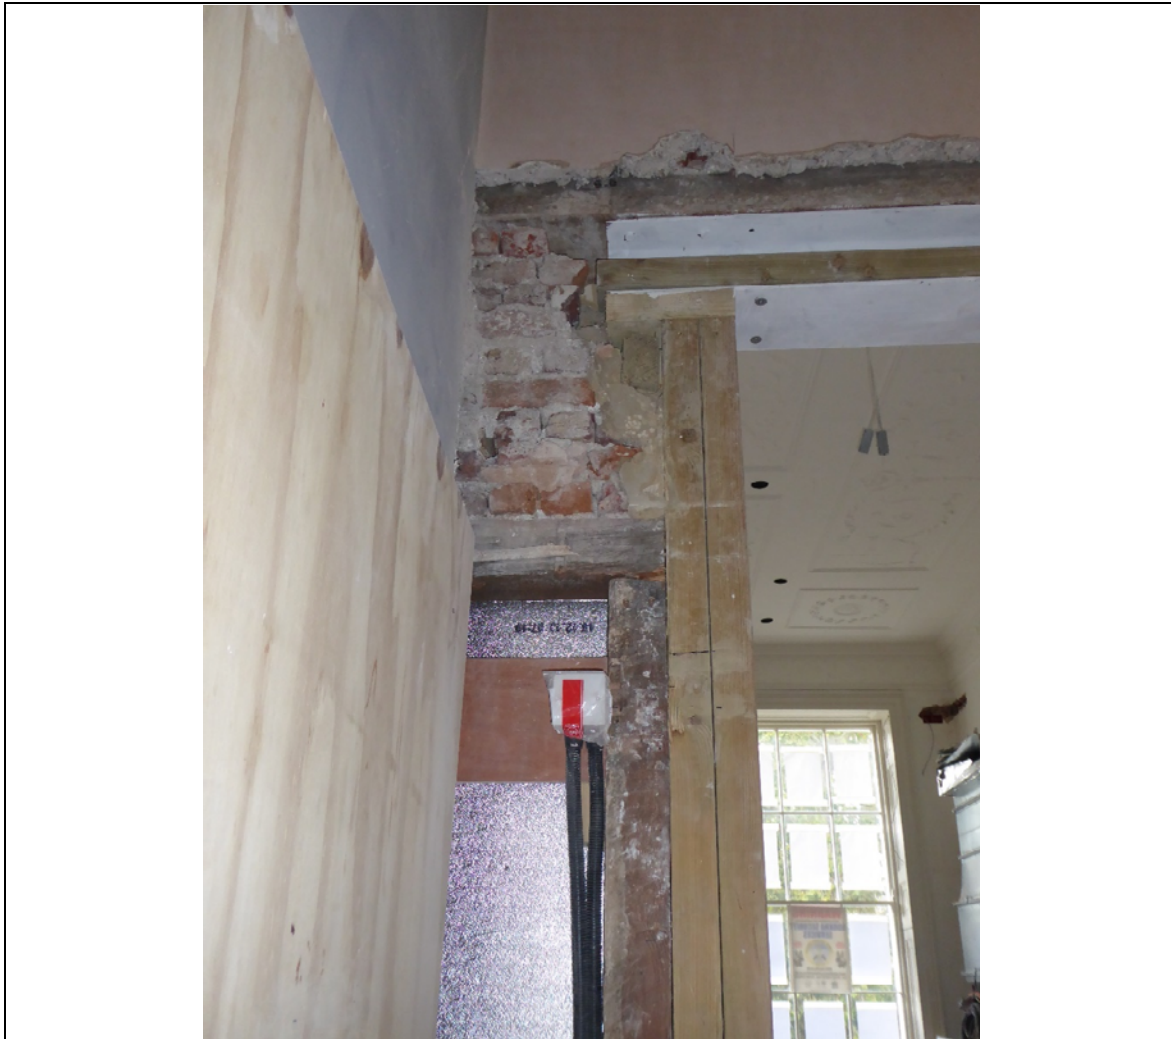
PHOTOGRAPH No. 283 - Door Opening No. 3 Left Side

- To the left side of the present opening there is a combination of brick masonry supported on a timber beam, which is in turn supported on a timber post. This was not expected but is of considerable age as illustrated by the very dark colour of the timber. During the work in the last 2 years the 203x203 UC was supported on an existing timber post and 2 new posts of size 72mmx219mm. With a new timber bearer under the recently installed UC. The brick and general timber arrangement are shown on photograph number 355 and 354. Please note the brick under the high-level timber beam and a further timber 700mm below. Below this low-level beam there is a timber post.

- 3.4 The left side presents the greatest difficulty as the new 72mmx219mm side studs must be removed to accommodate the architects wishes. Firstly, we ask if it would be possible to leave the recently inserted posts in position as their removal presents a lot of structural difficulties. This would result in the new door being moved 100mm to the right (standing in stair core).

- 3.5 We have on the attached drawing 5489-4001 shown the necessary details to achieve the removal of side studs.
