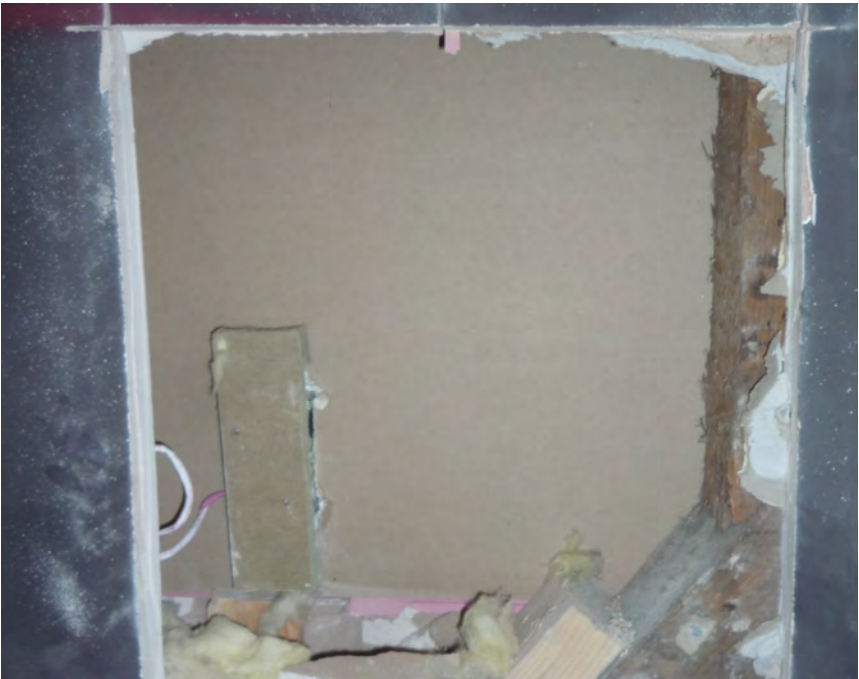
Image of intrusive investigation taken within the second floor front room prior to the 2014 application. Illustrating the partial survival of timber stud construction between the front rooms but modern plasterboard linings and timber structure.

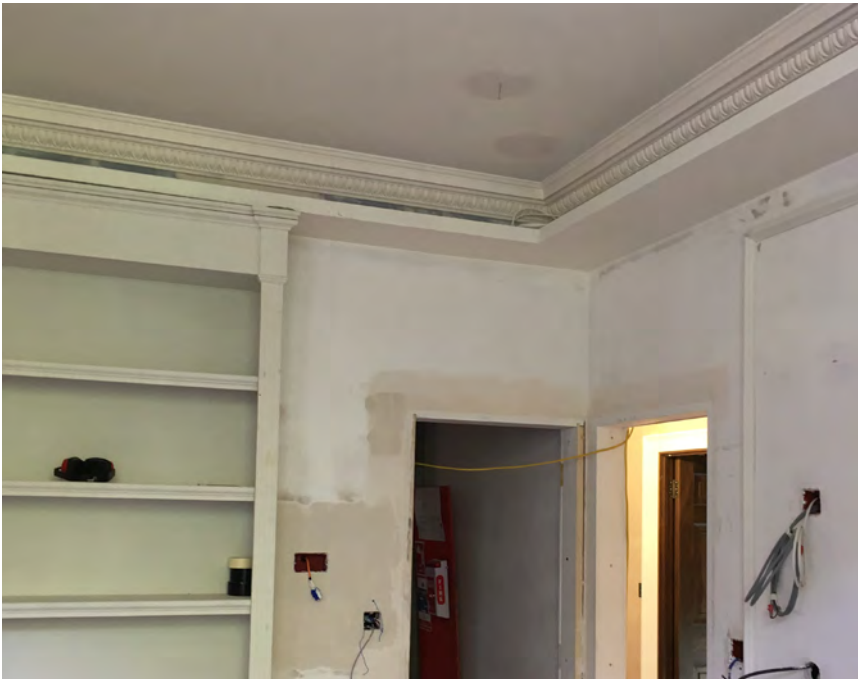
Photograph taken in the master sitting room illustrating contemporary ceiling arrangement to be carefully removed and door opening to adjacent master bedroom to be reinstated.

Carefully remove modern ceiling and timber beading and infill new door opening leading to master bedroom.

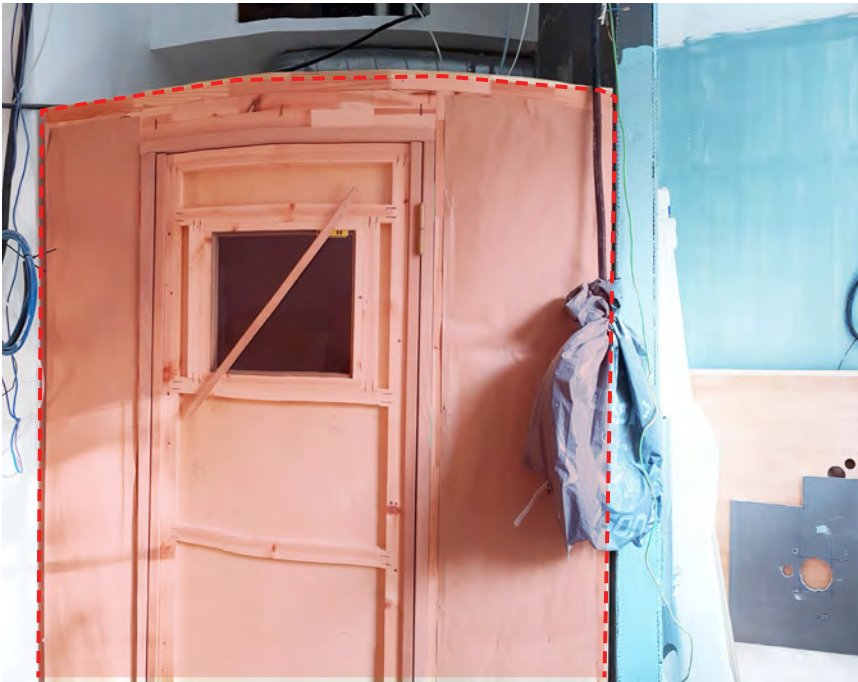
Photograph taken in the Ensuite Bathroom of the sauna to be removed and replaced with a shower.

Remove sauna and install reduced scale shower in its place. Complete furniture & bathroom installation. Existing windows have been refurbished and redecorated. Consented secondary glazing to be installed. Re-instate existing window architraves, make good and decorate.

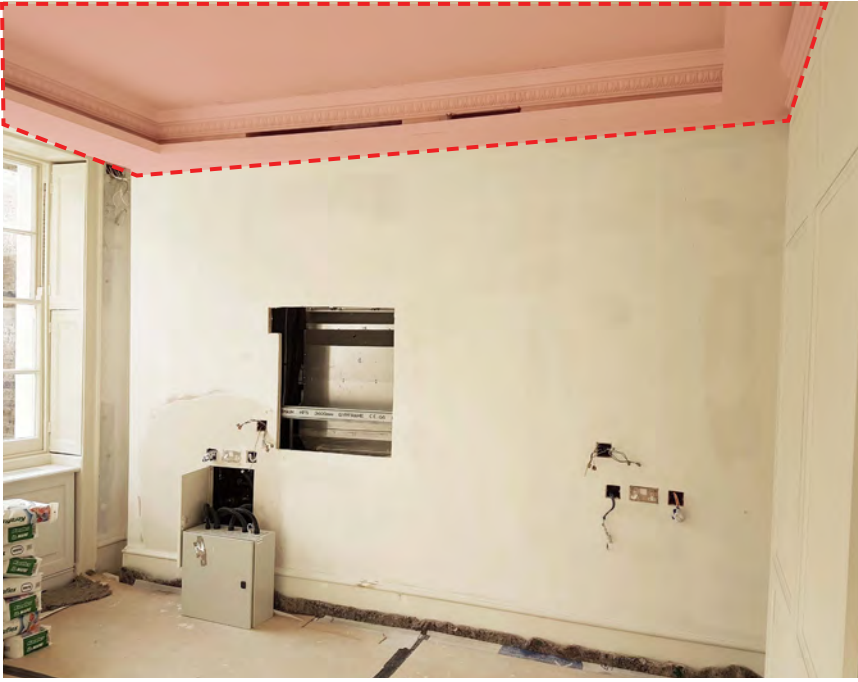
Contemporary wall lining in His Master Bedroom to be retained, however 'coffered' ceiling to be removed.

Ceilings_
Carefully Remove coffered ceiling and new cornice. Make good any damage to original fixtures and fittings in line with method statements, make good areas of modern plaster and redecorate.

Remove modern timber beading work. High level socket outlets adjacent to windows to be carefully removed and made good.

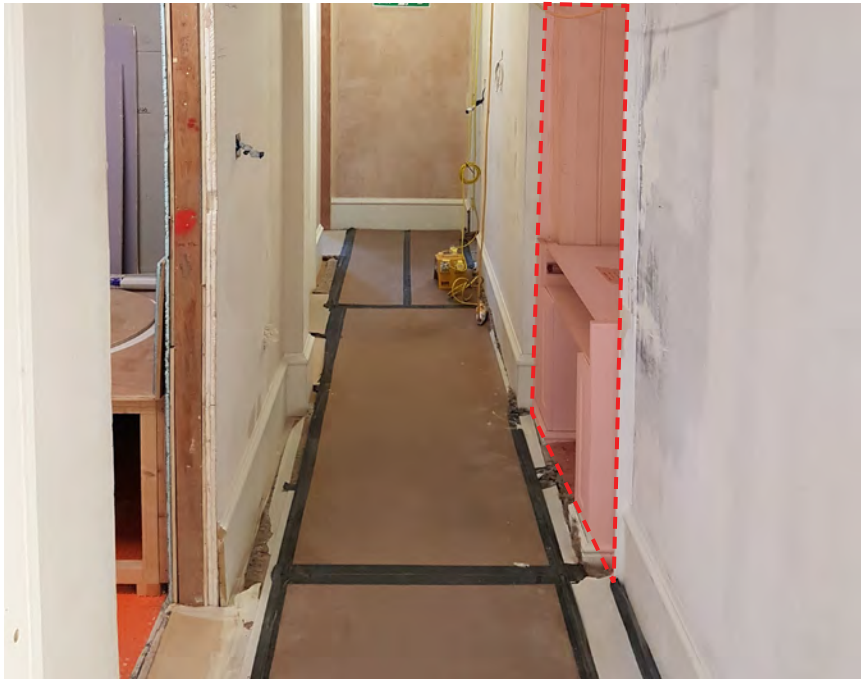
Photograph taken in the corridor outside the master bathroom, showing the original opening to be reinstated.

The existing opening linking the rear rooms to the main stair hall has been in filled with a lightweight stud partition system and furniture. It is proposed that this is carefully removed and that the existing opening is reinstated.

Lightweight partitions forming corridor to be carefully removed and original opening to stairwell to have infill carefully removed.

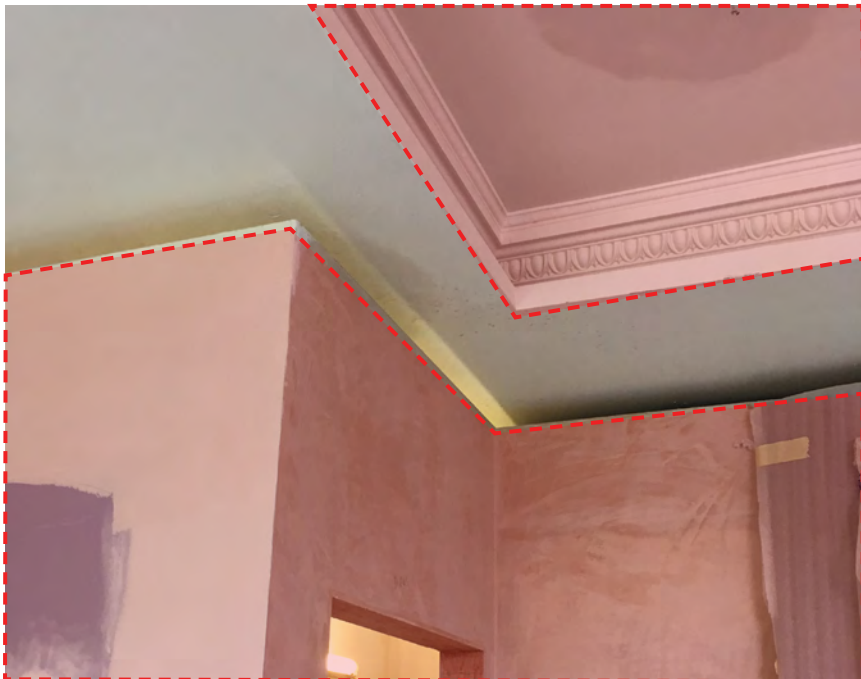
A closet and lobby arrangement have been constructed within the master bedroom in a lightweight partitioning. These partitions stop short of the ceiling but adjoin adjacent walls.

Photograph taken in the master bedroom illustrating suspended ceiling and lightweight partitioning to be carefully removed.

It is proposed that all of these modern partitions are carefully removed. Repairs to adjacent fabric are to be carried out in materials to match the existing.

Carefully remove closet volume and modern ceilings to reinstate volume of room.

Carefully remove coffered ceiling and new cornice with associated LED lighting. Make good any damage to adjacent fabric in line with method statements.

Remove lightweight partitions to closet & corridor, to return room to original volume. Make good, using timber stud work wall between master bedroom and master sitting room. High level socket outlets adjacent to windows to be carefully removed and made good.

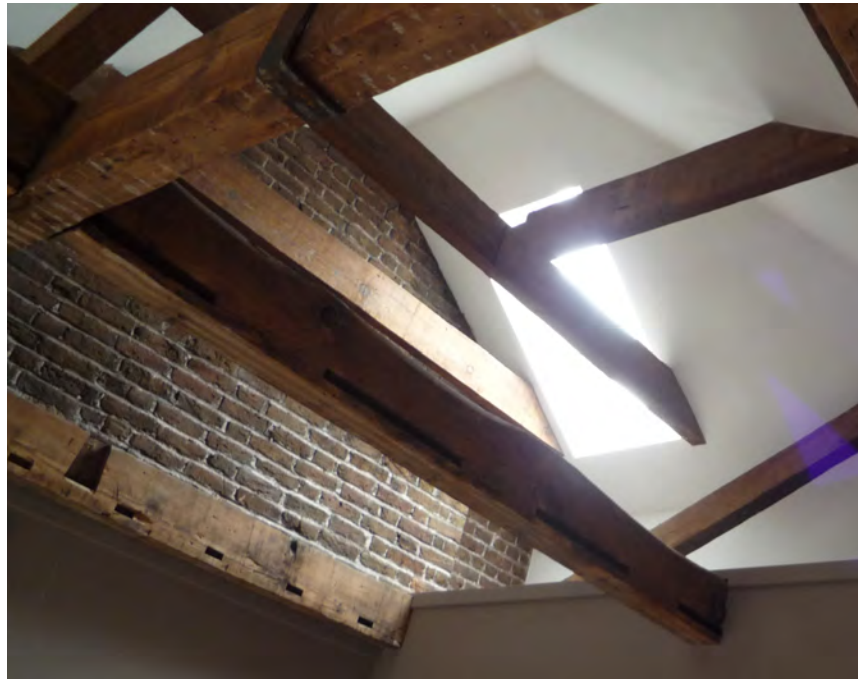
Images taken within the third floor prior to the 2014 application. Open ceilings, modern plasterboard wall finishes and ceiling linings and rooflights.

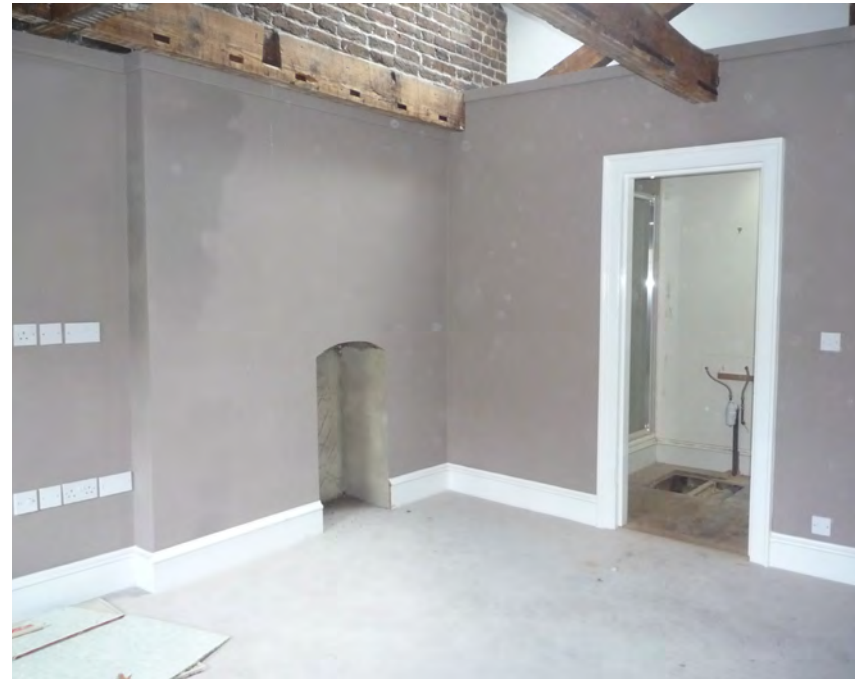
Images taken within the third floor prior to the 2014 application. Note the open ceilings, modern plasterboard wall finishes and ceiling linings and rooflights.

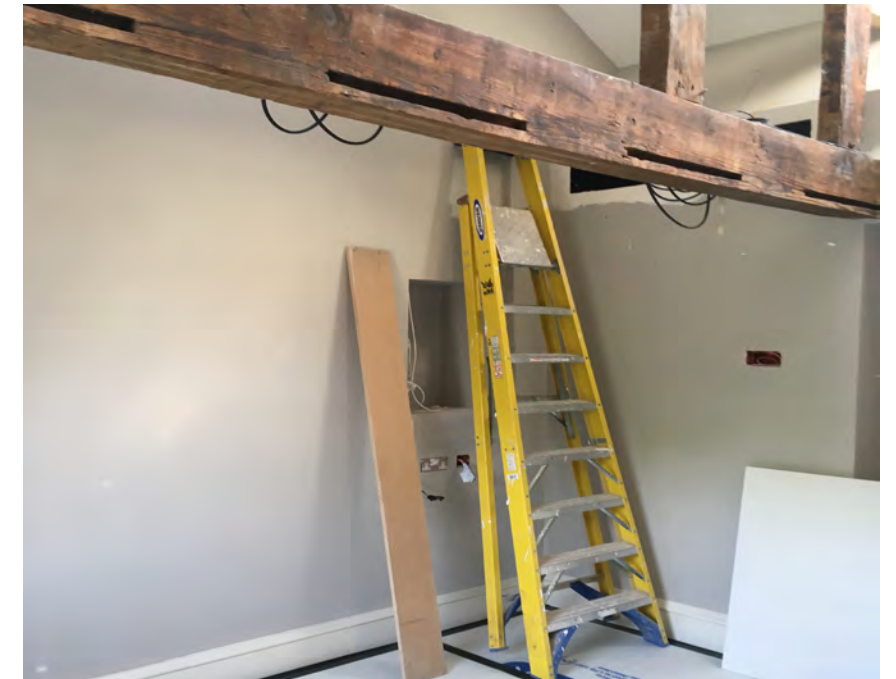
Photograph of modern plasterboard lining installed in front of chimney breast. To be removed. New ceilings to be installed below timber roof structure.

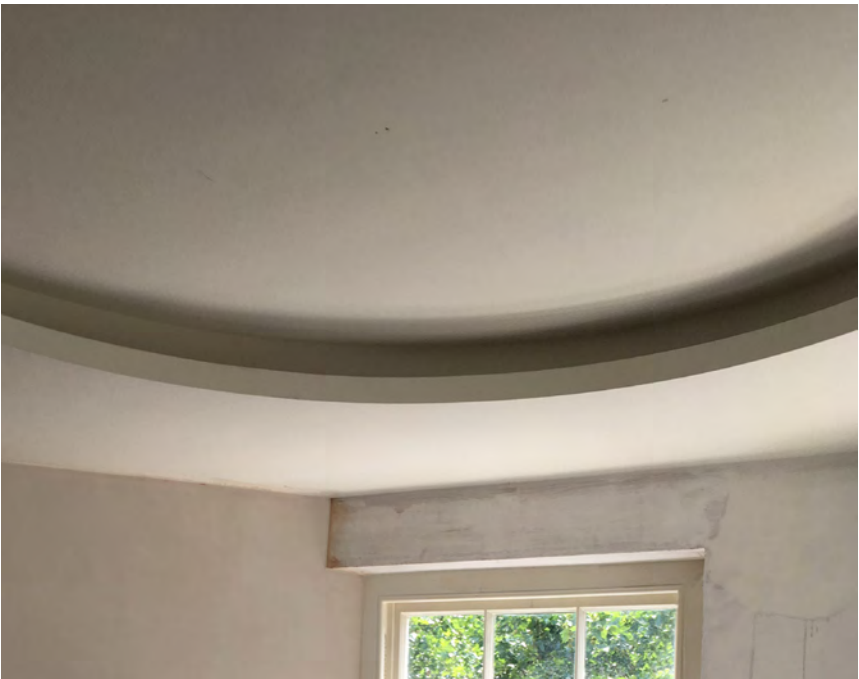
Photograph of as installed modern ceiling arrangement in rear bay to be retained.

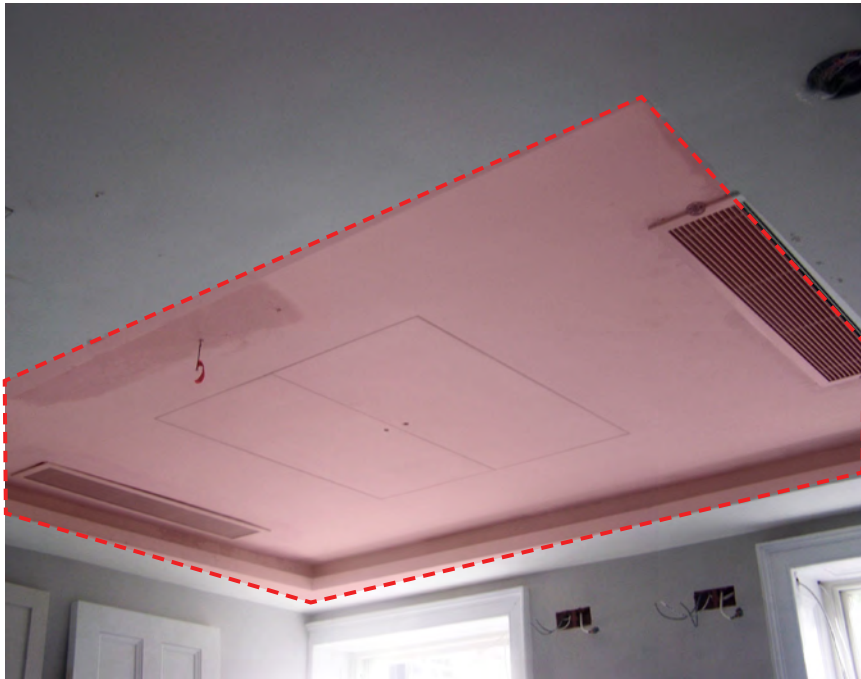
3.03. Modern ceiling to be modified to provide simple plain ceiling.

Carefully remove new modern suspended ceiling in coffer arrangement and replace with simple plain ceiling. High level socket outlet locations to be carefully removed and made good.

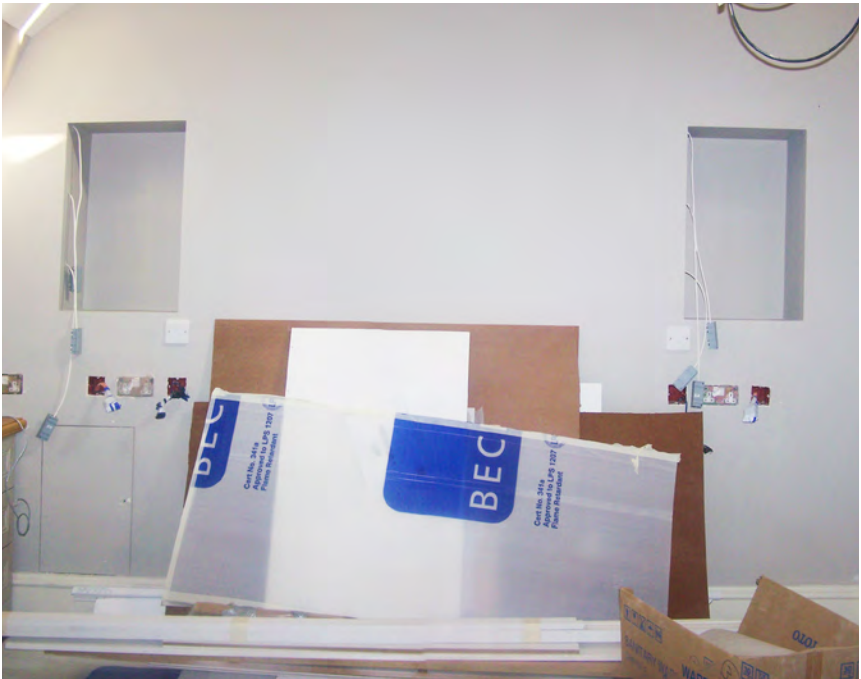
3.07. Wall lining with niches in front of chimney breast to be removed.

Remove new conservation roof lights and replace with roof build up to match existing. Install new modern flat ceiling beneath existing exposed roof timbers. New wall lining in front of chimney breast to be carefully removed. Recessed light fittings in window reveals to be carefully removed. Underfloor heating manifold to be relocated beneath concealed wash hand basin. Ceiling concealed fan coil units to be relocated to work with new ceilings.
