The Heath & Hampstead Society

To London Borough of Camden, Tree Preservation Team

Planning Ref: 2020/1700/T and 2020/1705/T
Address: 21 and 25 for subsidence case at 23A Nassington Road
Case Officer: Tom Little
Date: 29th May 2020

These two applications to fell willows accused of causing vegetation-related subsidence to the rear extension of 23A Nassington Road provide *no evidence* of significant tree involvement and the engineering appraisals are full of discrepancies.

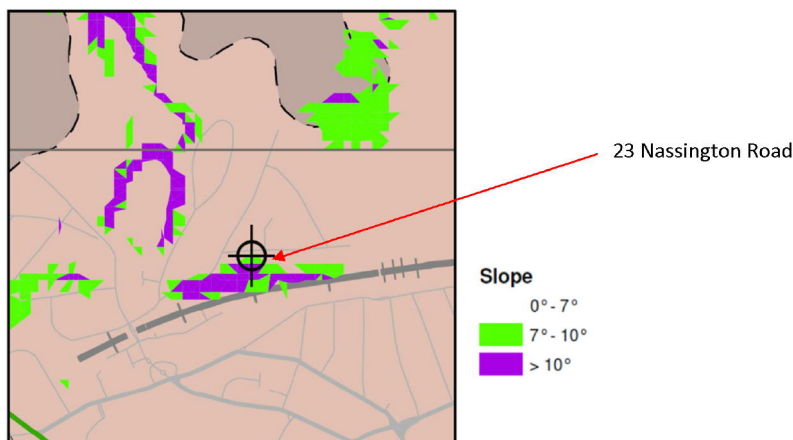
The plot is described as level. A description elsewhere of 9 Nassington Road indicates otherwise:

'The natural slope lies at between 7° and 10°, but falls more steeply beyond the rear boundary across the allotments down towards the London Overground railway.'

- as does Arup's 'Slope Angle Map' (Fig 16) from the 'Camden Geological, Hydrogeological and Hydrological Study':

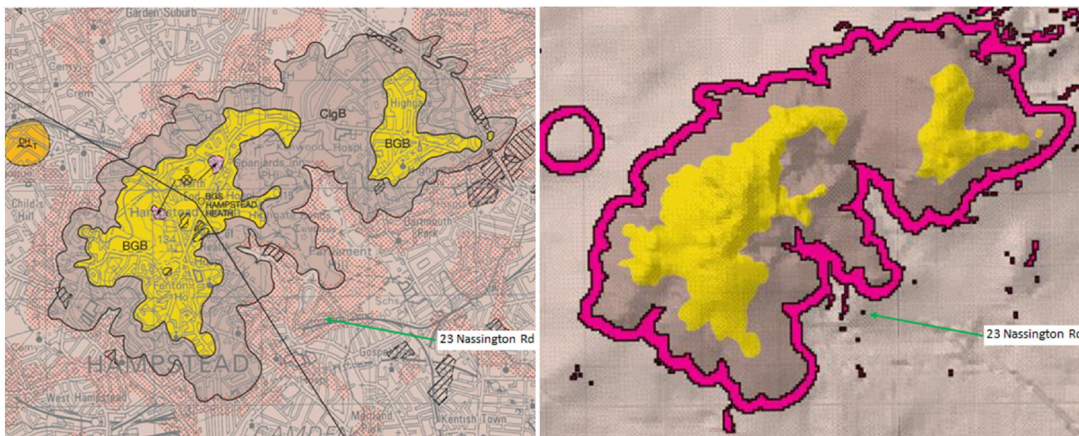
BGS 1:500,000 series N. London Sheet 256 Bedrock & Superficial Deposits BGS Survey Areas for Greatest Potential for Slope Instability
<http://www.largeimages.bgs.ac.uk/iip/mapsportal.html?id=1001750>

23 Nassington Road above the railway cutting lies on a thick superficial deposit of 'Head' (red stippled areas on geological map over). This deposit is permeable unlike the underlying clay and susceptible to sliding when disturbed. While 5-13 Nassington Road are, 23A Nassington Road is not on an area of greatest potential for slope instability (solid crimson, map over on right), but of course does not need to be, since it is already on a slope more acute than that known to cause sliding of clays, partly but not wholly due to the railway cutting dug here in the

C19. Add in an aquifer between the 'Head' and clay layers affecting water pressures within the clay and slip is a possibility, as is silt erosion due to groundwater or leaking drains water action. Drains can also cause heave followed by a greater degree of subsidence during dry weather (leaking rainwater drains) or family holidays (leaking waste water drains).
