The Heath & Hampstead Society

To London Borough of Camden, Tree Preservation Team

Planning Ref: 2020/1700/T and 2020/1705/T
Address: 21 and 25 for subsidence case at 23A Nassington Road
Case Officer: Tom Little
Date: 29th May 2020

These two applications to fell willows accused of causing vegetation-related subsidence to the rear extension of 23A Nassington Road provide *no evidence* of significant tree involvement and the engineering appraisals are full of discrepancies.

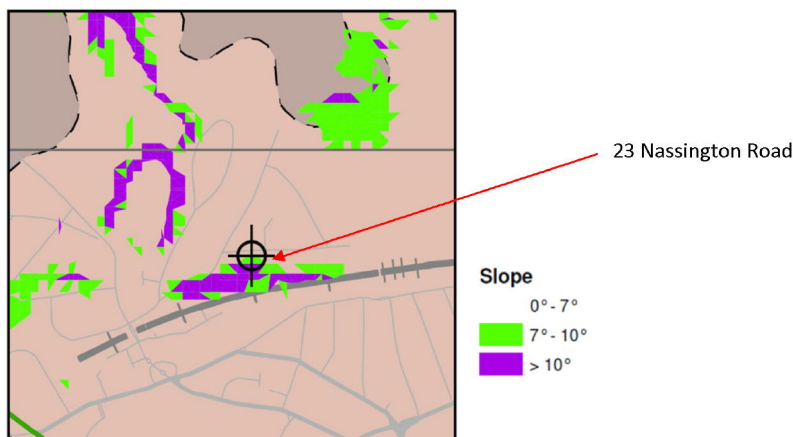
The plot is described as level. A description elsewhere of 9 Nassington Road indicates otherwise:

'The natural slope lies at between 7° and 10°, but falls more steeply beyond the rear boundary across the allotments down towards the London Overground railway.'

- as does Arup's 'Slope Angle Map' (Fig 16) from the 'Camden Geological, Hydrogeological and Hydrological Study':

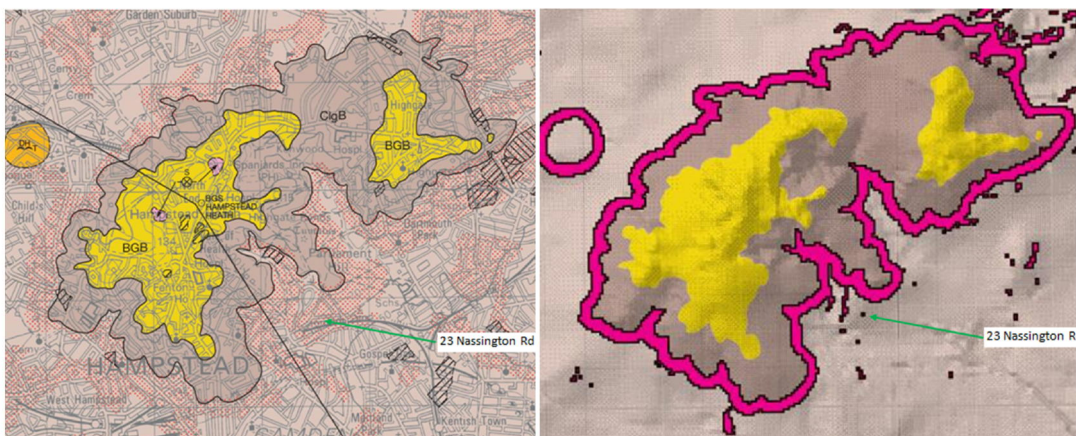
BGS 1:500,000 series N. London Sheet 256 Bedrock & Superficial Deposits BGS Survey Areas for Greatest Potential for Slope Instability
<http://www.largeimags.bgs.ac.uk/iip/mapsportal.html?id=1001750>

23 Nassington Road above the railway cutting lies on a thick superficial deposit of 'Head' (red stippled areas on geological map over). This deposit is permeable unlike the underlying clay and susceptible to sliding when disturbed. While 5-13 Nassington Road are, 23A Nassington Road is not on an area of greatest potential for slope instability (solid crimson, map over on right), but of course does not need to be, since it is already on a slope more acute than that known to cause sliding of clays, partly but not wholly due to the railway cutting dug here in the

C19. Add in an aquifer between the 'Head' and clay layers affecting water pressures within the clay and slip is a possibility, as is silt erosion due to groundwater or leaking drains water action. Drains can also cause heave followed by a greater degree of subsidence during dry weather (leaking rainwater drains) or family holidays (leaking waste water drains).
