5 HAMPSTEAD HILL GARDENS

CLIENT: MR & MRS BEECROFT - 5 HAMPSTEAD HILL GARDENS
PROJECT: FRONT WALL AND RAILINGS RECONSTRUCTION
TITLE: EXISTING PLAN AND ELEVATION
DATE: FEB 2017 SCALE: 1:50 DWG NO: BD-01

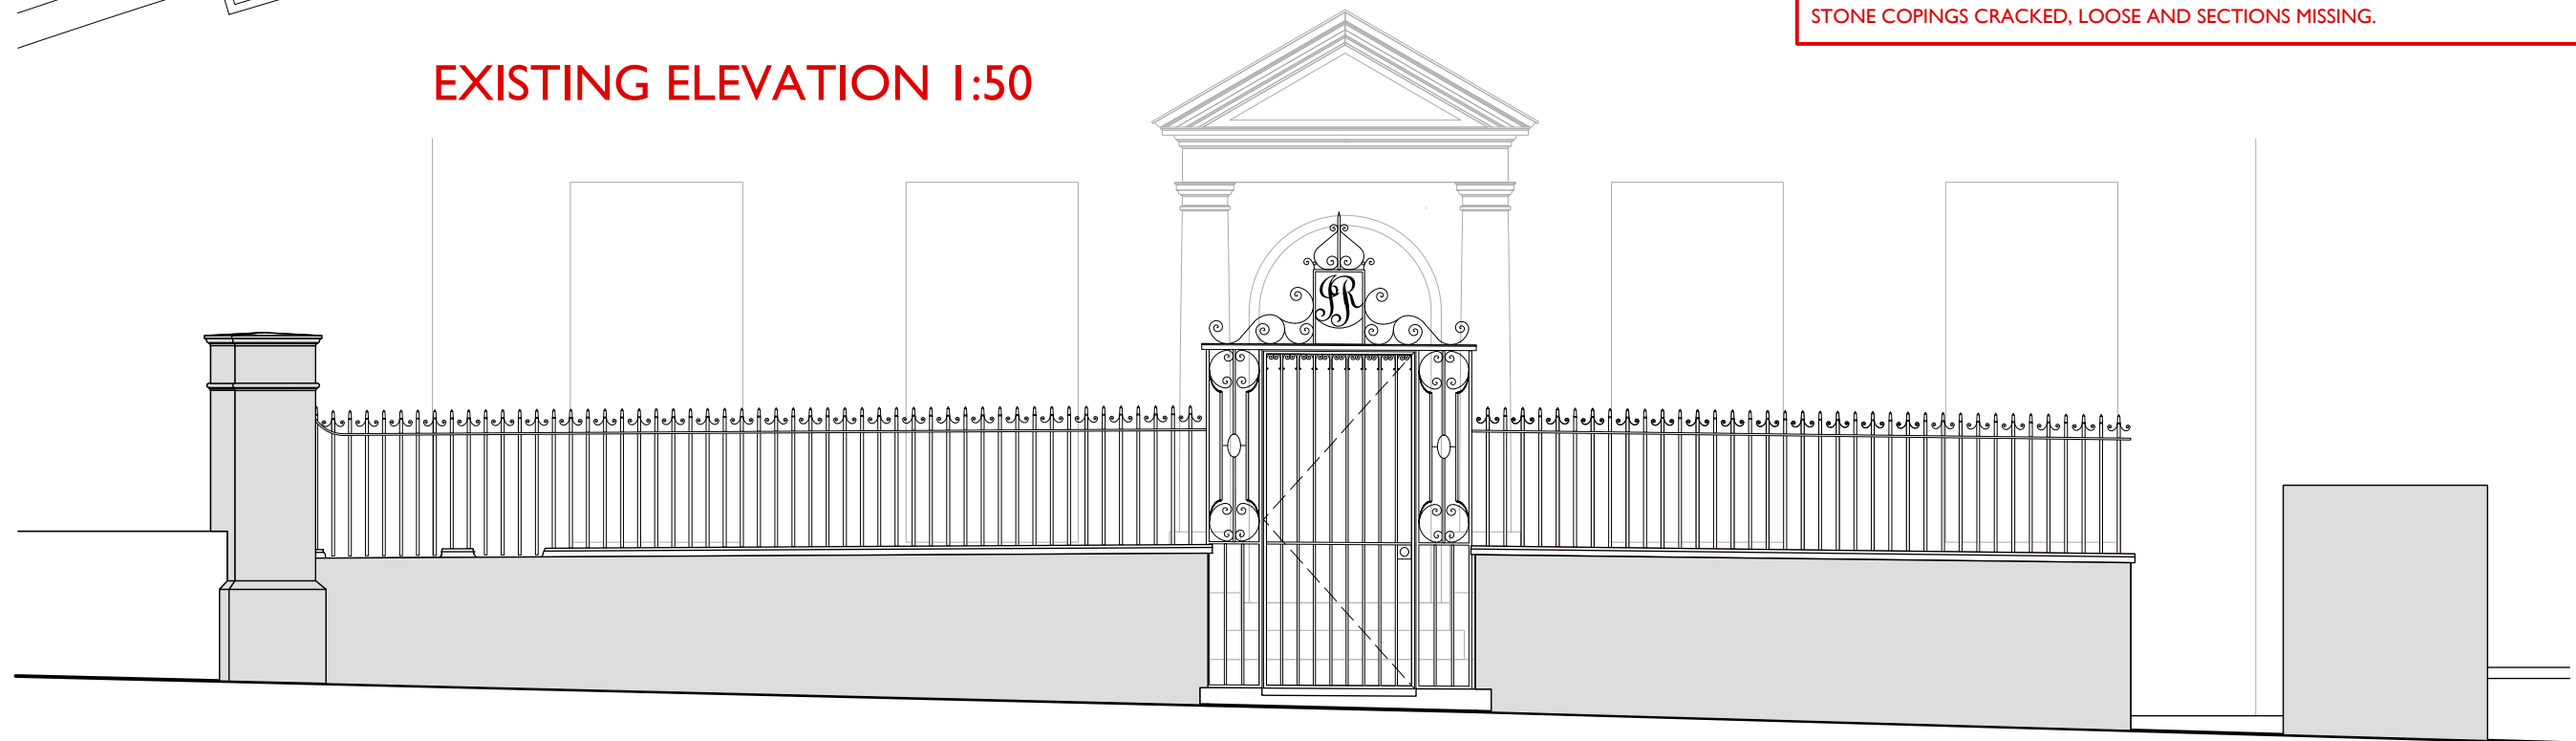
EXISTING ELEVATION 1:50

EXISTING RAILINGS AND GATE CORRODED AND UNSTABLE. GENERIC DETAIL ONLY SHOWN ON MAIN GATE AND SURROUNDING FRAME (SEE PHOTOGRAPHS FOR FULL DETAILS).
FRONT BOUNDARY WALL IN POOR STATE OF REPAIR, SUBJECT TO SETTLEMENT, LEANING AND UNSTABLE (SEE PHOTOGRAPHS).
STONE COPINGS CRACKED, LOOSE AND SECTIONS MISSING.
