**5b Prince Arthur Road, Hampstead, NW3 6AX**

**Tree survey and arboricultural method statement. May 2020.**

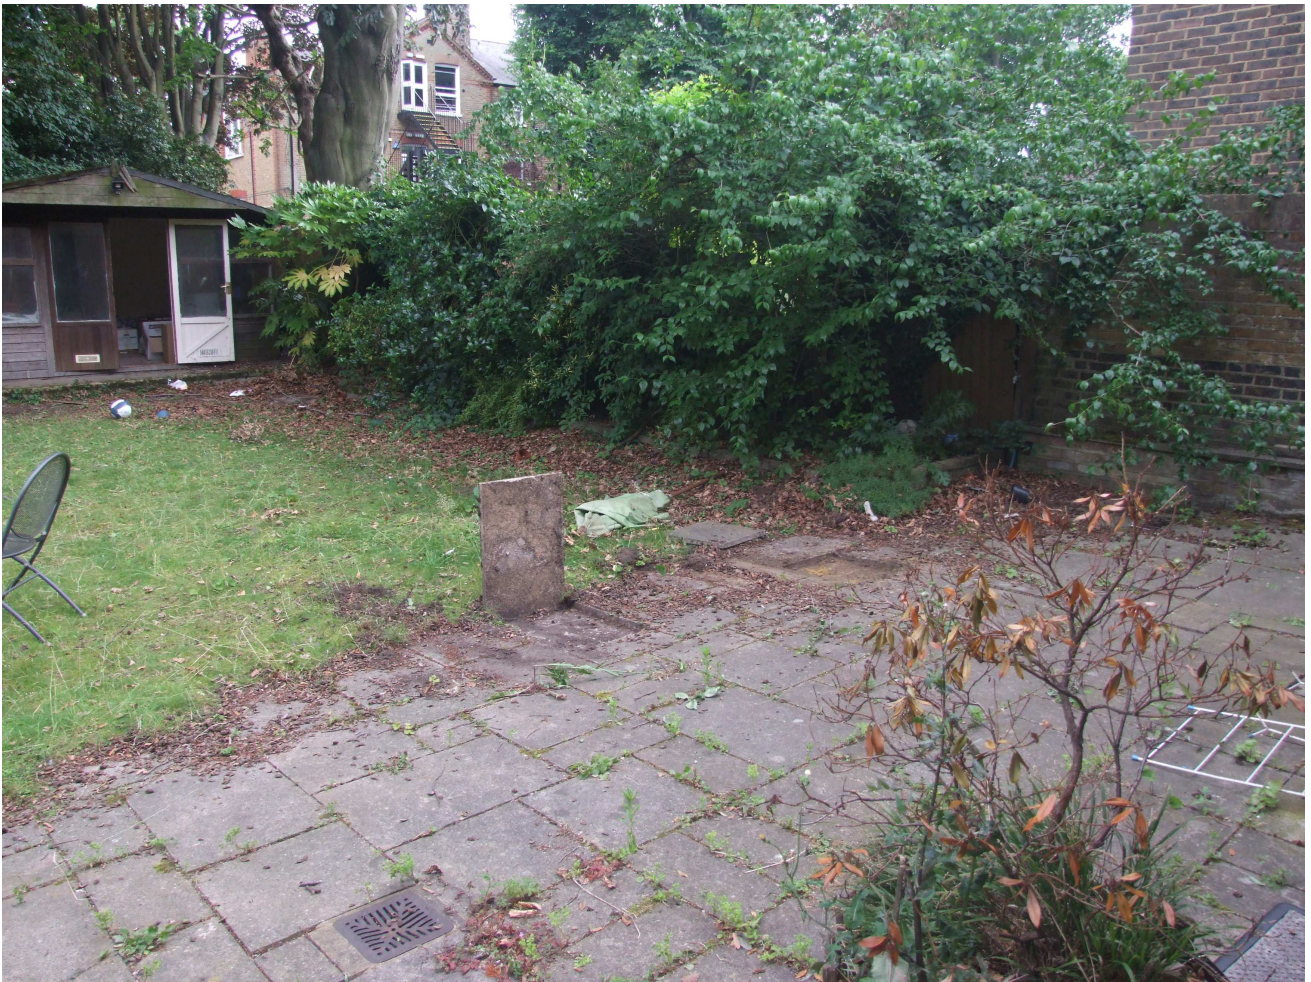
During its lifetime the Beech at 5b has had a substantial garden room built adjacent to it. The building is founded on concrete and is serviced. Presently it represents a significant rain shadow.

Investigations have revealed that paths, paving and raised beds are also laid on concrete.

Garden building and lifted paver to show extent of concreting. Present drainage increases the rain shadow effect of the pavers.

The building proposal removes the built features in the rear garden and introduces topsoil to make the entire area permeable and conducive to root growth.

Prior to any other building works the built features in the rear garden will be removed. This work will be done using hand held tools only.

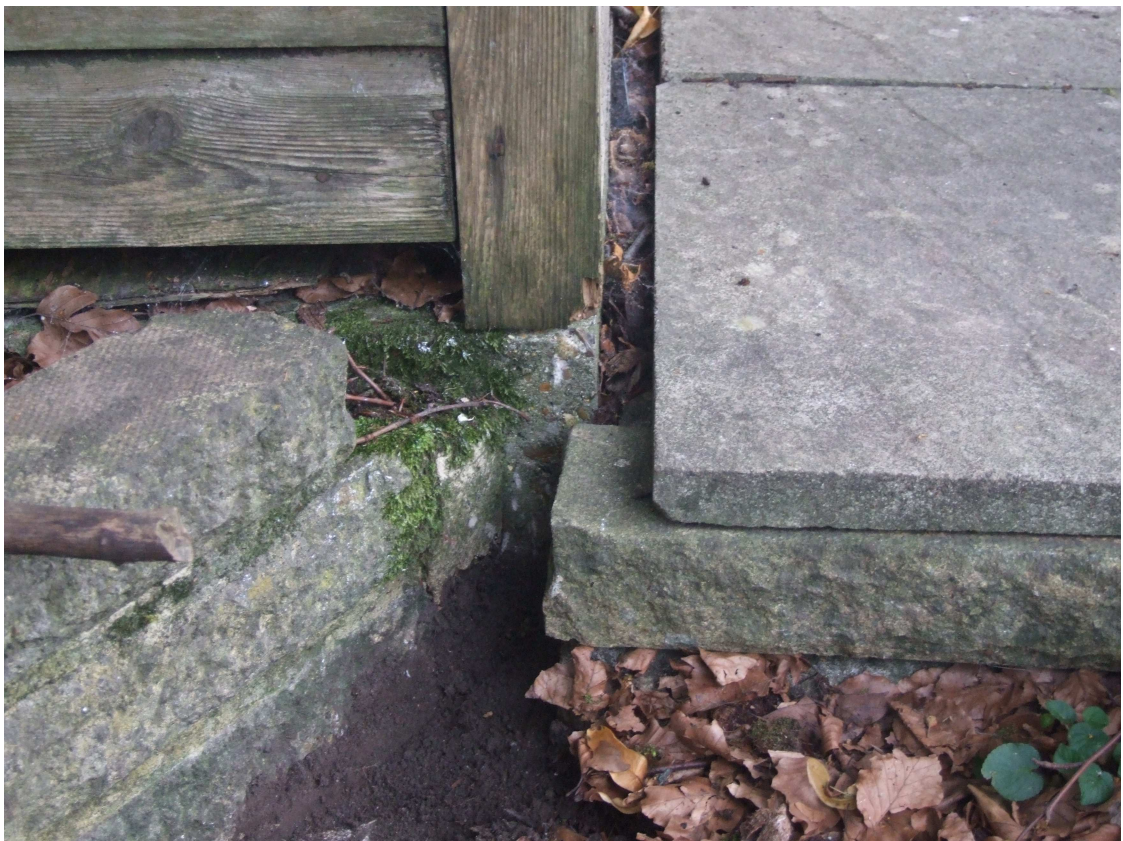
Detail of garden building foundations and associated built garden features.
