SITE INVESTIGATION FACTUAL REPORT

Report No: [REDACTED]
Client: Sedgwick International UK - Maidstone
Site: 17 Brookfield Park
Client Ref: [REDACTED]
Date of Visit: 13/01/2020

Home Emergency Response - Subsidence Investigation - Drainage Services – Crack & Level Monitoring – Property Video Surveys

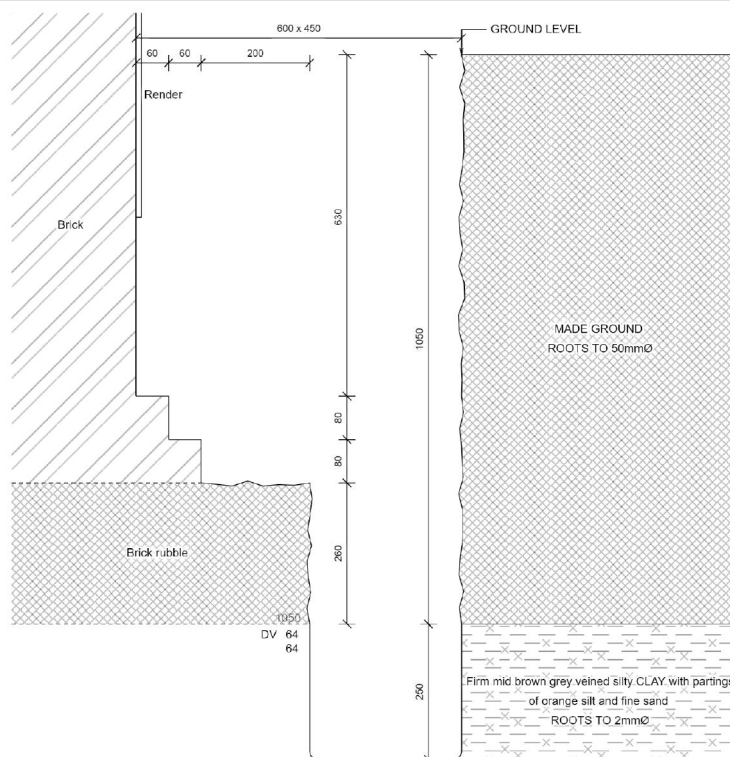
TRIAL PIT REF: TP1

For Strata below 1300mm see Bore Hole log
