TECHNICAL REPORT ON A SUBSIDENCE CLAIM

**Somerset House
31 Dartmouth Park Hill
London
NW5 1HR**

SUBSIDENCE CLAIM

29 October 2018

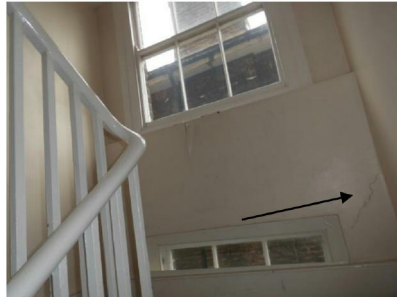
Mid landing rear window – cracks around window

Rear bathroom - Stepped crack above right of rear window, **Front lounge** - Separation crack to ceiling wall junction, **Front kitchen** - Separation crack to ceiling wall junction, **Front bedroom** - Separation crack to ceiling wall junction, **Communal area to 1st floor and mid landing** - Stepped cracks around the rear landing windows.

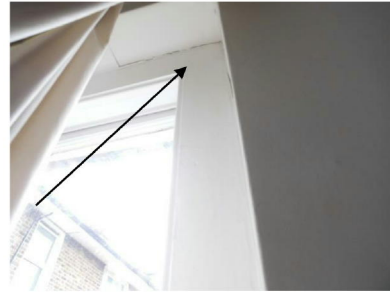
Separation crack around flat 4 rear bedroom window

1st floor flat 4 - Rear bedroom - Diagonal crack below left and above right of rear window 1 to 6mm with separation to ceiling wall junction.

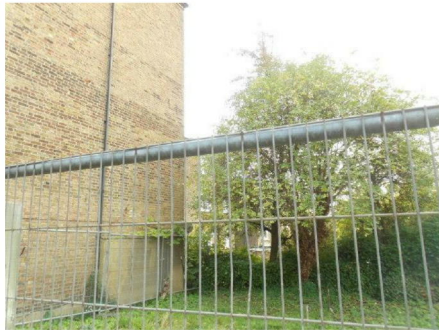
Type	Height	Distance	Ownership
T1 Pear	11 m	4 m	Neighbours
T2 Deciduous	8 m	2 m	Same owner who owns the land

Owners tree on land to the right T2

Although the cause of the movement needs to be dealt with, we note the involvement of a third party commercial tree. Unfortunately, they will require certain investigations to be carried out to demonstrate the influence of their vegetation.

Typically, these investigations would involve trial pit(s) to determine the depth and type of footings, boreholes to determine the nature of the subsoil/influence of any roots and monitoring to establish the rate and pattern of movement. It may also be necessary to obtain a specialist Arboricultural Report.

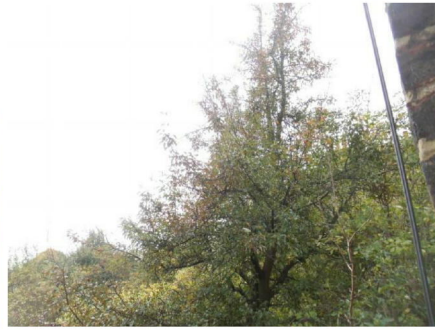
Neighbours tree to the rear T1

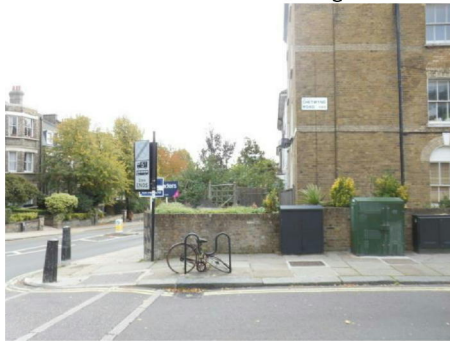
There has been a previous claim in 2015 reference SU1505185. This was finalised following completion of tree removals to the front left corner of the property. The front left corner of the property was repaired as part of the remedial works. The damage has now returned with similar damage to the same area and the old files will need to be re-opened to investigate further the cause of the damage. It is unclear if drainage works were completed.

Vegetation to front left corner

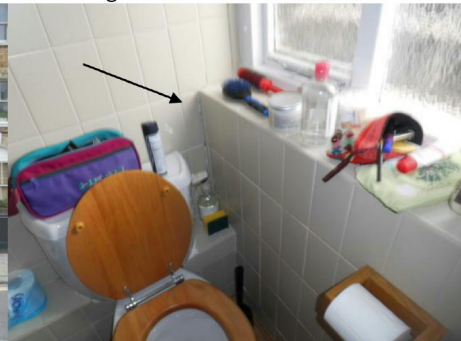
Ground floor flat 2 - Rear bathroom - Stepped cracks to rear wall around the window wall tiles.

Rear elevation - Stepped cracks around ground floor flat 2 bathroom window with cracks extending to 1st floor level.

Stepped cracks around ground floor rear window
