## Arboricultural Appraisal Report

### Subsidence Damage Investigation at:

Somerset House  
31 Dartmouth Park Hill  
London  
NW5 1HR

CLIENT:	Crawford & Company
CLIENT REF:	[REDACTED]
MWA REF:	[REDACTED]
MWA CONSULTANT:	George Peters BSc. (Hons)
REPORT DATE:	17/02/2020

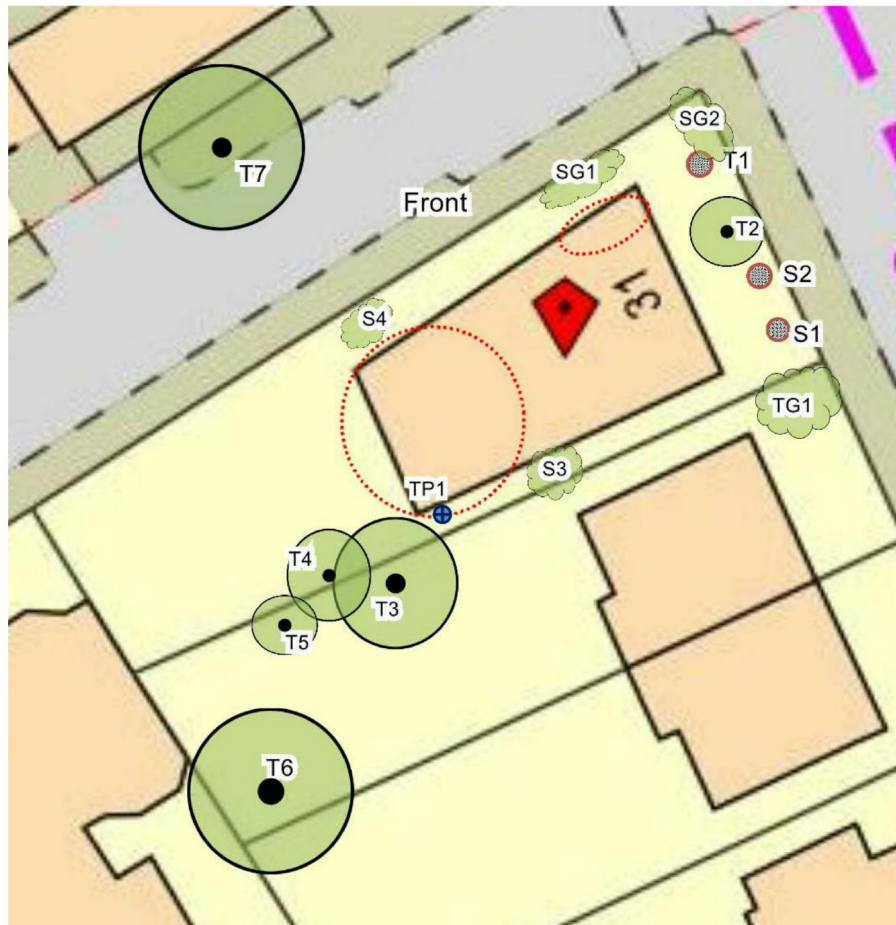
Site Plan

Approximate areas of damage

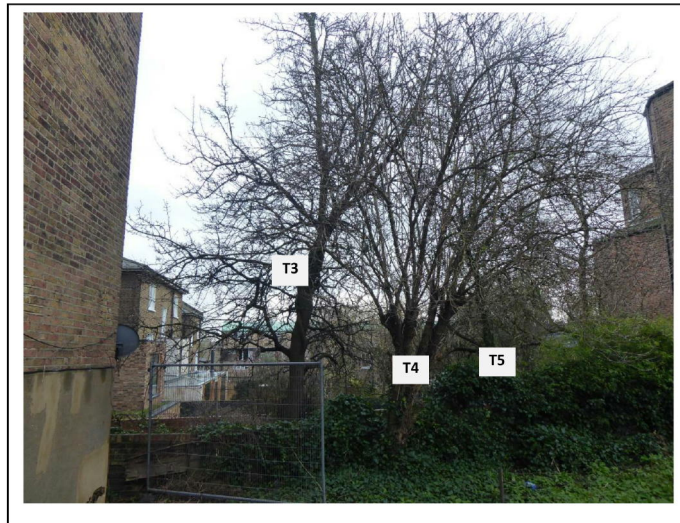
Irrespective of the identification of recovered root samples, the roots of SG2 (mixed species group including buddleia removed December 2019) and T2 (cherry) are likely to be influencing soil moisture (and therefore volumes) proximate to the damage at the front left-hand corner. Additionally, T3 (pear) T4 (elder) and T5 (pear) are also likely to be present below foundation level in proximity to the area of movement/damage to the right of the building.

Based on the technical reports currently available, engineering opinion and our own site assessment we conclude the damage is consistent with shrinkage of the clay subsoil related to moisture abstraction by vegetation. Having considered the information currently available, it is our opinion that SG2 and T2 – T5 are the principal cause of or are materially contributing to the current subsidence damage.

View of T3 pear, T4 elder and T5 pear, current claim.

If an arboricultural solution is to be implemented to mitigate the influence of the implicated trees/vegetation we recommend that further to the removal of SG2, T2 – T5 are removed. Other vegetation recorded presents a potential future risk to building stability and management is therefore recommended.

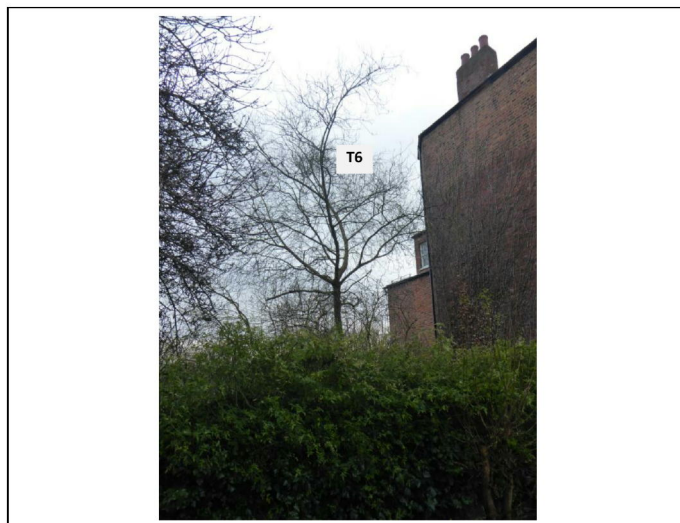
View of T6, possibly ailanthus (unable to positively ID due to access), future risk.

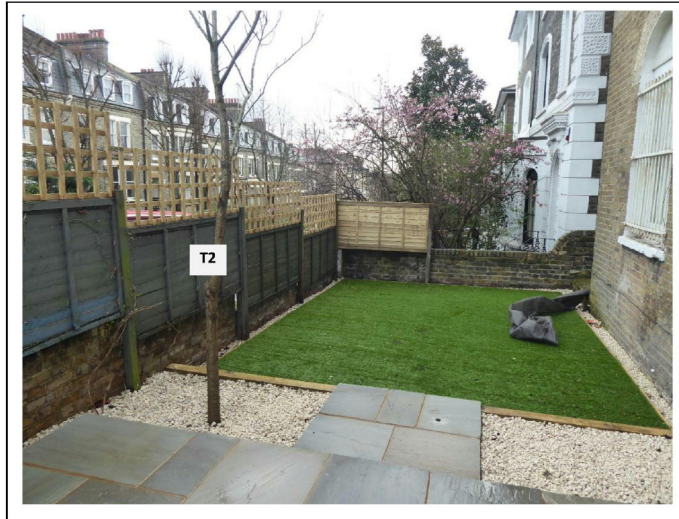
View of T2, cherry, current claim.

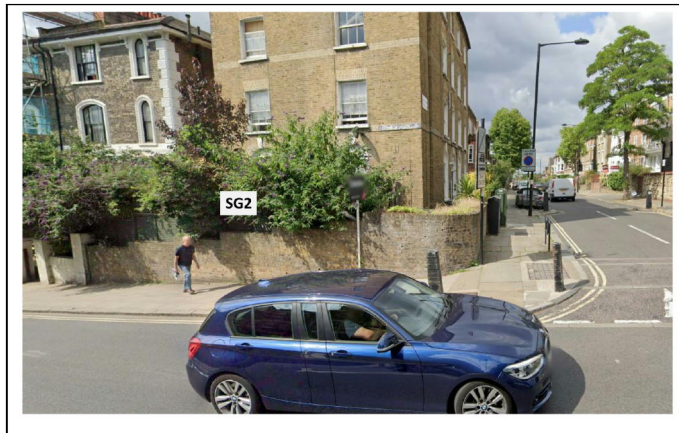
Google Street View July 2019 of SG2 mixed species including buddleia, removed December 2019, current claim.
