# TAVENER

## **3 Elm Row, London NW3: - Window Survey 7<sup>th</sup> May 2020, Rev: C**

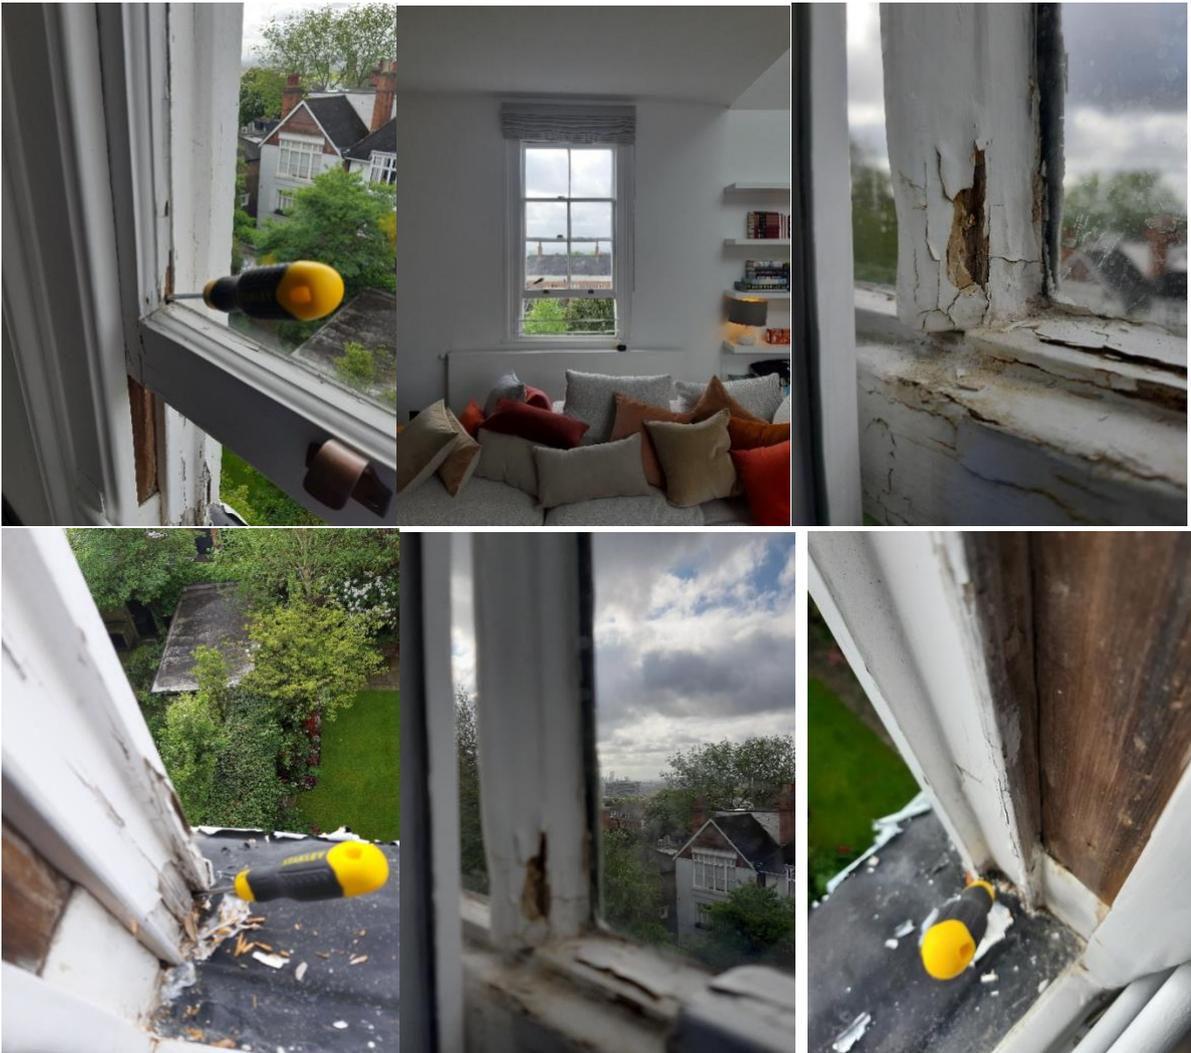
### 3F-W1 – seating area – approx. 1900 x 1100mm

Box frame & sashes in a poor state with pulley stiles, outside lining & cill ends decaying. Was unable to see further along cill due to lead covering. Bottom sash bottom rail & stiles starting decay. Top sash meeting rail & bar decaying & separating due to tenon rotting.

Recommendation: - Replace sashes & parting beads, carry out repairs to lower section of box. Splice in new sections of pulley stiles, outside linings, inside linings, strip back lead from cill & repair as necessary.

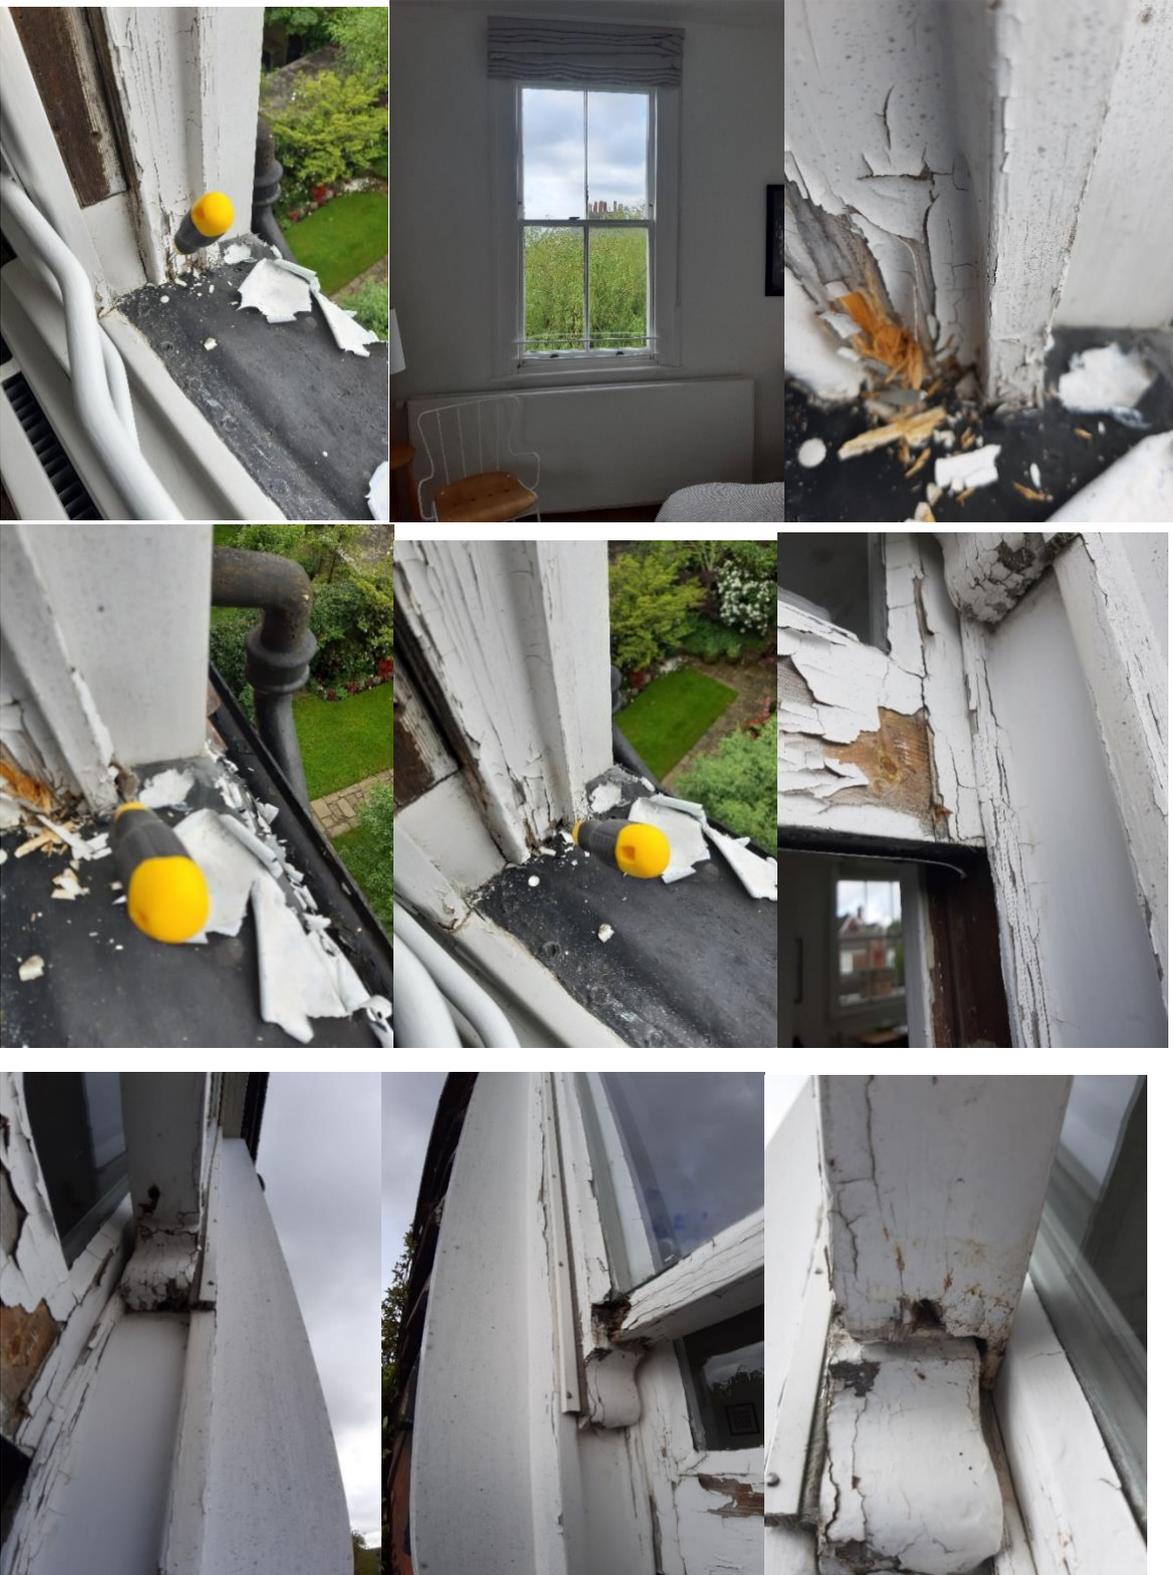
### 3F-W2 – Bed area – approx. 1900 x 1100mm

Box frame pulley stiles, outside lining & cill as TFW1. Bottom sash bottom rail & stiles showing signs of decay.

Top sash meeting rail & stile decayed to the point that the rail is loose. This sash is dangerous & should not be opened as glass is mainly supported by the putty above.

Recommendation: - Replace sashes & parting beads, carry out repairs to lower section of box. Splice in new sections of pulley stiles, outside linings, inside linings, strip back lead from cill & repair as necessary.

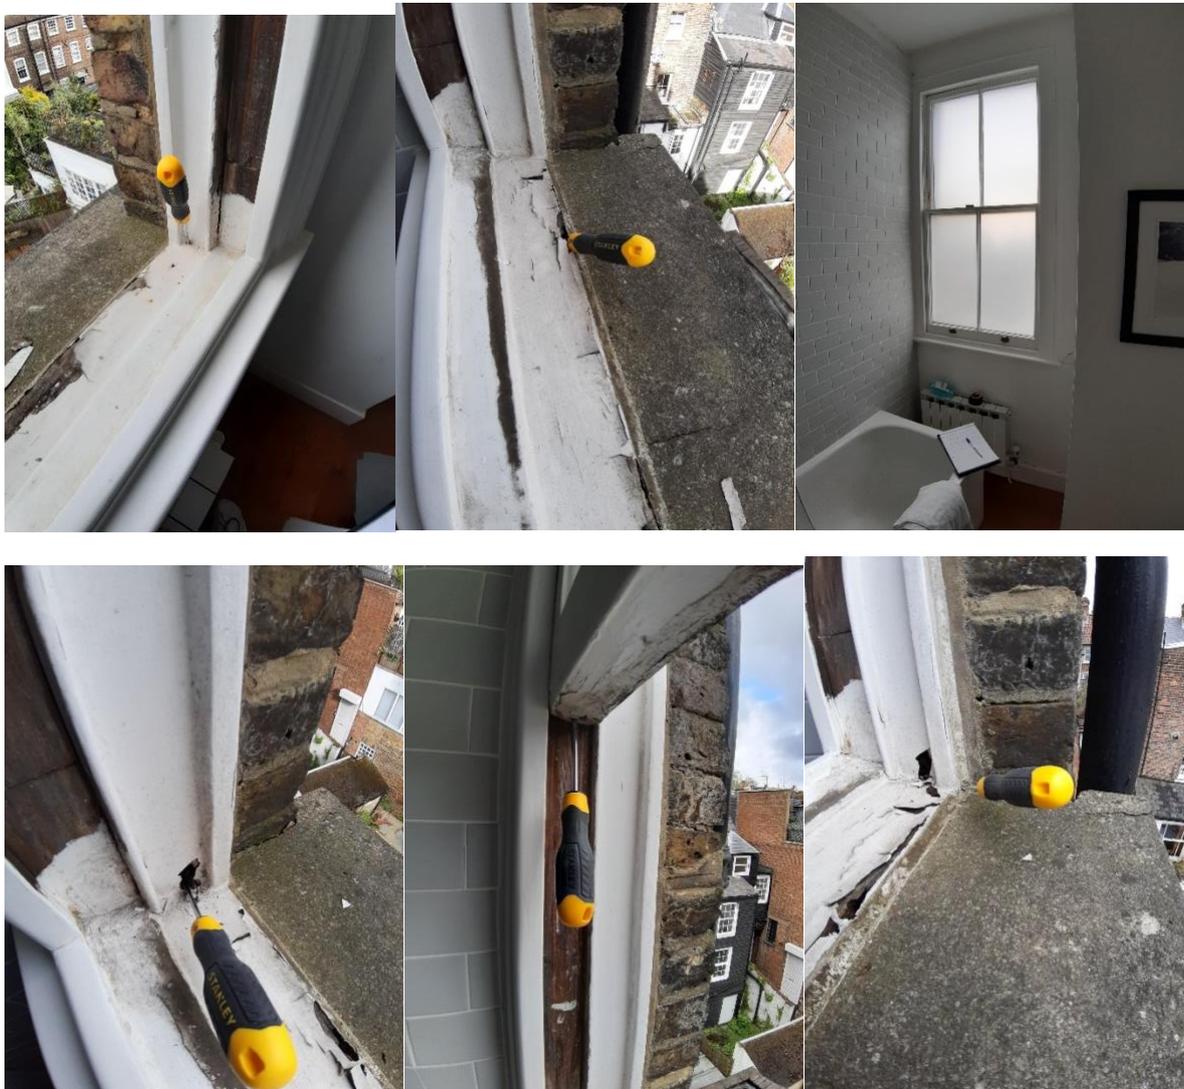
**3F-W3 – Bathroom – approx. 1900 x 1000mm**

Box frame cill decaying due to water ingress behind stone cill as this is not on top of stone cill (poor detail).

Pulley stiles decayed at bottom, bottom sash stile base showing early decay, top sash not accessible due to being painted shut.

Recommendation: - Replace sashes & parting beads, carry out repairs to lower section of box. Splice in new sections of pulley stiles, outside linings, inside linings, repair cill as necessary.

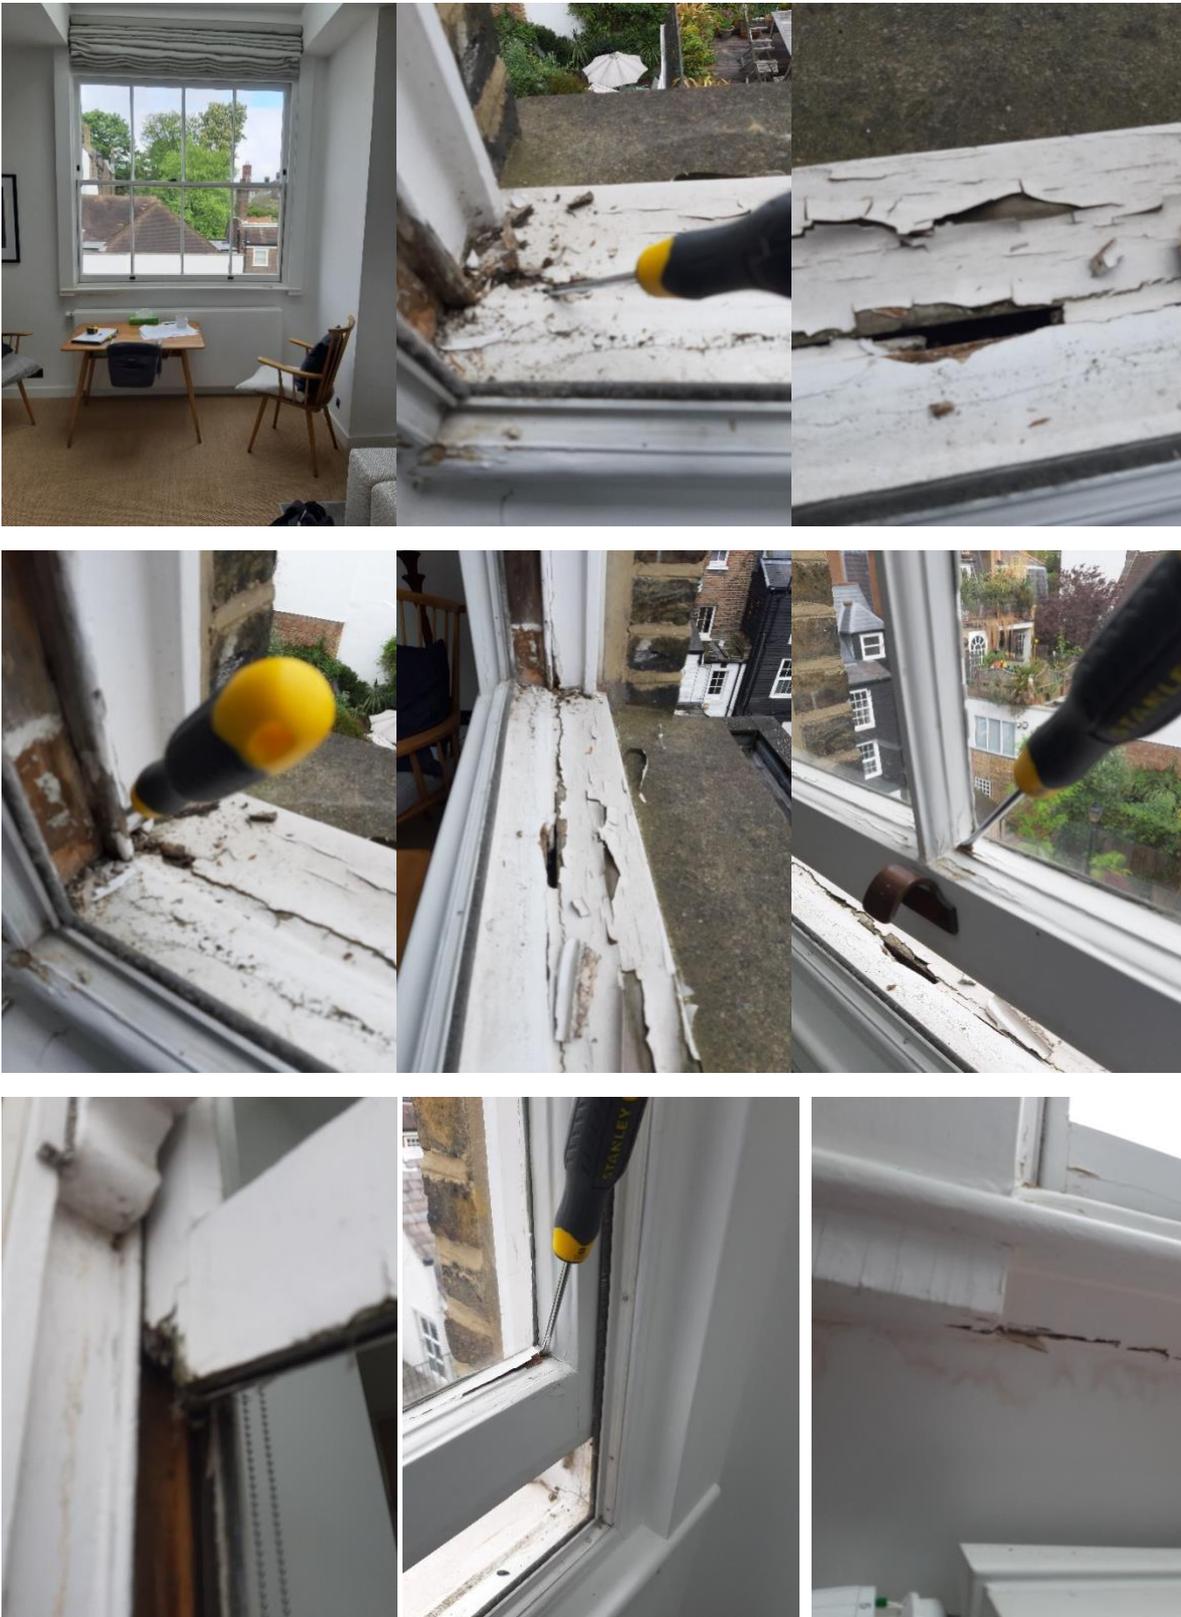
### **3F-W5 – Dining / seating – approx. 1900 x 2100mm**

Cill ends, pulley stiles & outside linings showing decay, large gaps along cill. Bottom sash bottom rail & stile decaying & part missing. Top sash has one cracked pane. Signs of water ingress on inside wall from outside due to poor cill condition.

Recommendation: - Replace sashes & parting beads, carry out repairs to lower section of box. Splice in new sections of pulley stiles, outside linings, inside linings. Repair cill as necessary.

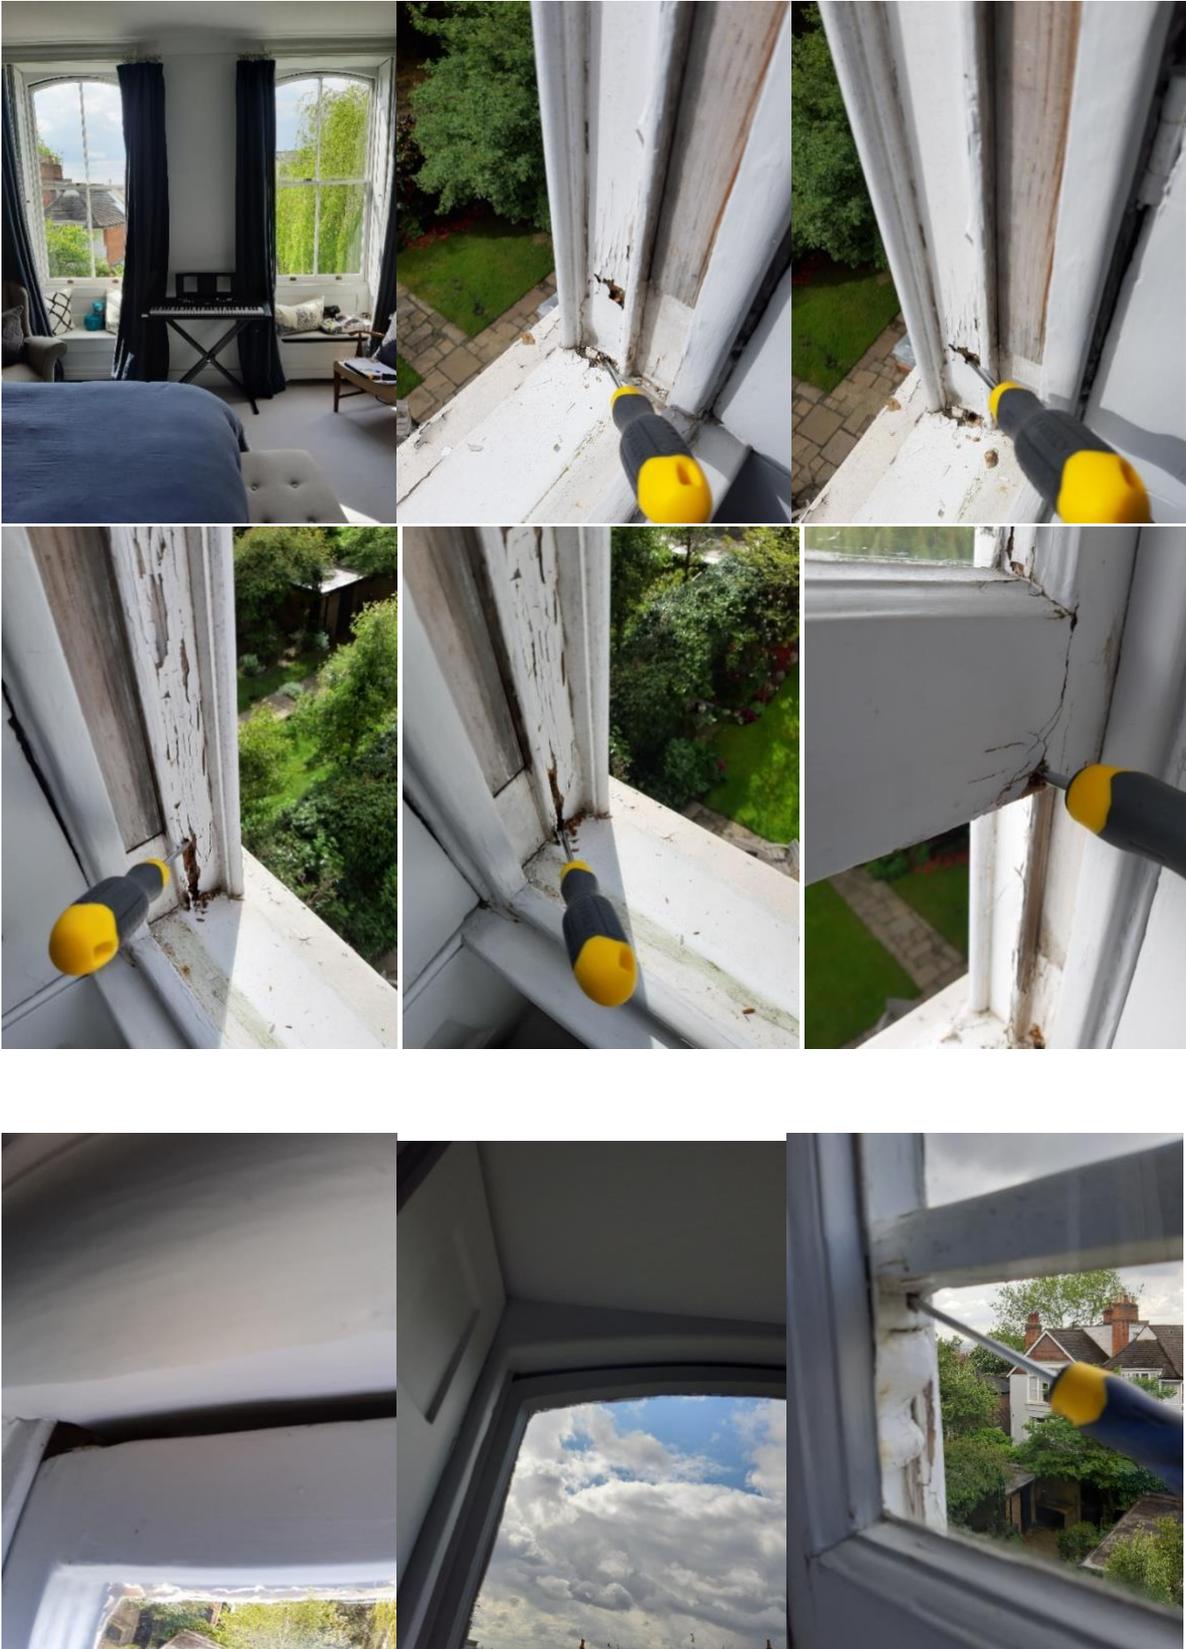
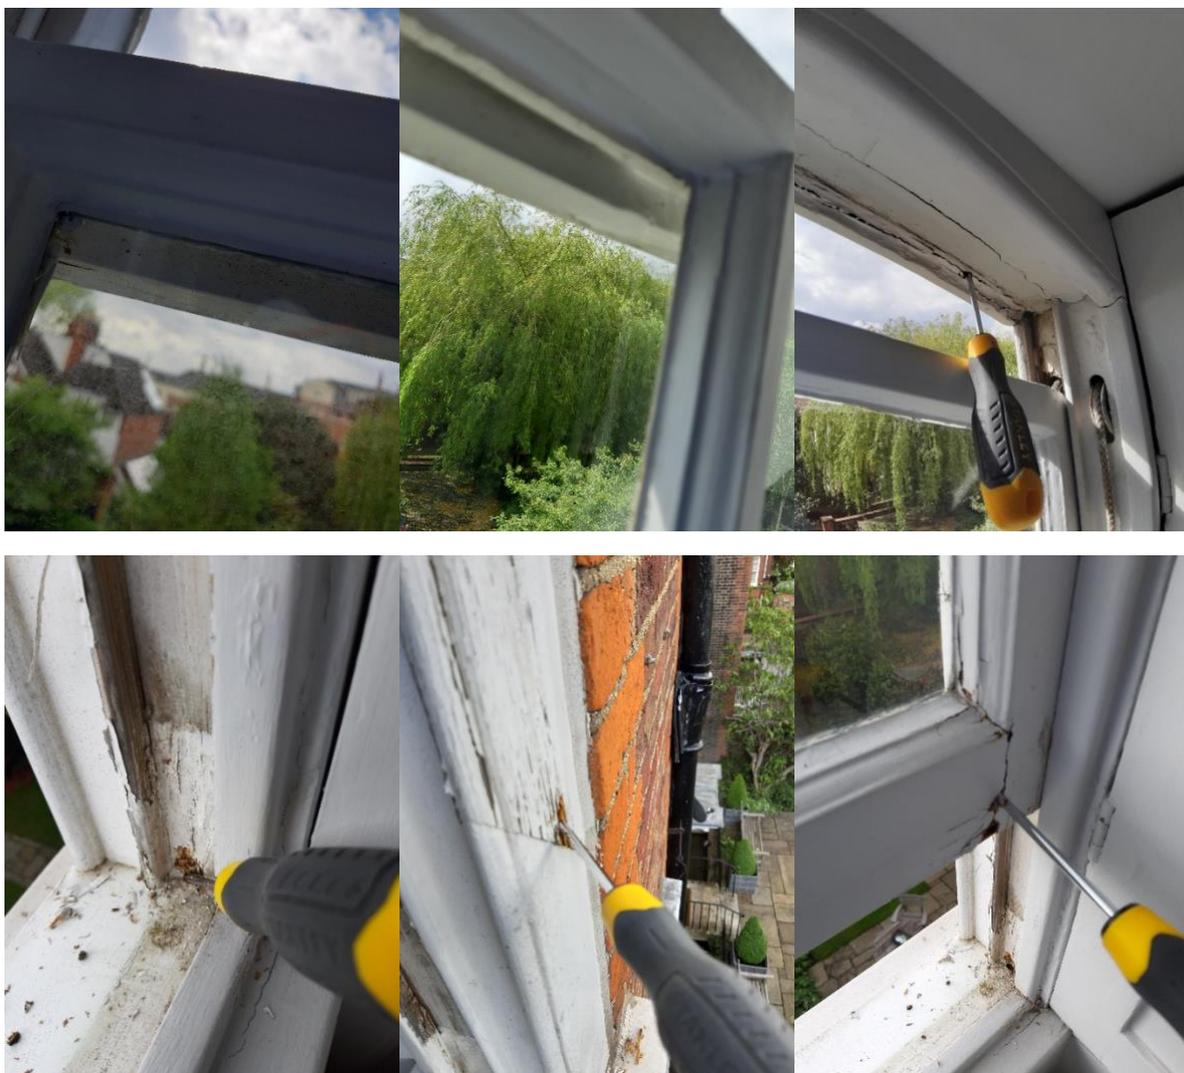
R/H side of cill & pulley stile showing decay. L/H outside lining decayed above previously spliced repair. Top sash meeting rail & stile decay. Meeting rails do not meet. Head & outside head lining decay.

Cill, pulley stile & l/h outside lining have decay. Top sash meeting rail has repair brackets with decay under. Meeting rails do not meet. Head & outside head lining have decay.

Recommendation: - Replace sashes & parting beads, carry out repairs to lower section of box. Splice in new sections of pulley stiles, outside linings, inside linings. Repair cill as necessary.

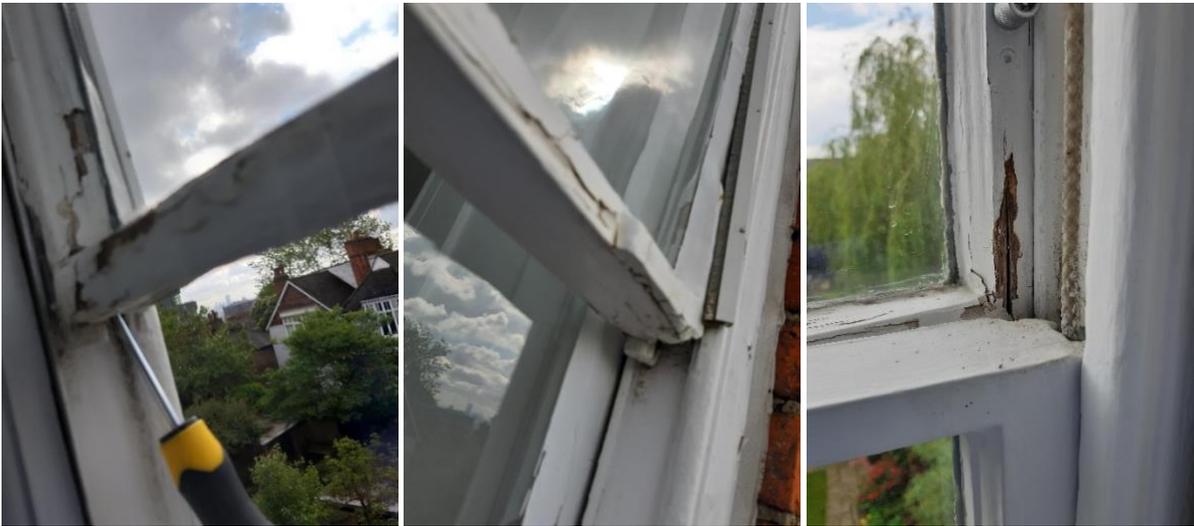
**2F-W3 – landing – 1900 x 1100mm – arched head.**

Decay at cill ends & pulley stiles. Top sash meeting rail & stile decayed, horn missing, rail dropped in centre, vertical bar loose. Top sash a hazard. Bottom sash bottom rail decay at bar & stile junction.

Recommendation: - Replace sashes & parting beads, carry out repairs to lower section of box. Splice in new sections of pulley stiles, outside linings, inside linings. Repair cill as necessary.

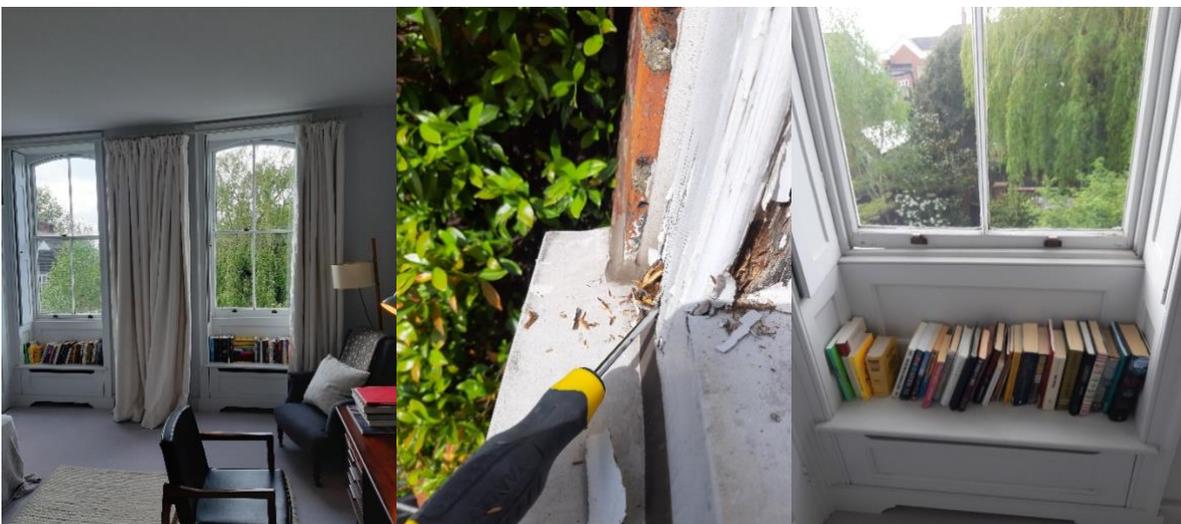
Pulley stiles & cill decay, outside lining decay above previous splice repair on both sides. Bottom sash bottom rail has decay at stiles and vertical bar, very poor fit at top and bottom due to previous subsidence, can see through to the outside, top sash meeting rail showing some decay behind previously installed repair brackets. Meeting rails do not meet.

Pulley stiles & cill decay, outside lining decay above previous splice repair. Bottom sash bottom rail has decay at stiles and vertical bar, very poor fit at top and bottom, due to previous subsidence, can see through to the outside, top sash meeting rail showing some decay behind previously installed repair brackets. Meeting rails do not meet.

Recommendation: - Replace sashes & parting beads, carry out repairs to lower section of box. Splice in new sections of pulley stiles, outside linings, inside linings. Repair cill as necessary.

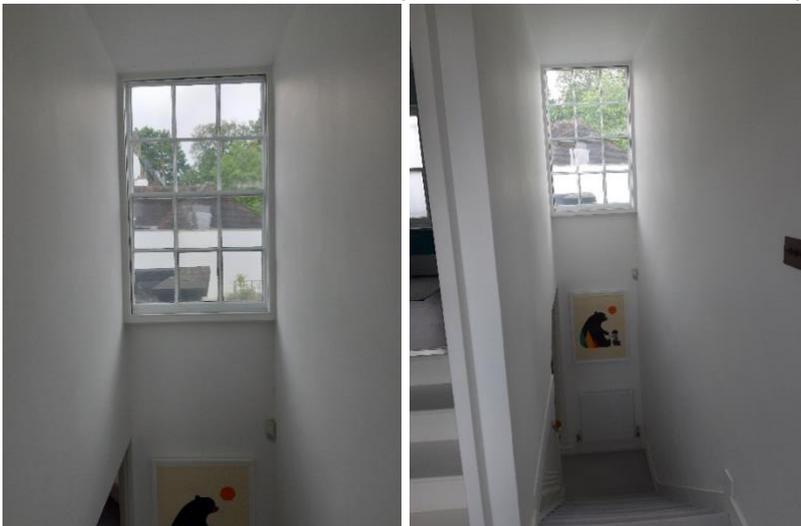
Top sash only operable, bottom sash painted shut. No access to outside due to bars therefore minimal view available to assess condition. Looks as if there is some decay at cill and pulley stiles, will need access to confirm.

Further access required to be able to confirm works required.

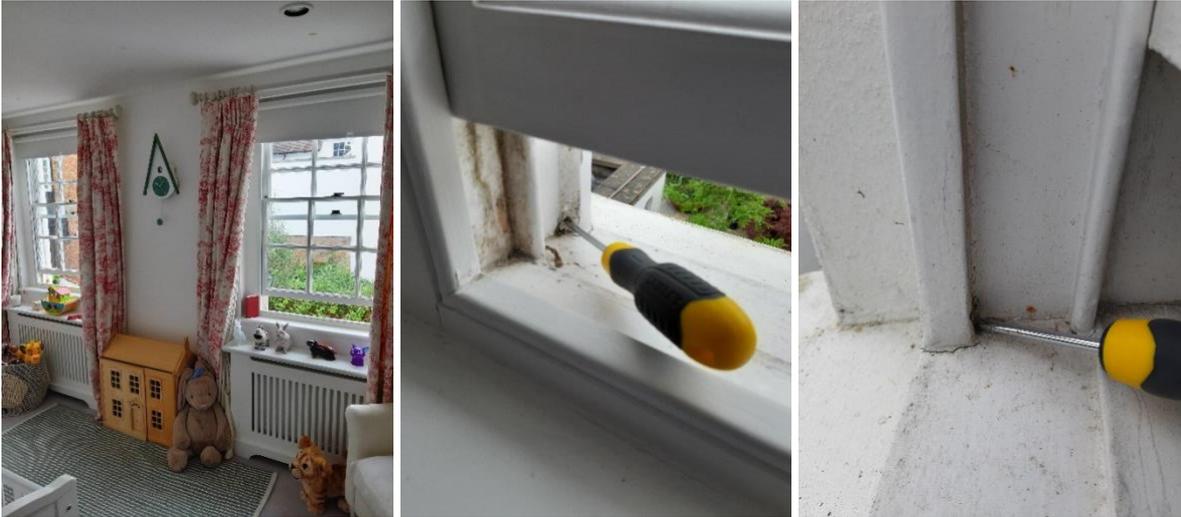
## Mezzanine bedroom 1 & 2 – approx. 1350 x 1050mm

Early decay to cill, pulley stile & outside lining.

Recommendation: - Carry out minor repairs.

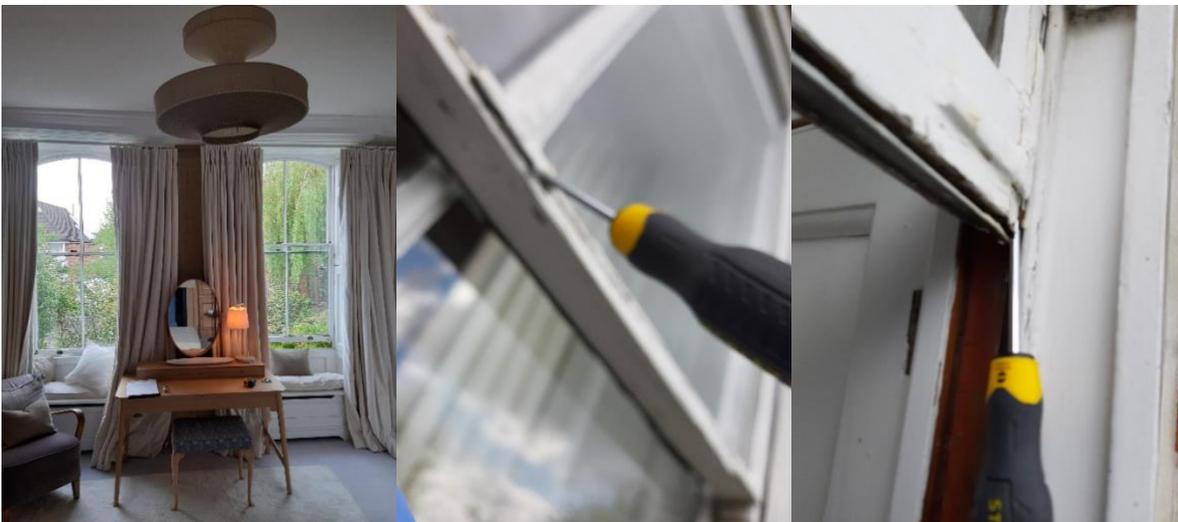
Left hand cill, pulley stile & outside lining decay.

Bottom sash bottom rail decayed, needs replacing.

Top sash meeting rail decaying.

Recommendation: - Replace sashes & parting beads, carry out repairs to lower section of box. Splice in new sections of pulley stiles, outside linings, inside linings. Repair cill as necessary.

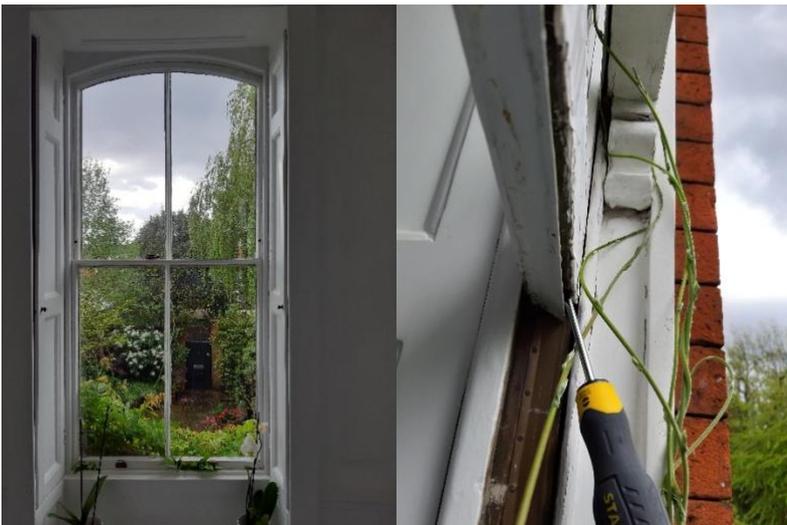
### **1F-W3 – landing – approx. 2000 x 1100mm – arched head.**

Bottom sash bottom rail decaying needs replacing. Meeting rails do not meet.

Recommendation: - Replace sashes & parting beads, carry out repairs to lower section of box. Splice in new sections of pulley stiles, outside linings, inside linings. Repair cill as necessary.

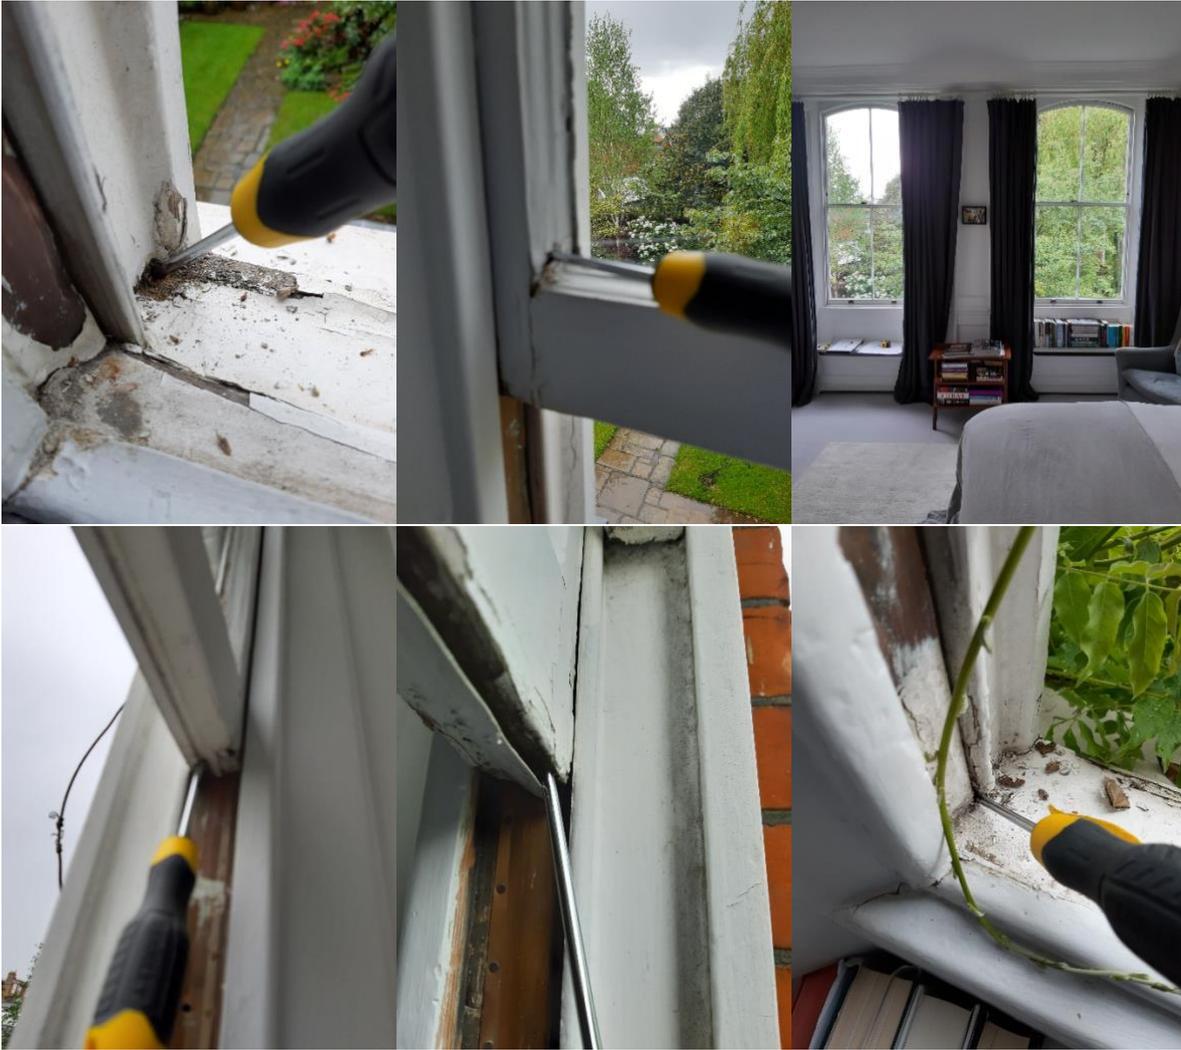
1F-W5 -

Decay to cill & pulley stile on left hand side. Decay to bottom sash bottom rail – replace. Signs of decay to top sash meeting rail.

Recommendation: - Replace sashes & parting beads, carry out repairs to lower section of box. Splice in new sections of pulley stiles, outside linings, inside linings. Repair cill as necessary.

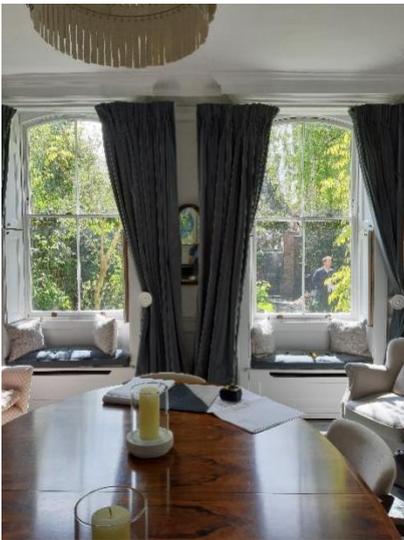
Some decay to bottom sash bottom rail. 1No pane of glass cracked.

Sashes need re weighting.

Recommendation: - Repair rail as necessary & replace broken glass.

Recommendation: -Re-weight sashes.

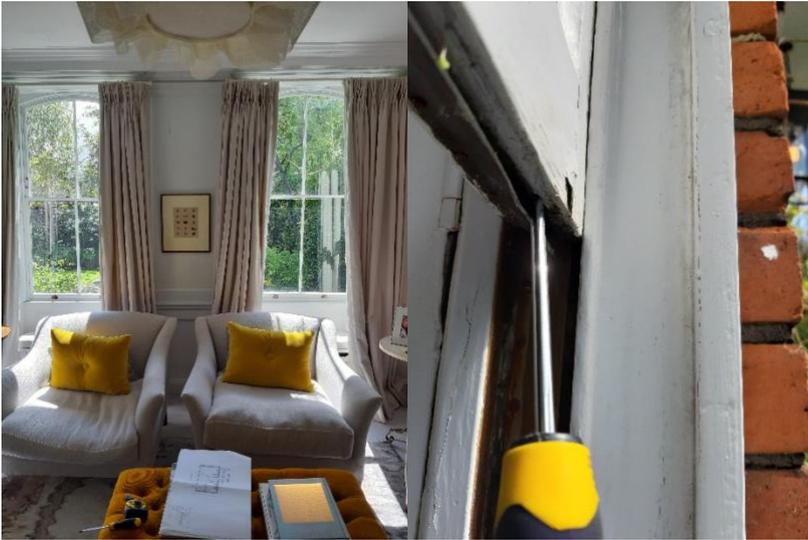
Decay to cill behind parting bead. Decay to bottom sash bottom rail.

Slight decay, but condition ok.

Recommendation: - Repair cill & rail as necessary.

Recommendation: -Minor repair and decoration.
