## 7.1 APPENDIX: POST-FIRE PHOTOGRAPHIC SURVEY- INITIAL SITE VISIT

## 7.2 APPENDIX: POST-FIRE PHOTOGRAPHIC SURVEY- PRE-DEBRIS REMOVAL

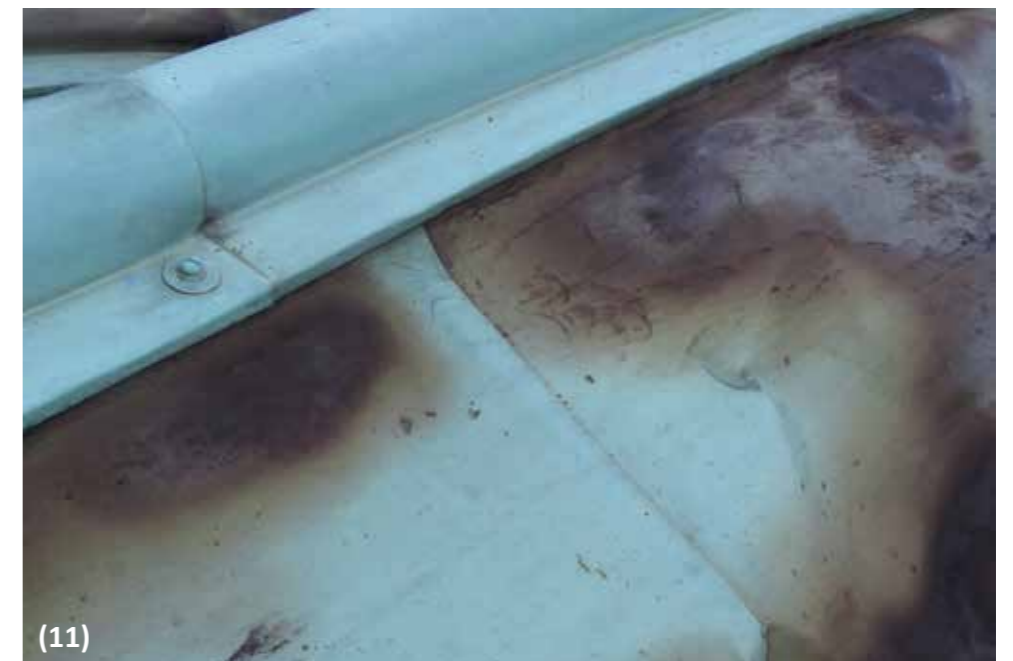
(11)

### 11. Damaged and collapsed copper roof cladding detailing

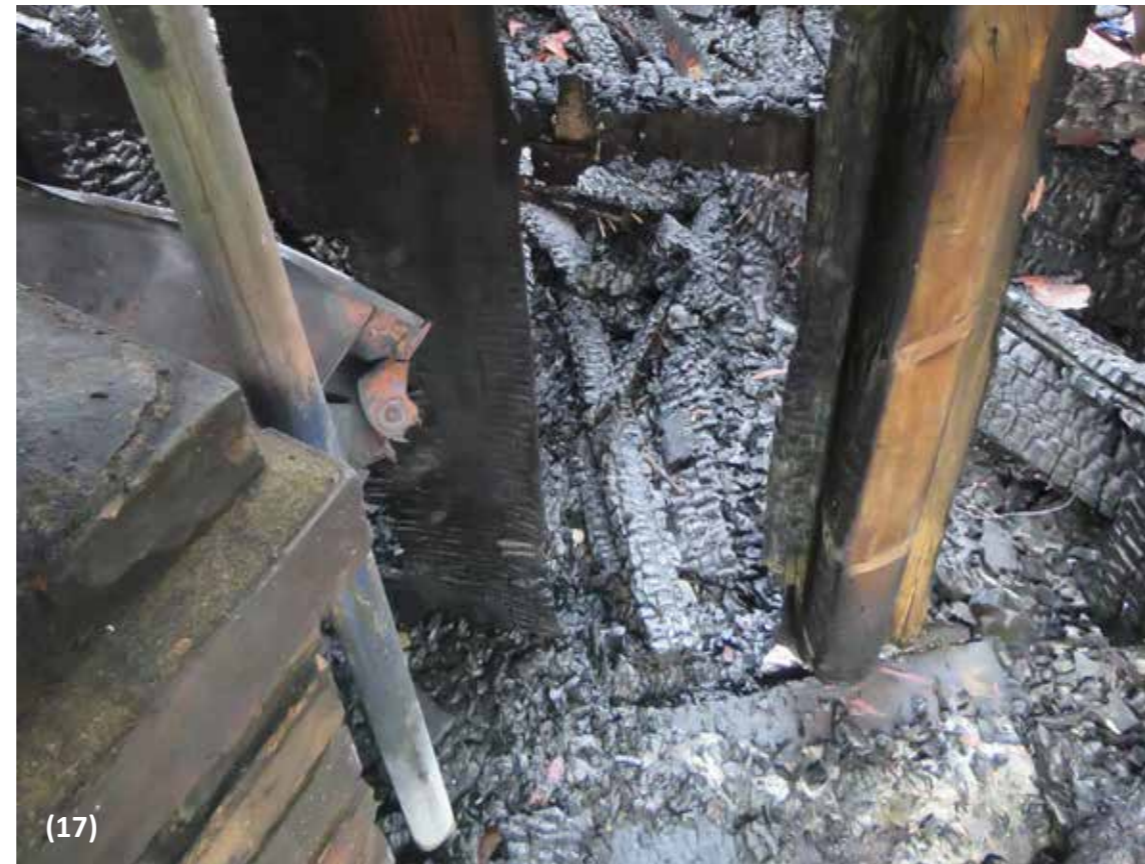
(17)

### 17. View down of amount of debris by the perimeter ring

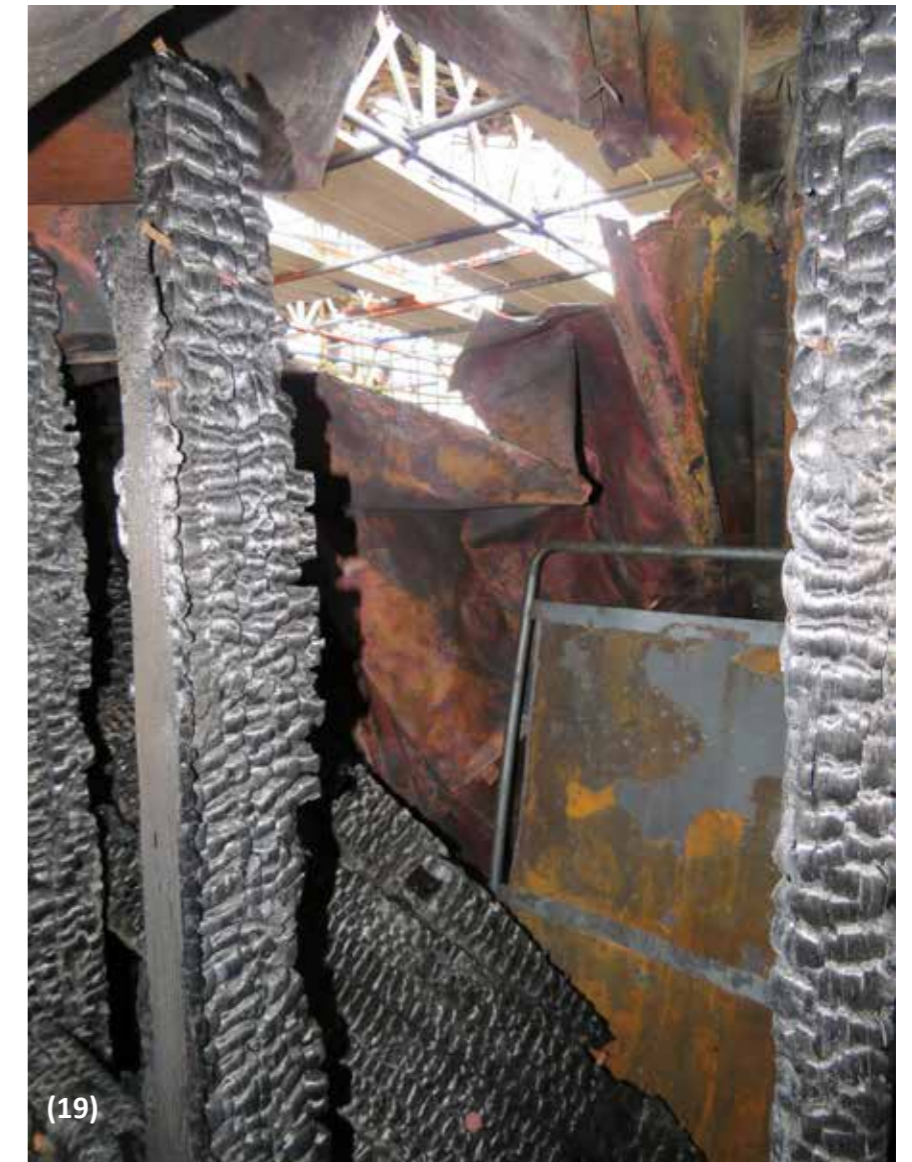
(19)

### 19. Damaged fire extinguisher signboard inside the dome

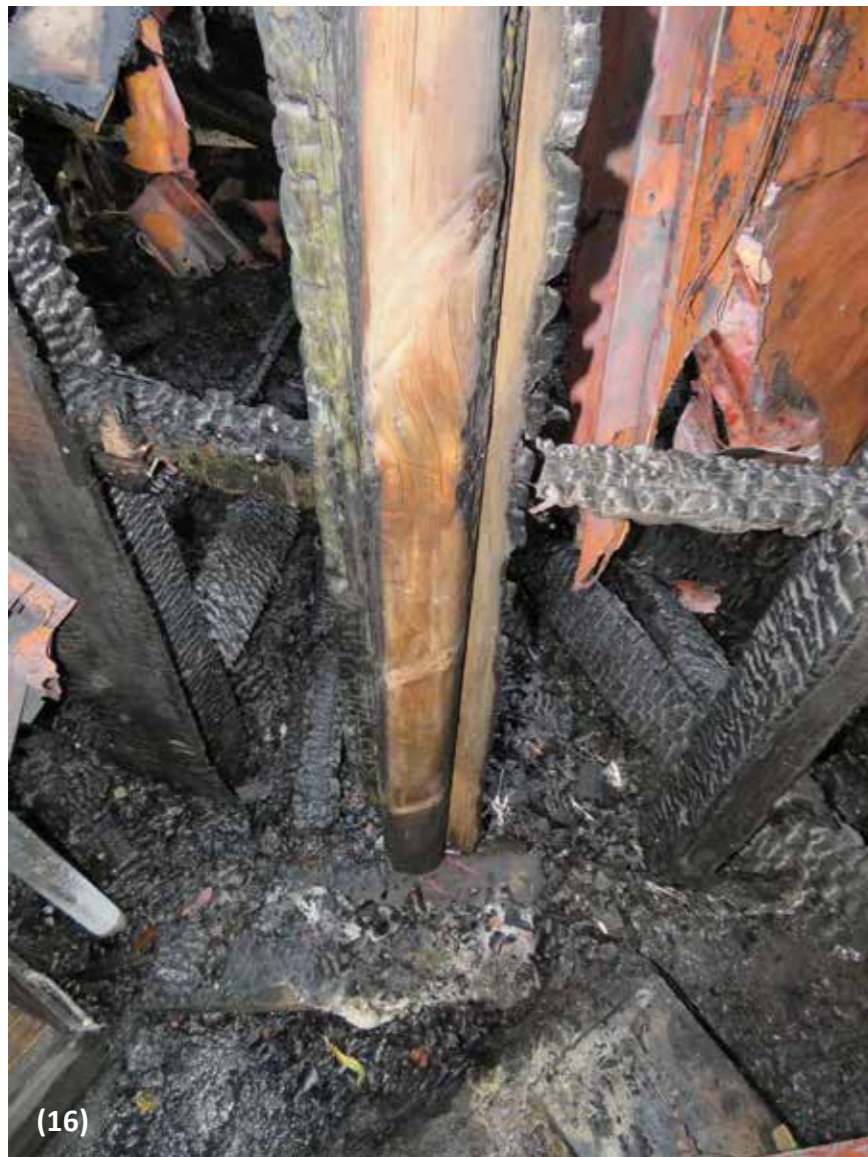
(16)

### 16. Charred timber roof roll at base level

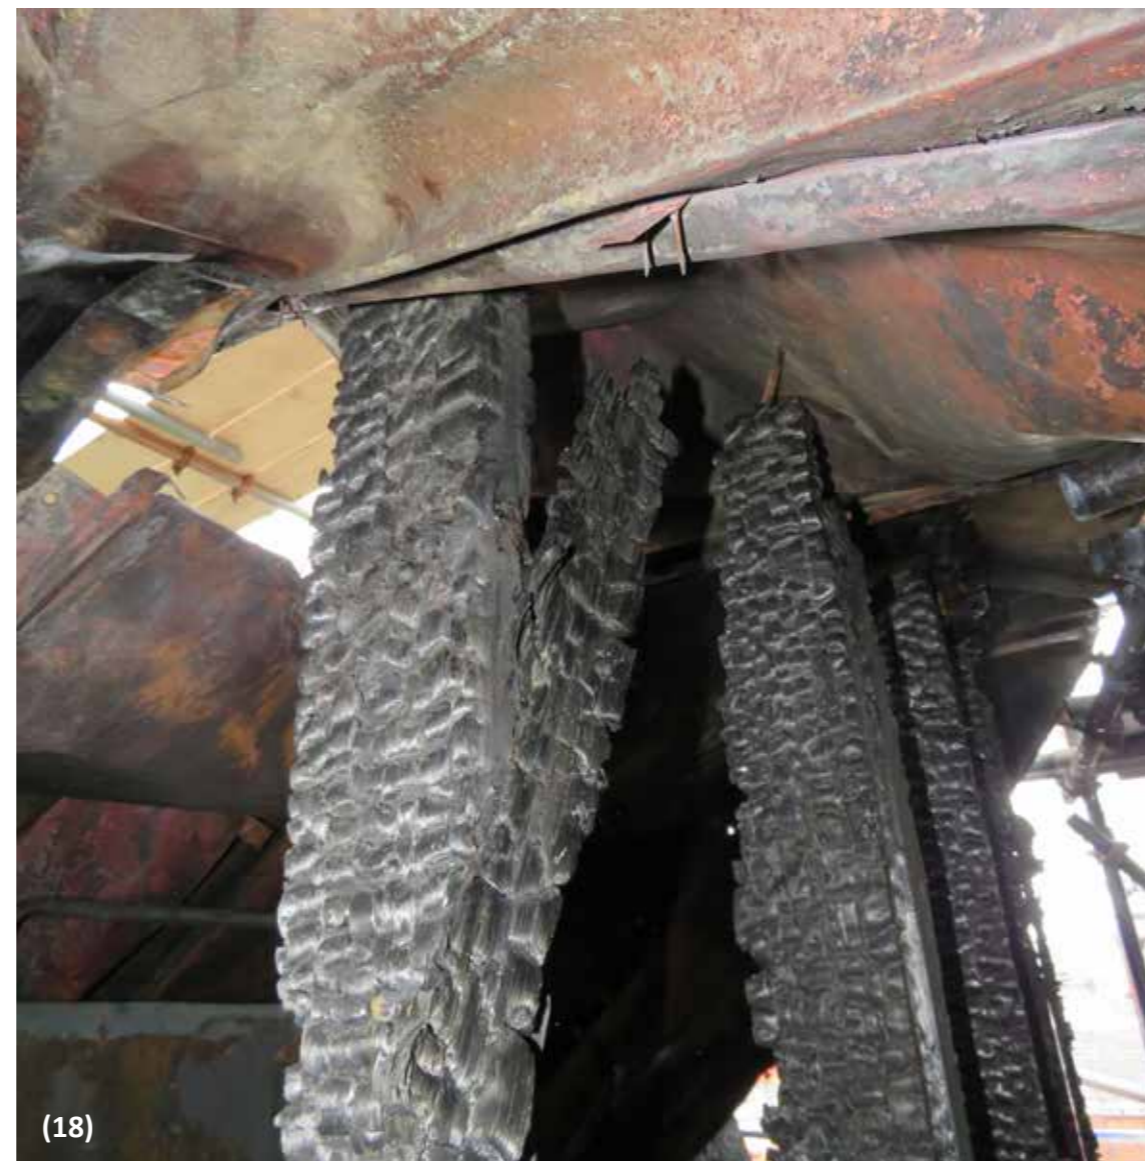
(18)

### 18. Charred wall studs with small parts of charred wall boardings

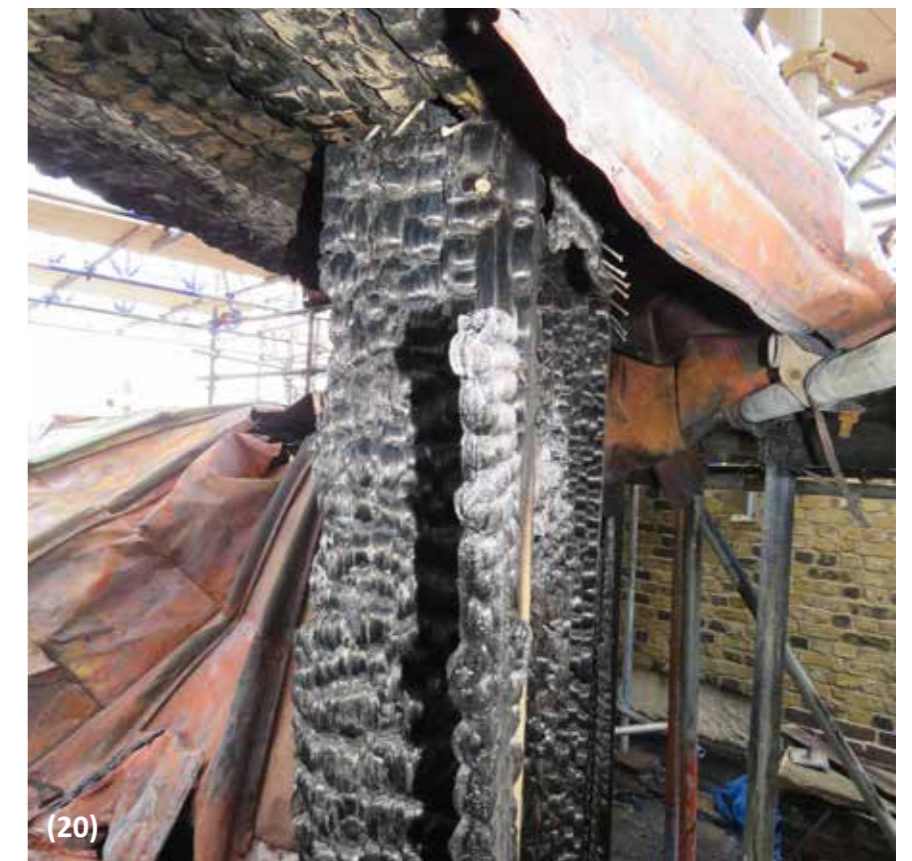
(20)

### 20. Heavily damaged wall stud
