6. INVENTORY REPORT - PRINCIPAL TIMBER ELEMENTS DETAILS

6. DOME INVENTORY - PRINCIPAL TIMBER ELEMENTS DETAILS

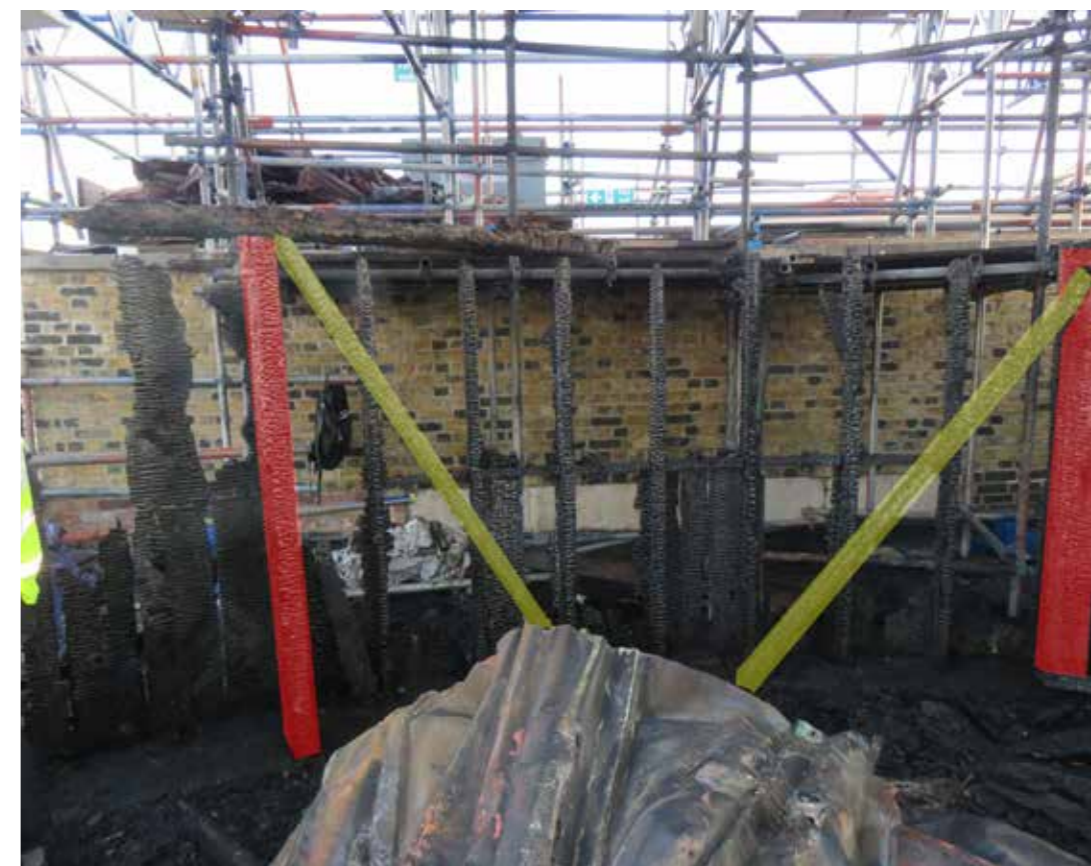
Most of the main support posts and supporting braces are charred, how-ever they were found in their original position.

Figure 42: Main support posts (A) & Supporting braces (G) indicated in situ (2020) © SLHA

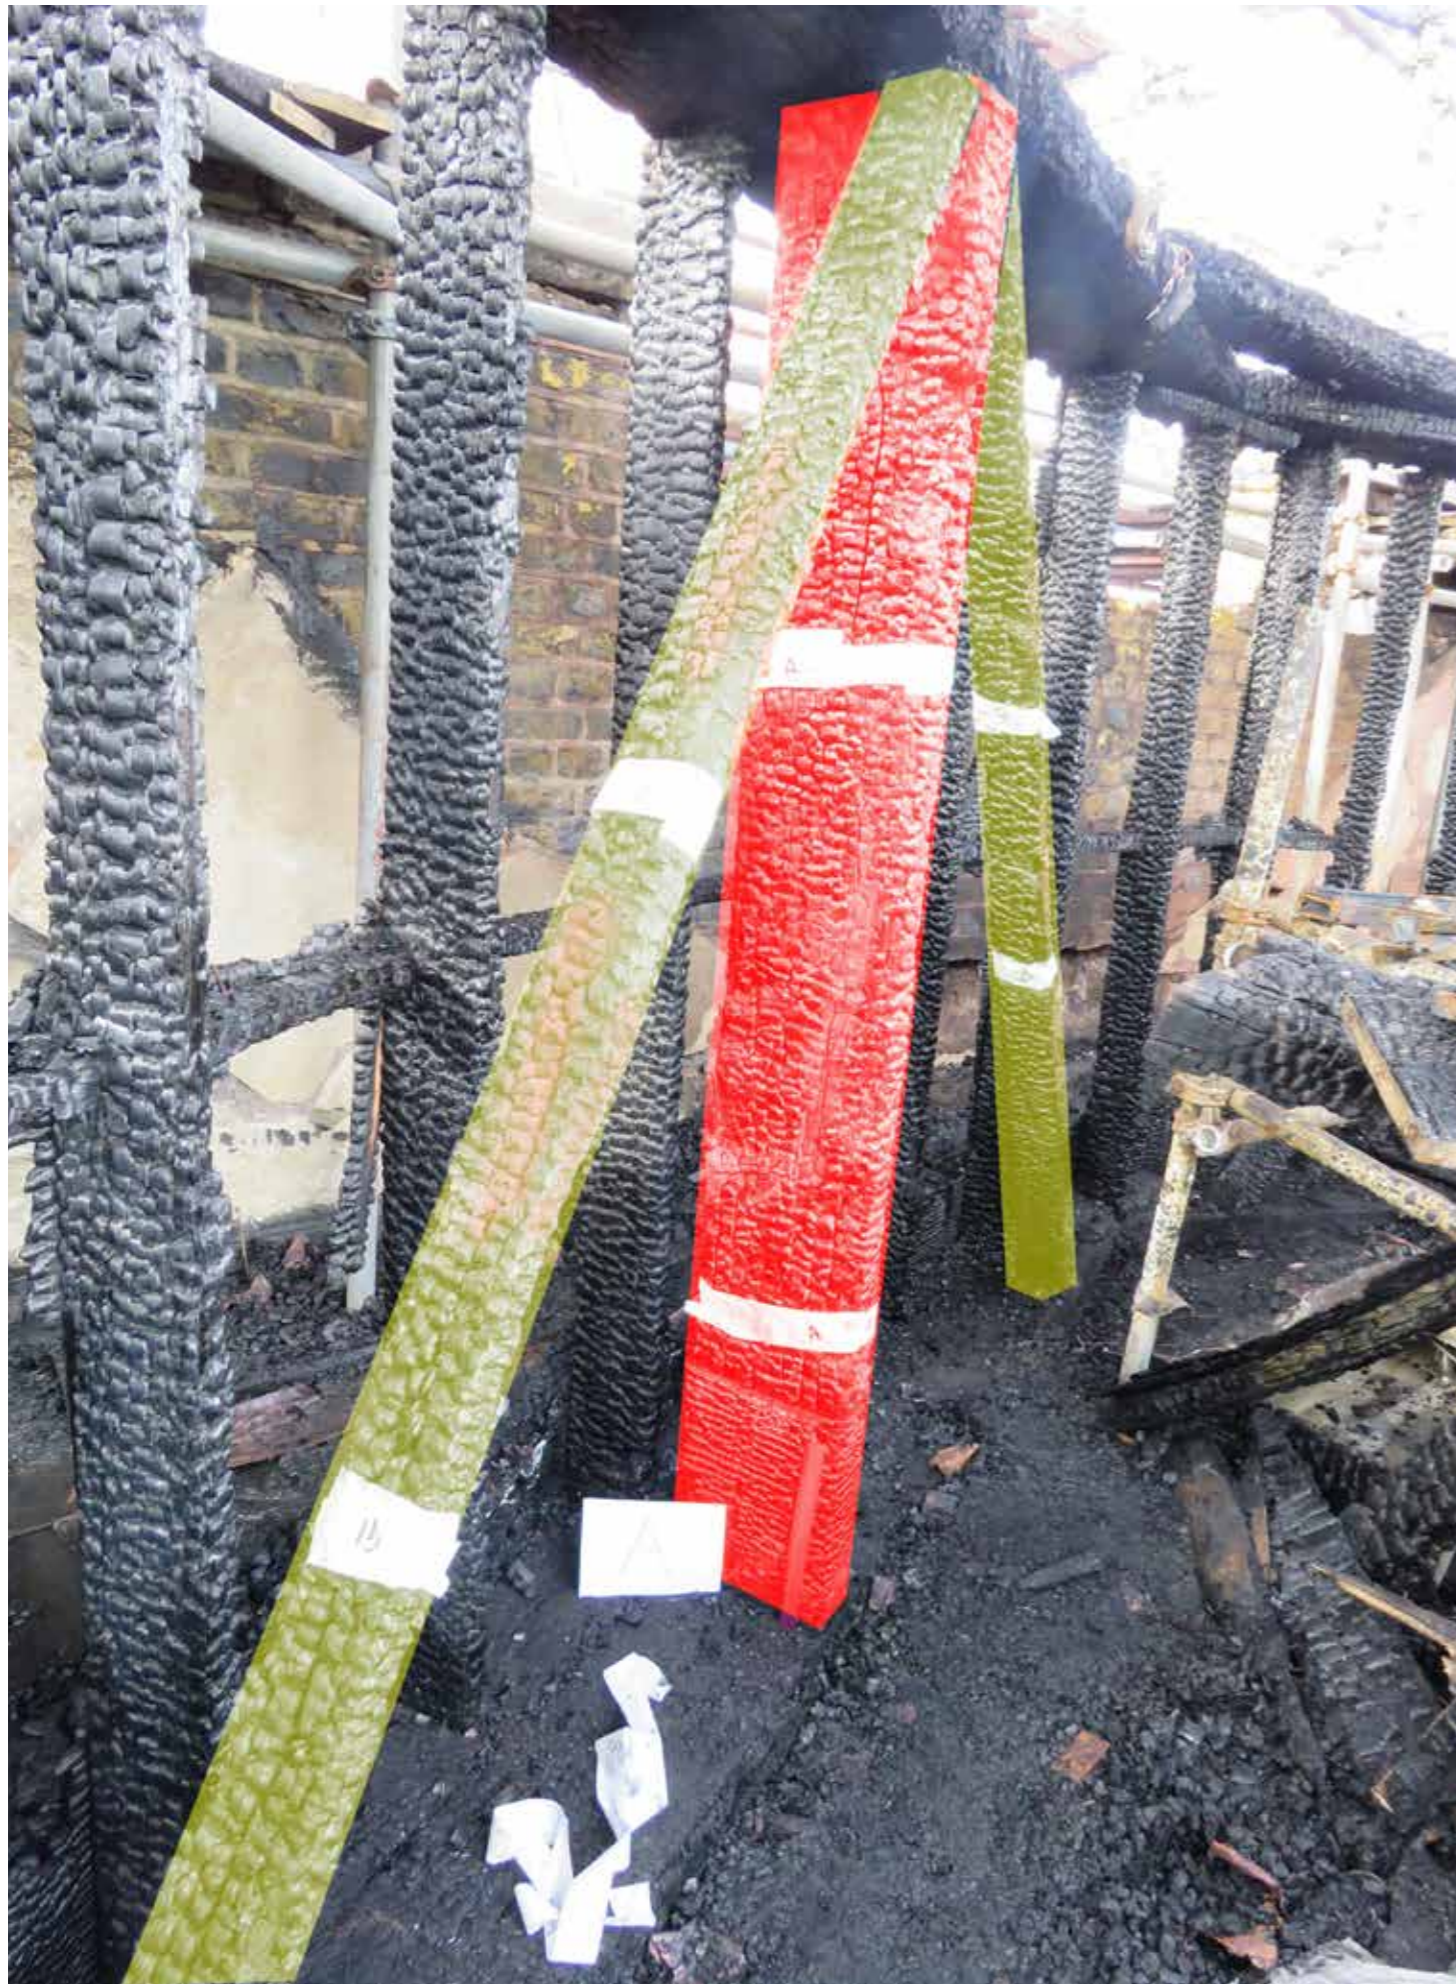
Figure 44: Main support posts (A) & Supporting braces (G) indicated in situ (2020) © SLHA

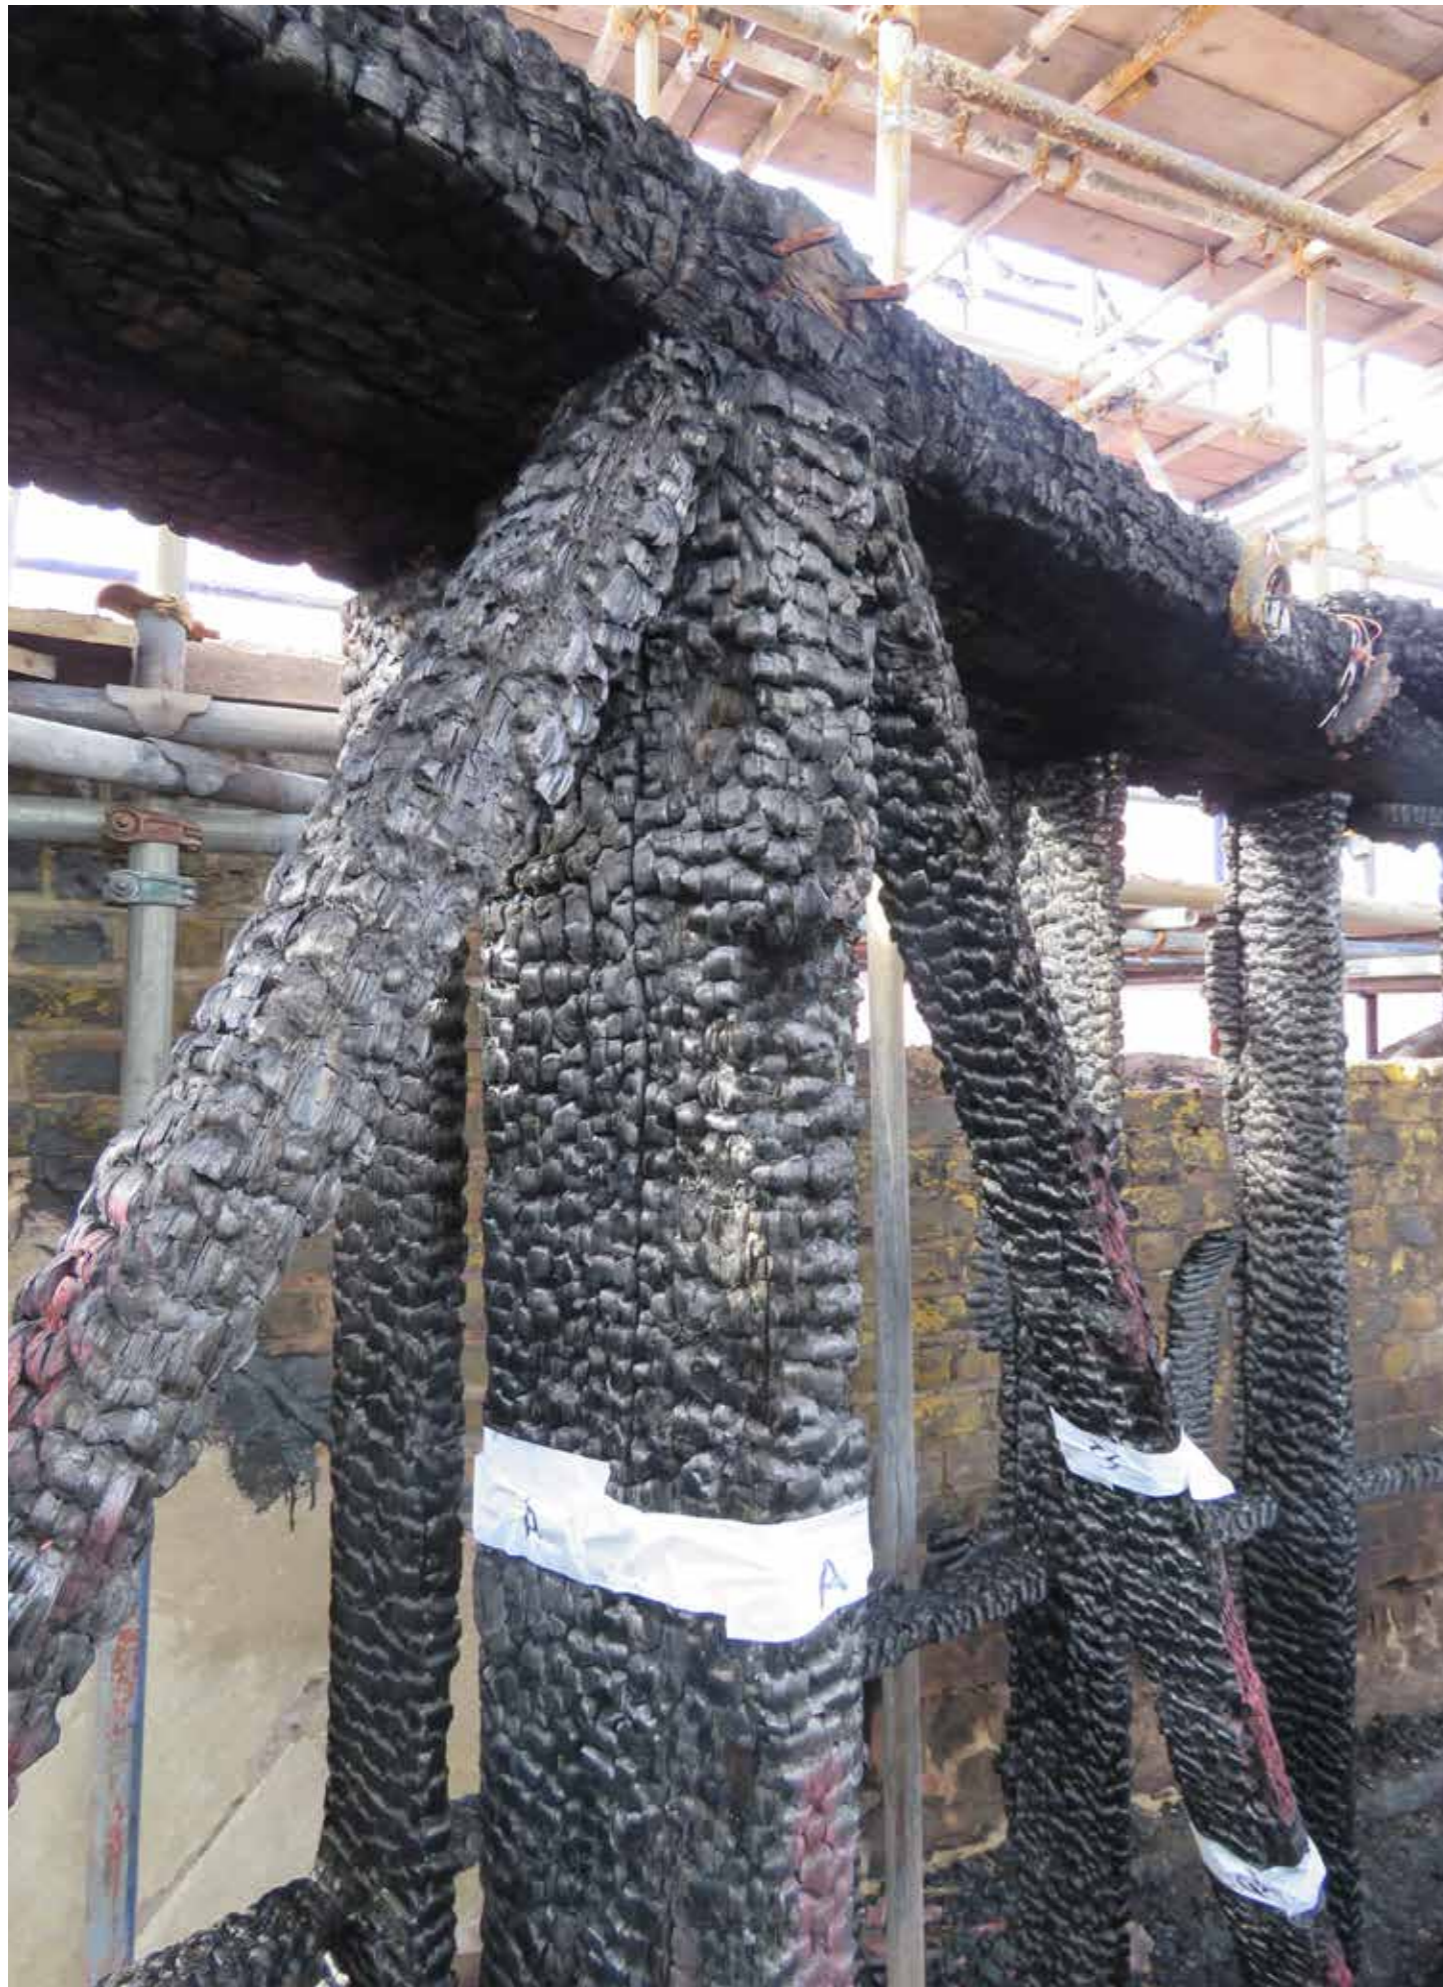
Figure 47: Main support posts (A) & Supporting braces (G) in situ (2020) © SLHA

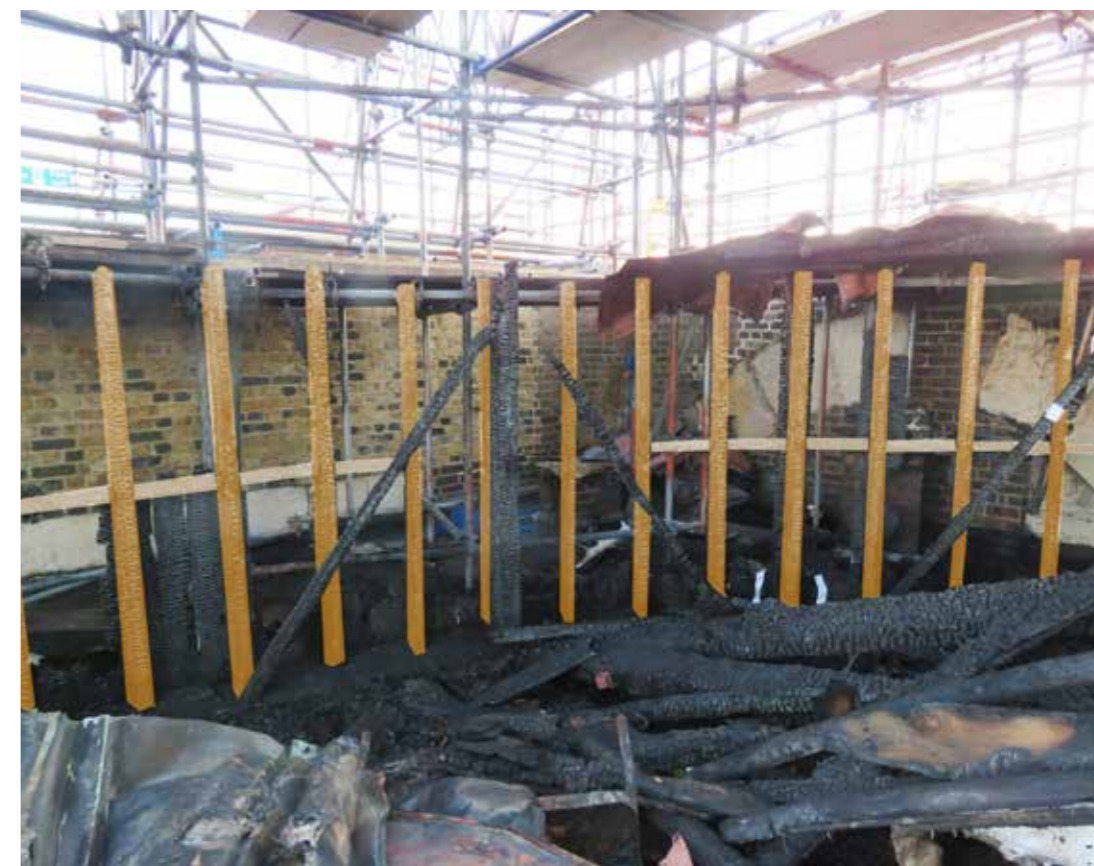
Most of the timbers are significantly charred due to fire damage, although most remained in position.

Figure 56: Wall studs and ties (B) in situ (2020) © SLHA

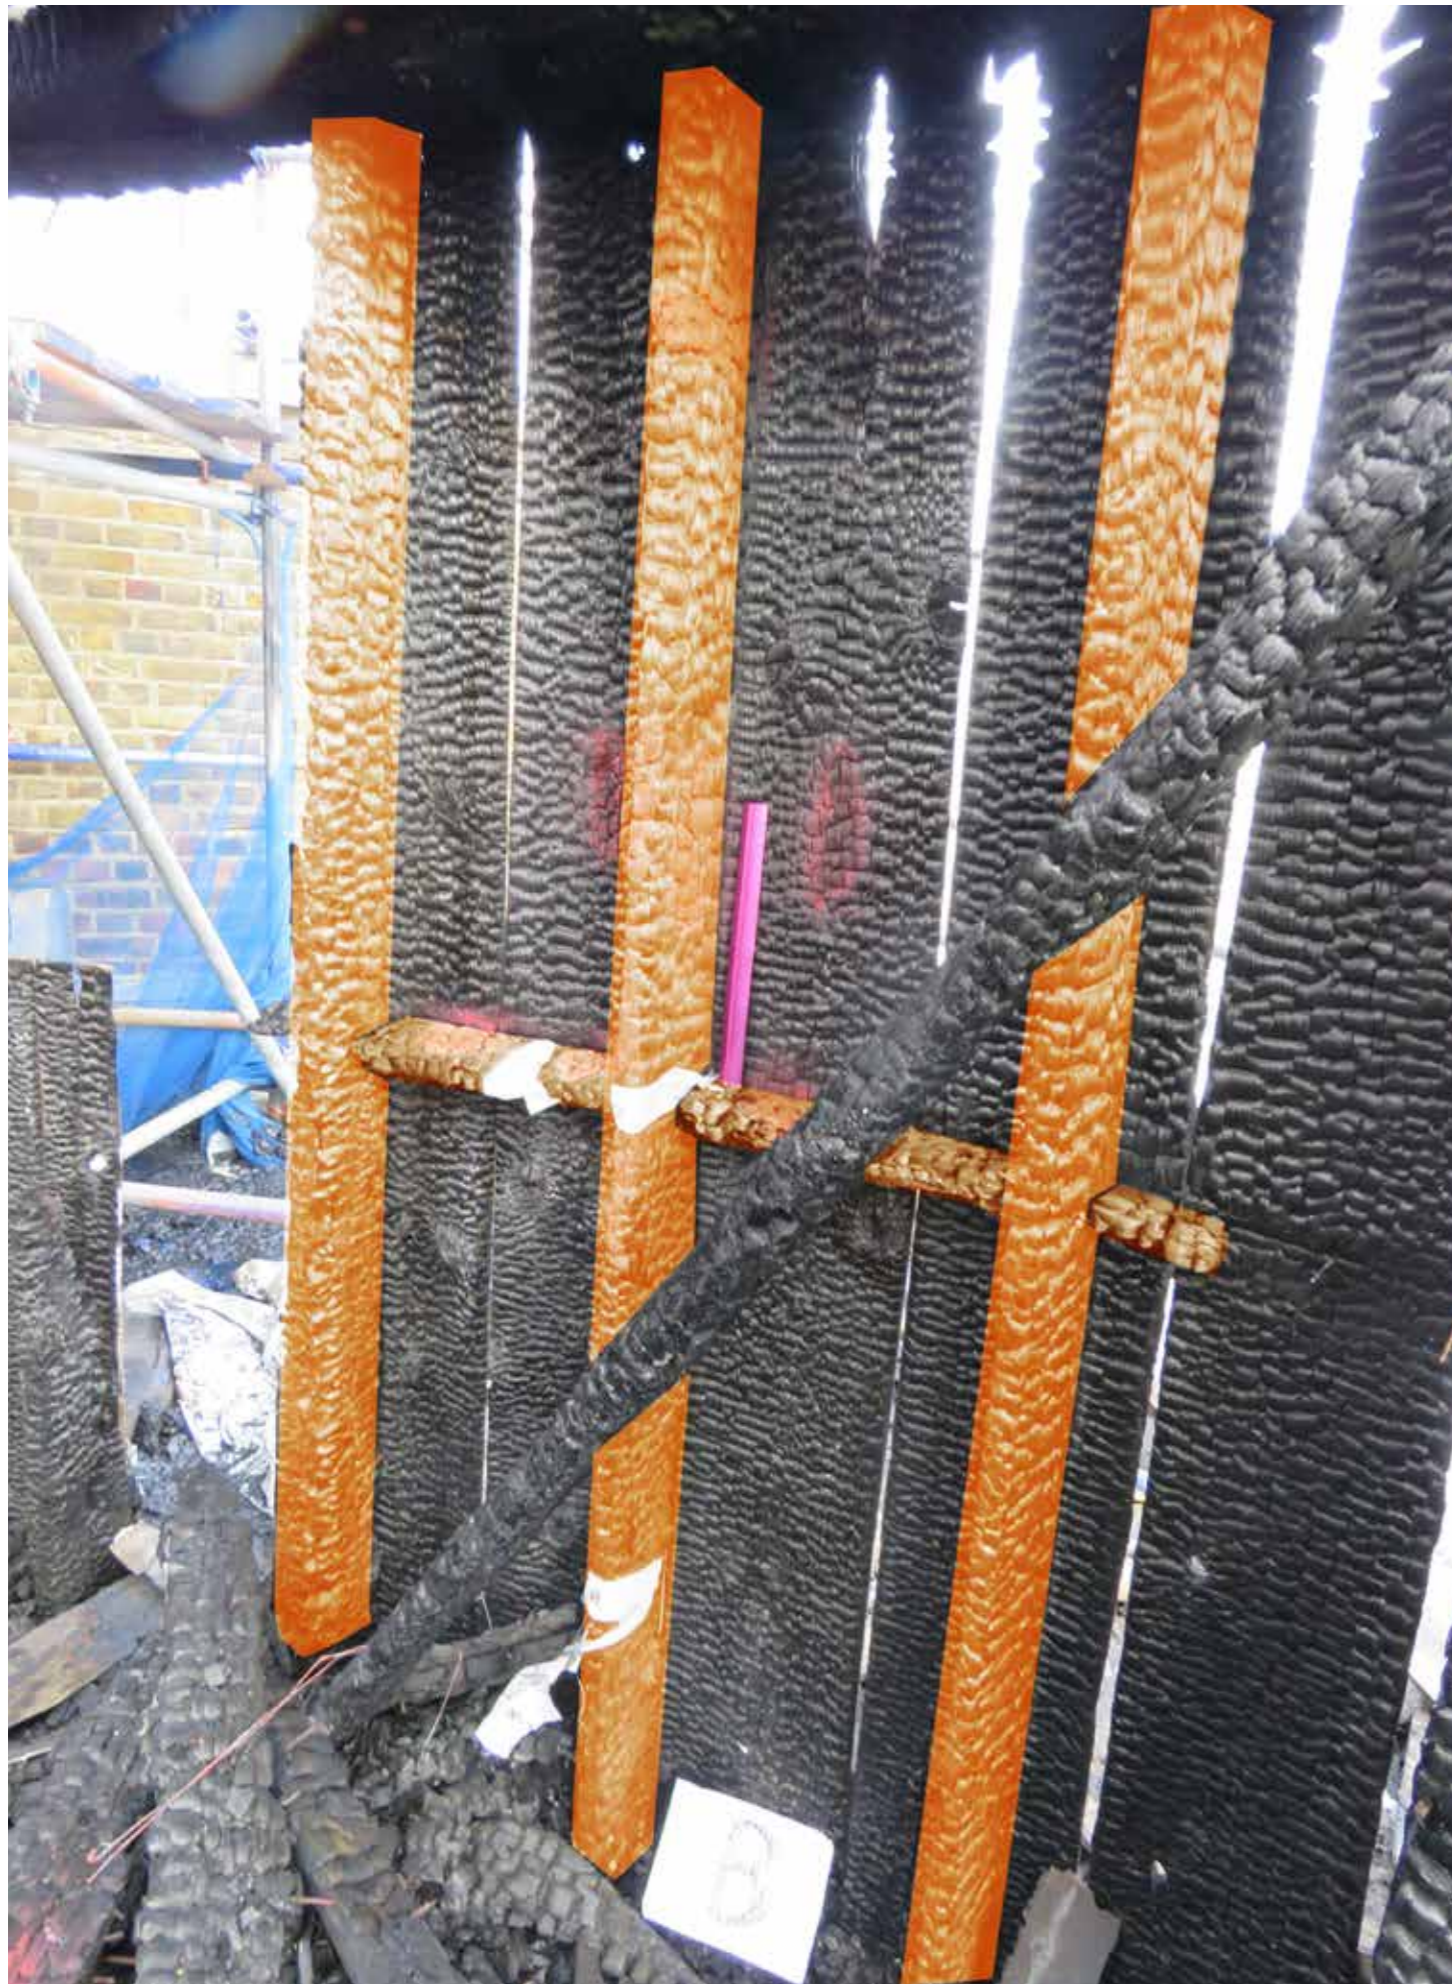
Figure 58: Wall studs and ties (B) in situ (2020) © SLHA

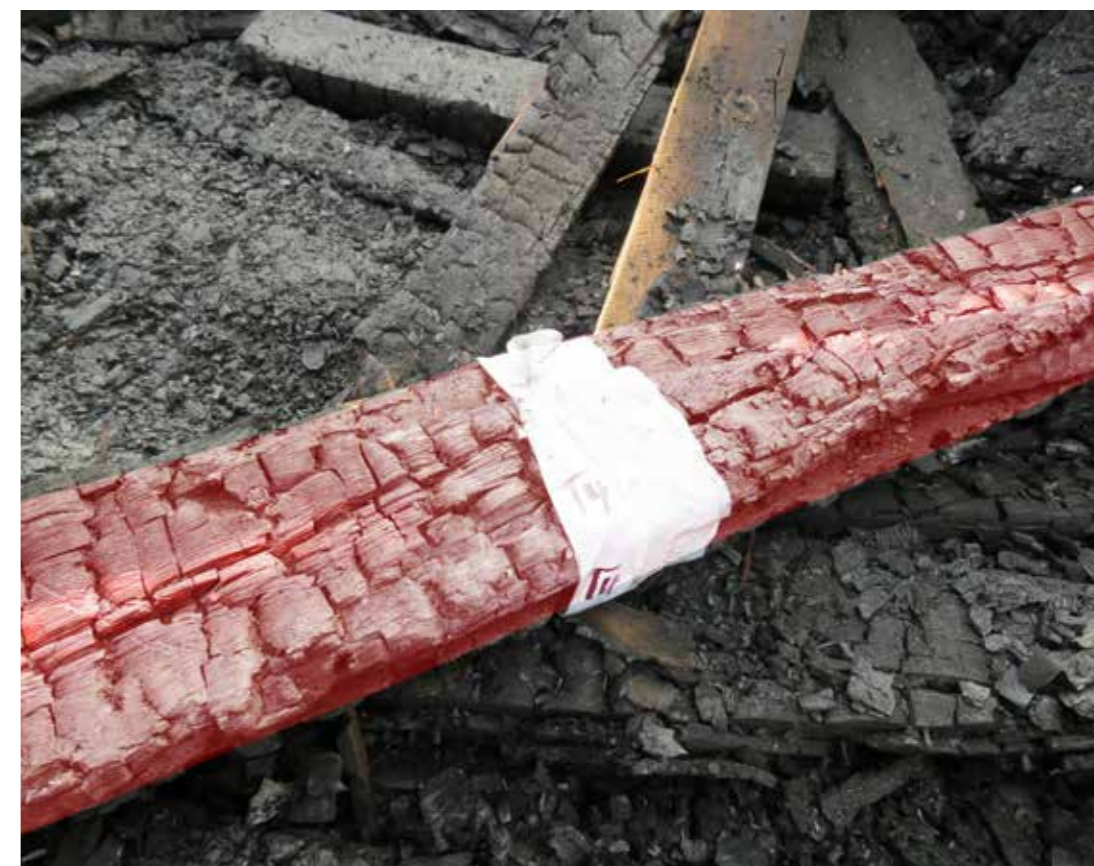
All the ribs have been heavily damaged by the fire and only fragmentary evidence was discovered in the debris.

Figure 69: Sample #7 - 2-Part ribs (C) found within debris (2020) © SLHA

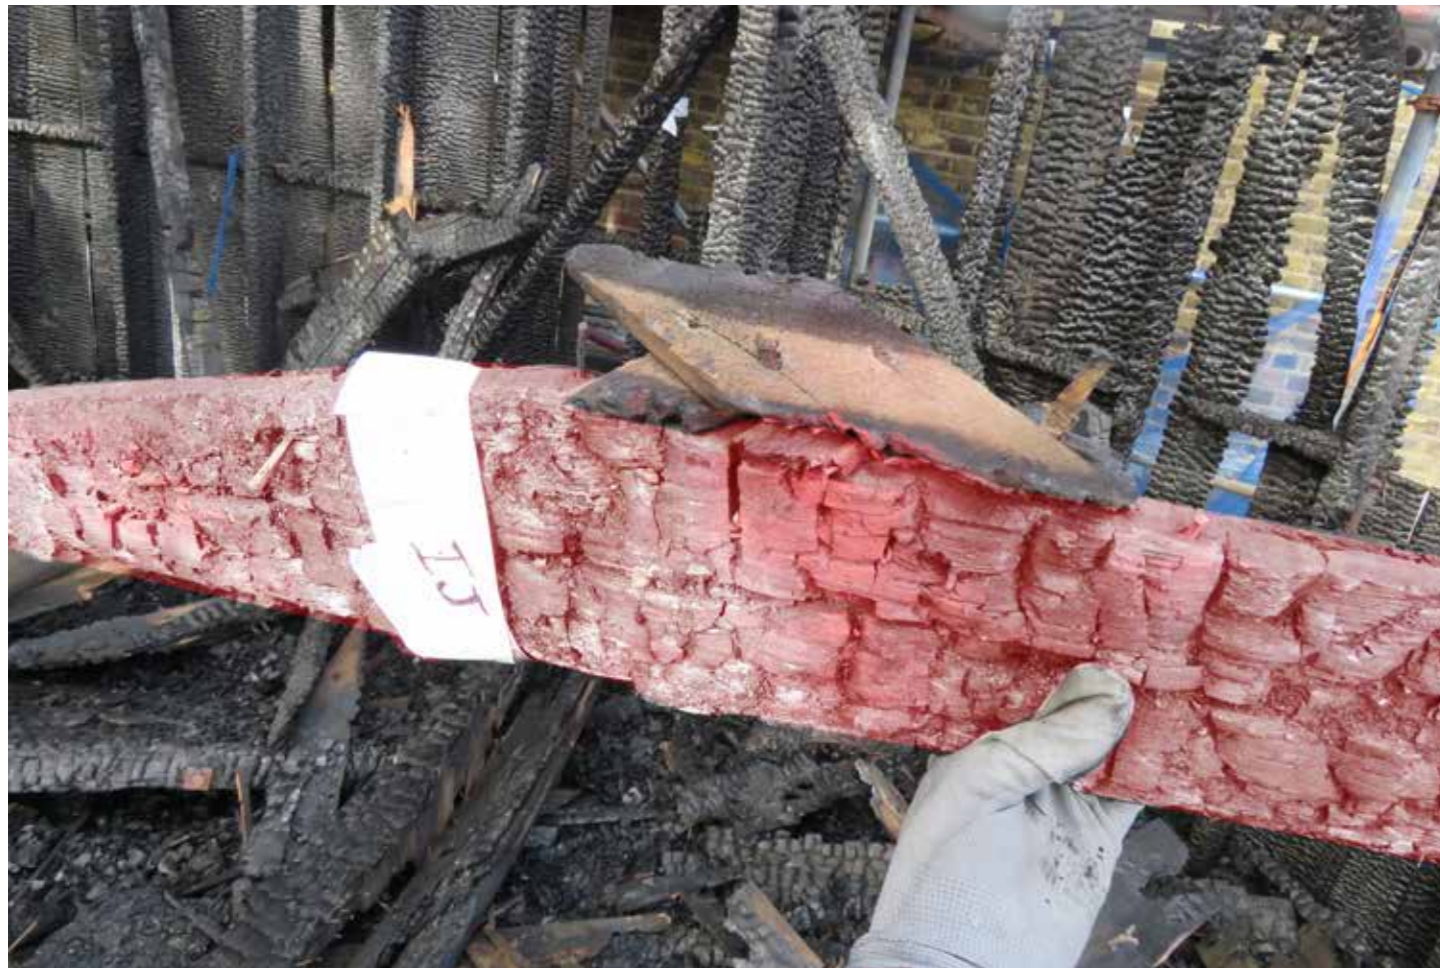
Figure 71: Sample #8 - 2-Part ribs (C) found within debris (2020) © SLHA

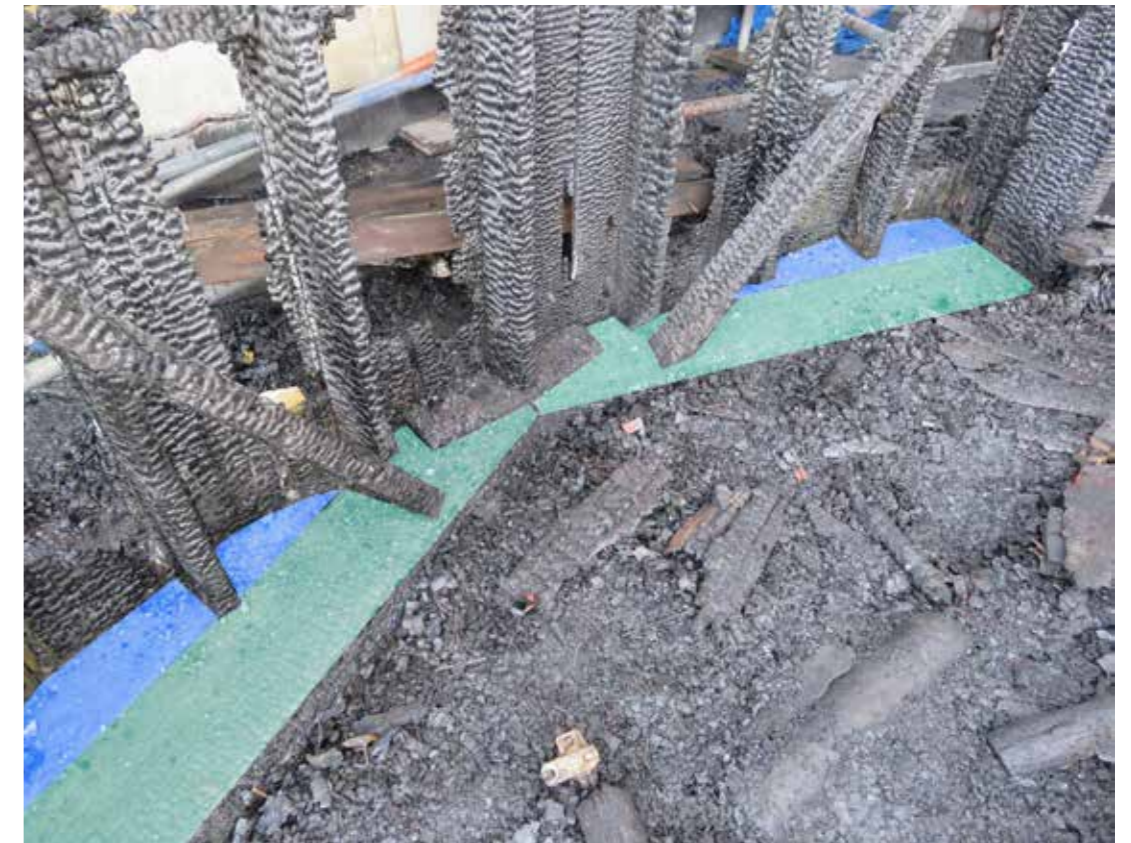
The lower stud wall plate timbers have suffered significant fire damage but have been found in situ.

Figure 76: Lower stud wall plates (D) in situ (2020) © SLHA

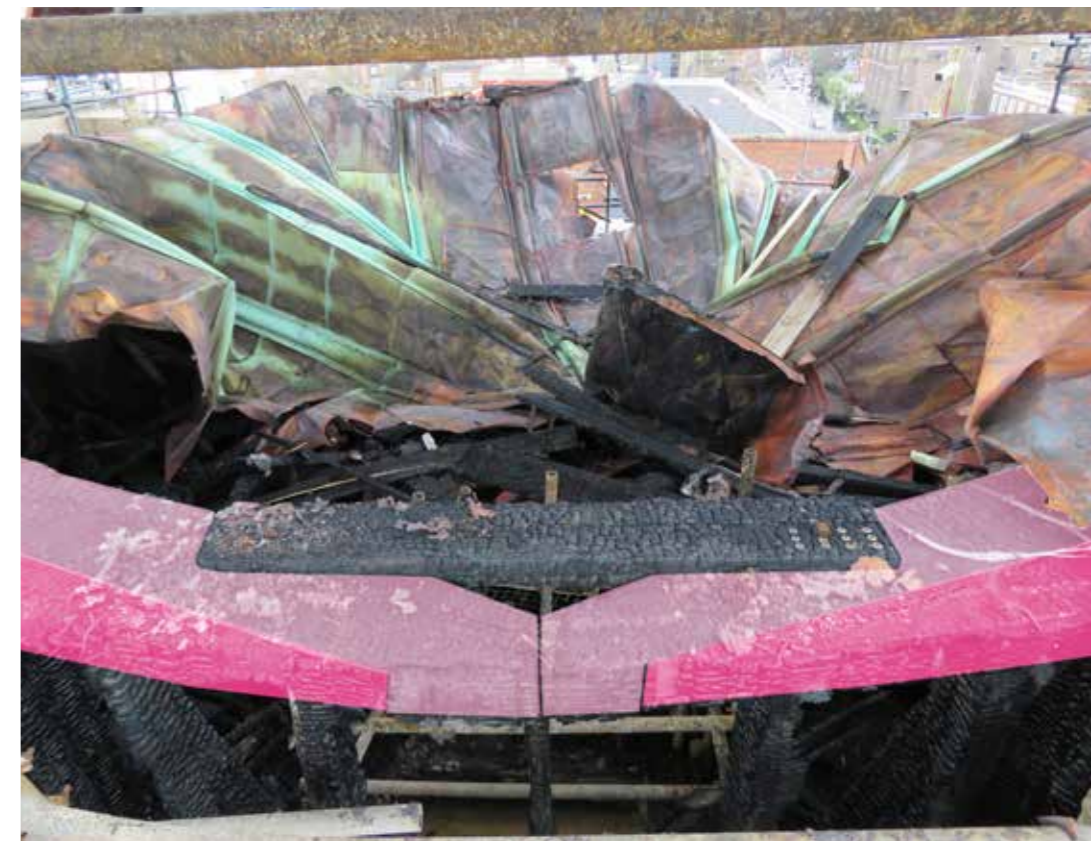
The upper rafter plate has been severely damaged in the fire, however aside from a small section on the southeast side, most of the plate was found in situ. All dome elements above this level had collapsed resulting in severe damage to some sections of the rafter plate.

Figure 90: Upper rafter plates (E) in situ (2020) © SLHA

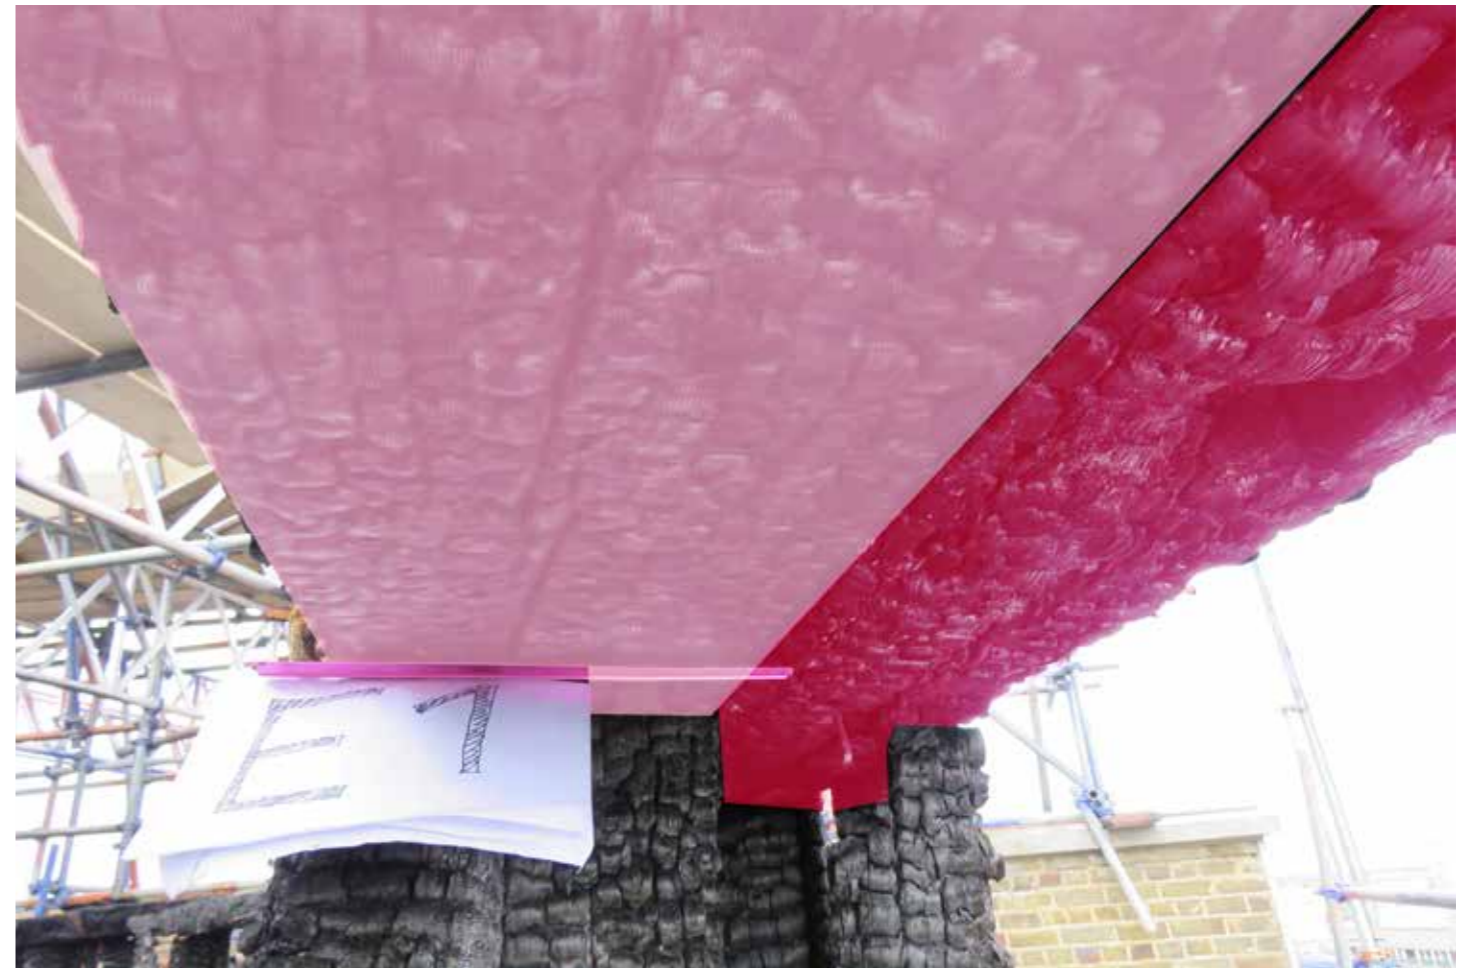
Figure 94: Upper rafter plates (E) in situ (2020) © SLHA
