6. DOME INVENTORY - PRINCIPAL TIMBER ELEMENTS DETAILS

6.6 H - Wall boarding

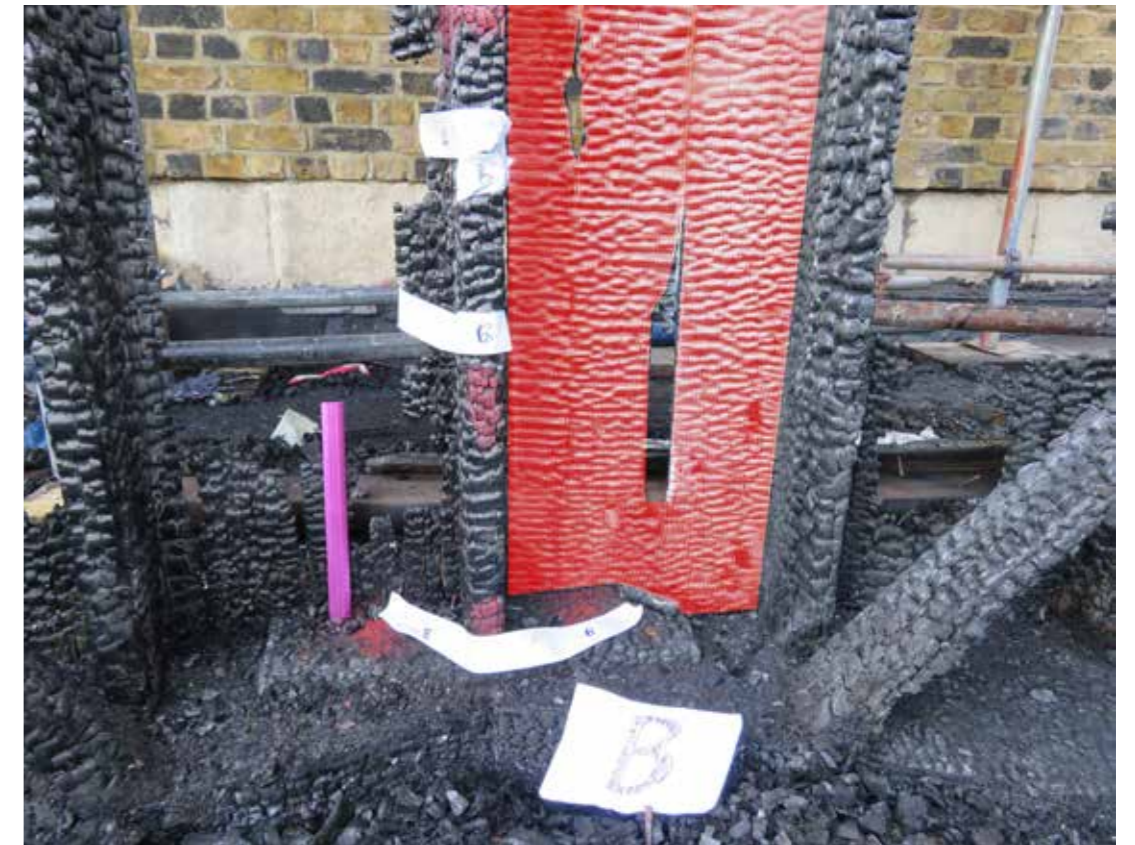
While a significant part of the wall boarding was completely destroyed by the fire, charred timber panels were preserved in situ on the west, north and north east sides.

Figure 104: Wall boarding (H) in situ (interior view) (2020) © SLHA

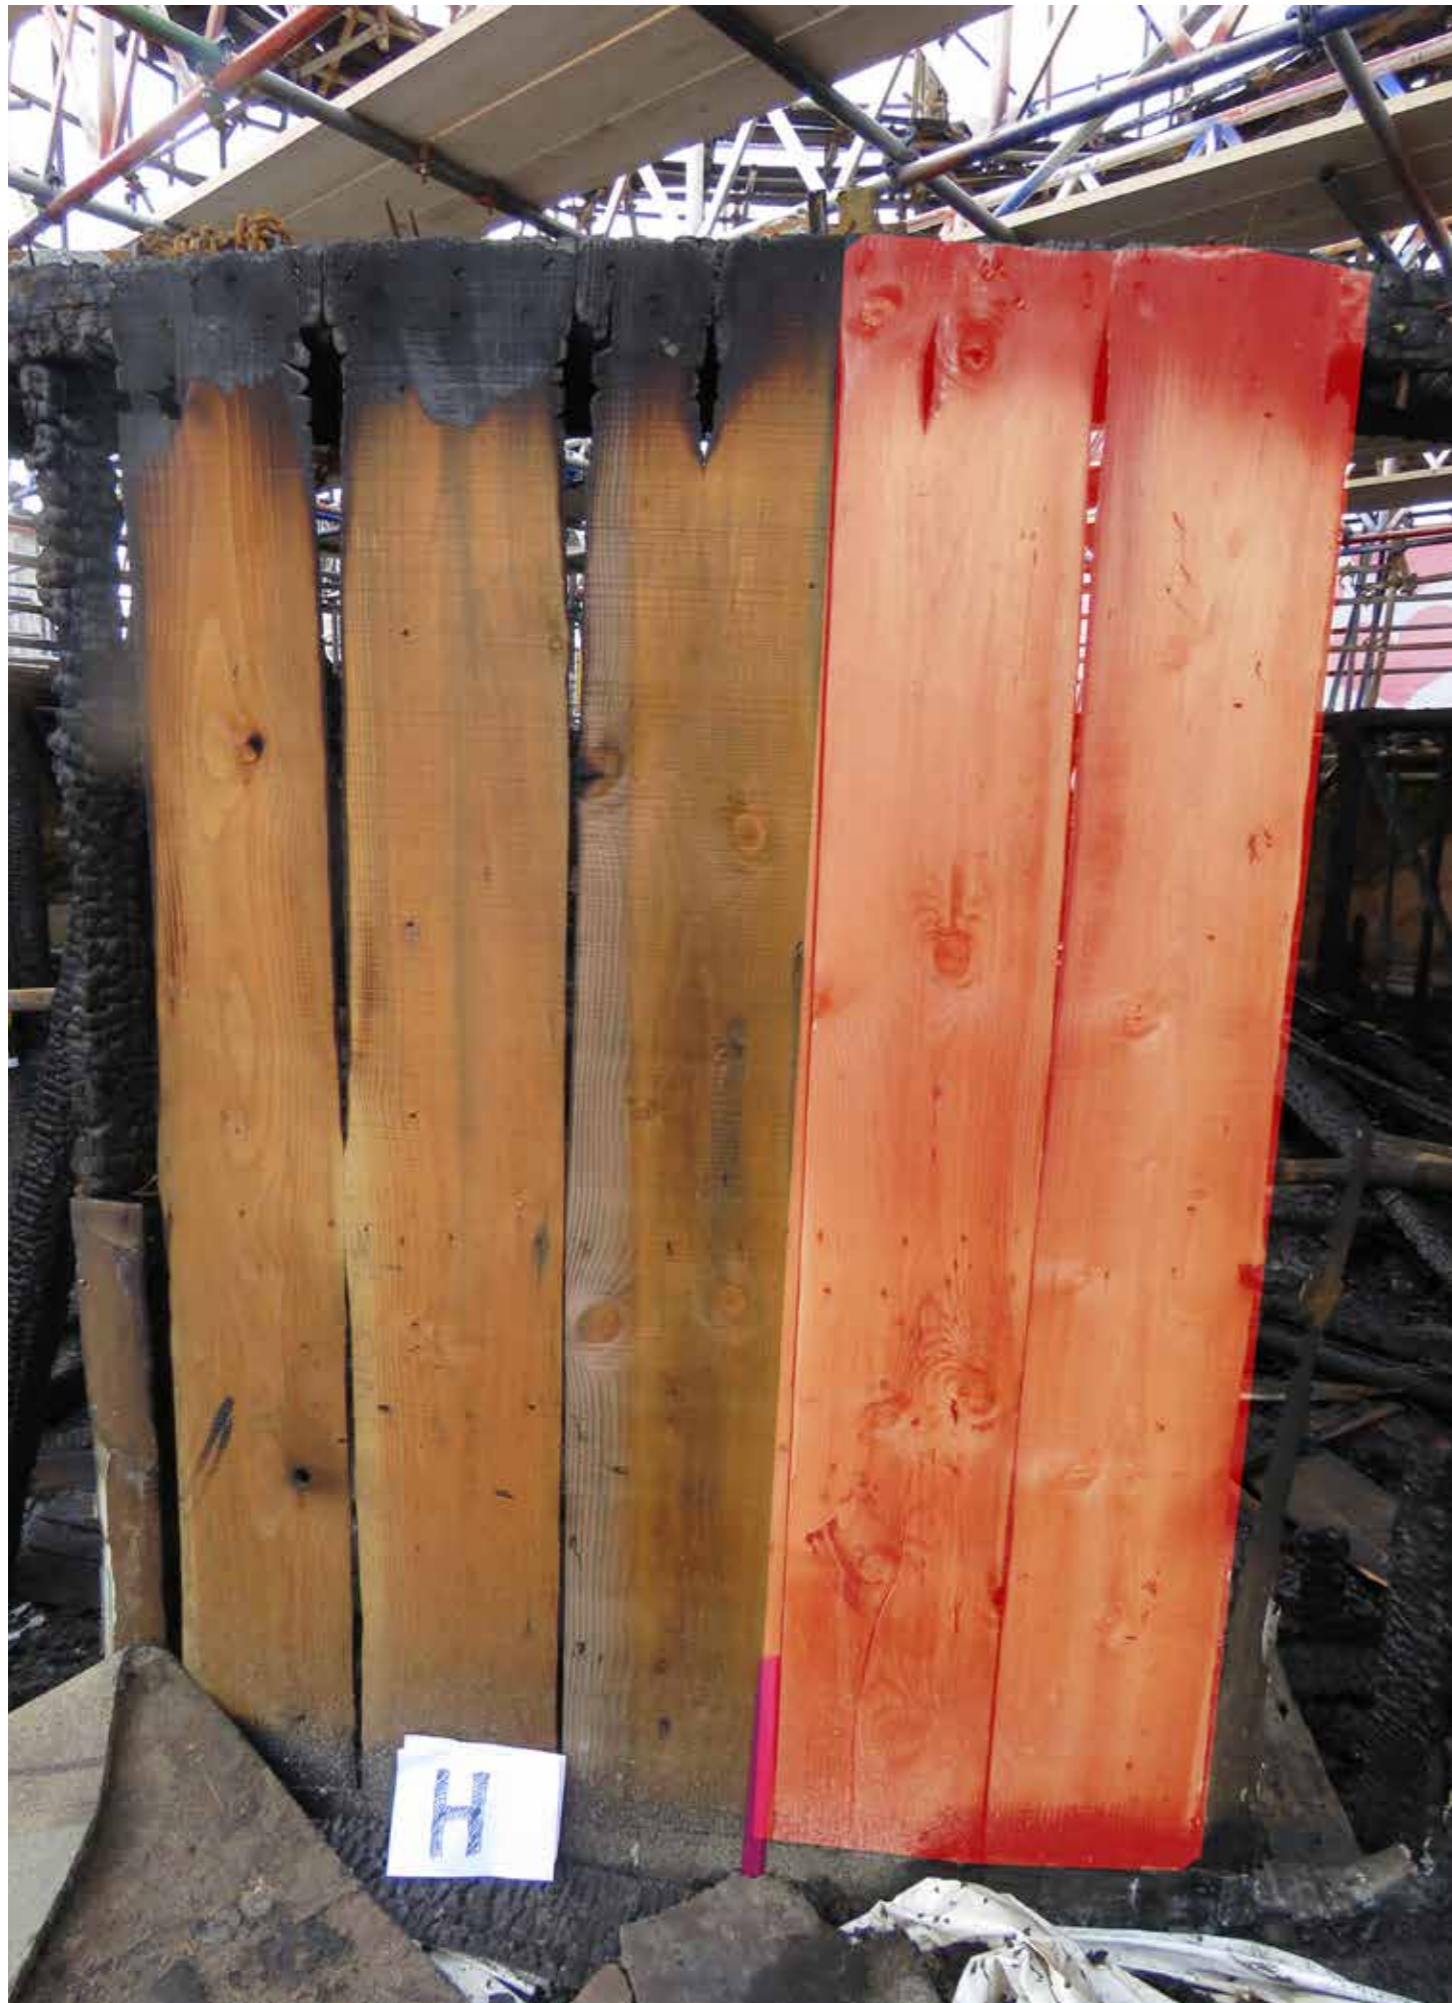
Figure 106: Wall boarding (H) in situ (exterior view) (2020) © SLHA

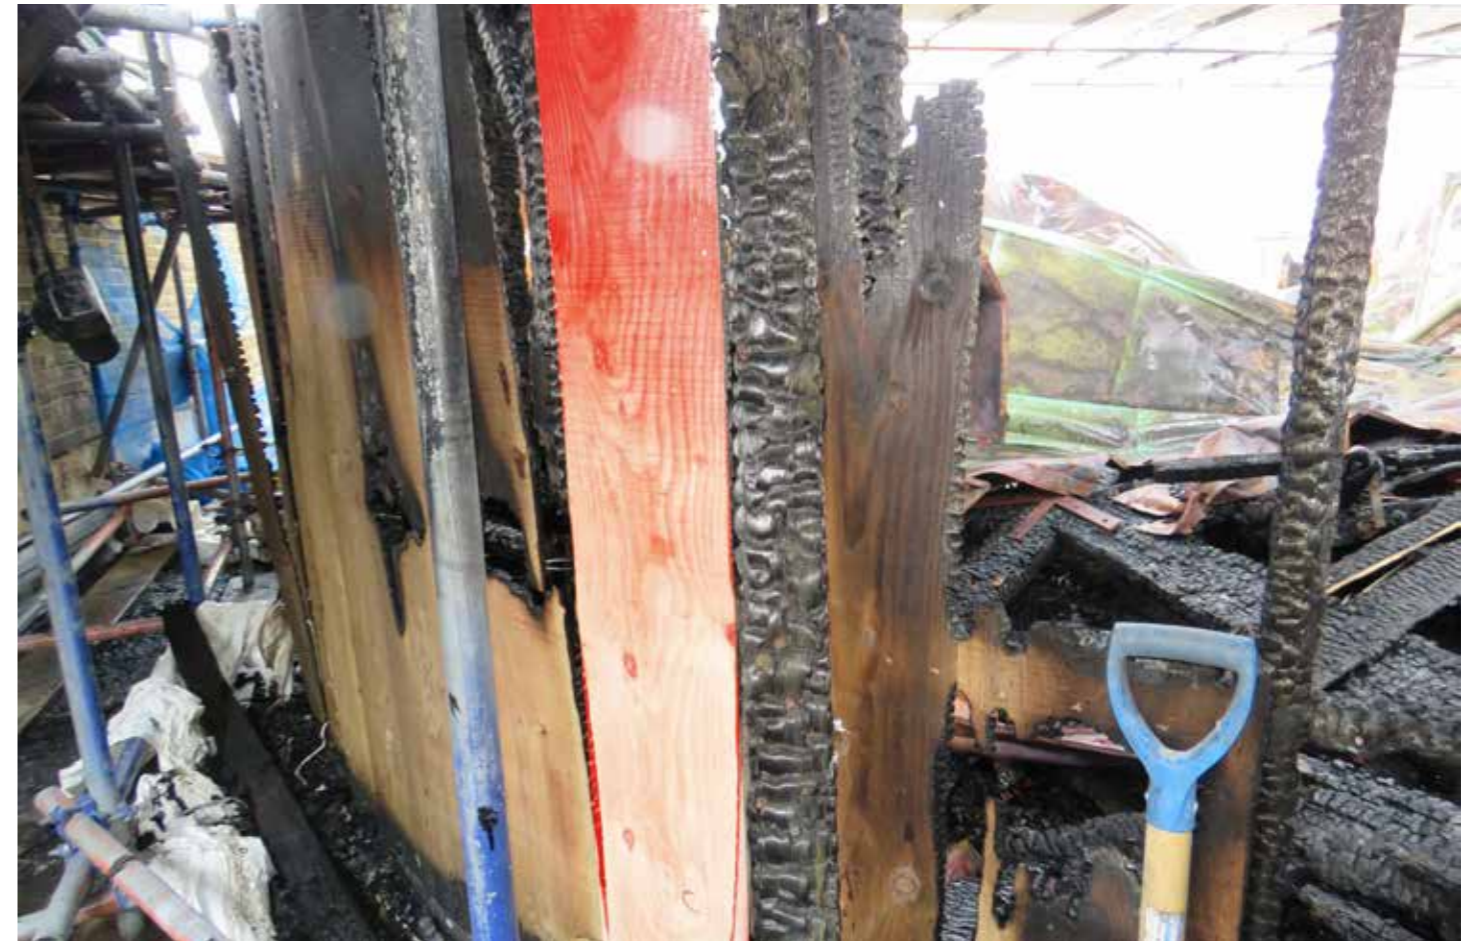
Figure 107: Wall boarding (H) in situ (exterior view) (2020) © SLHA

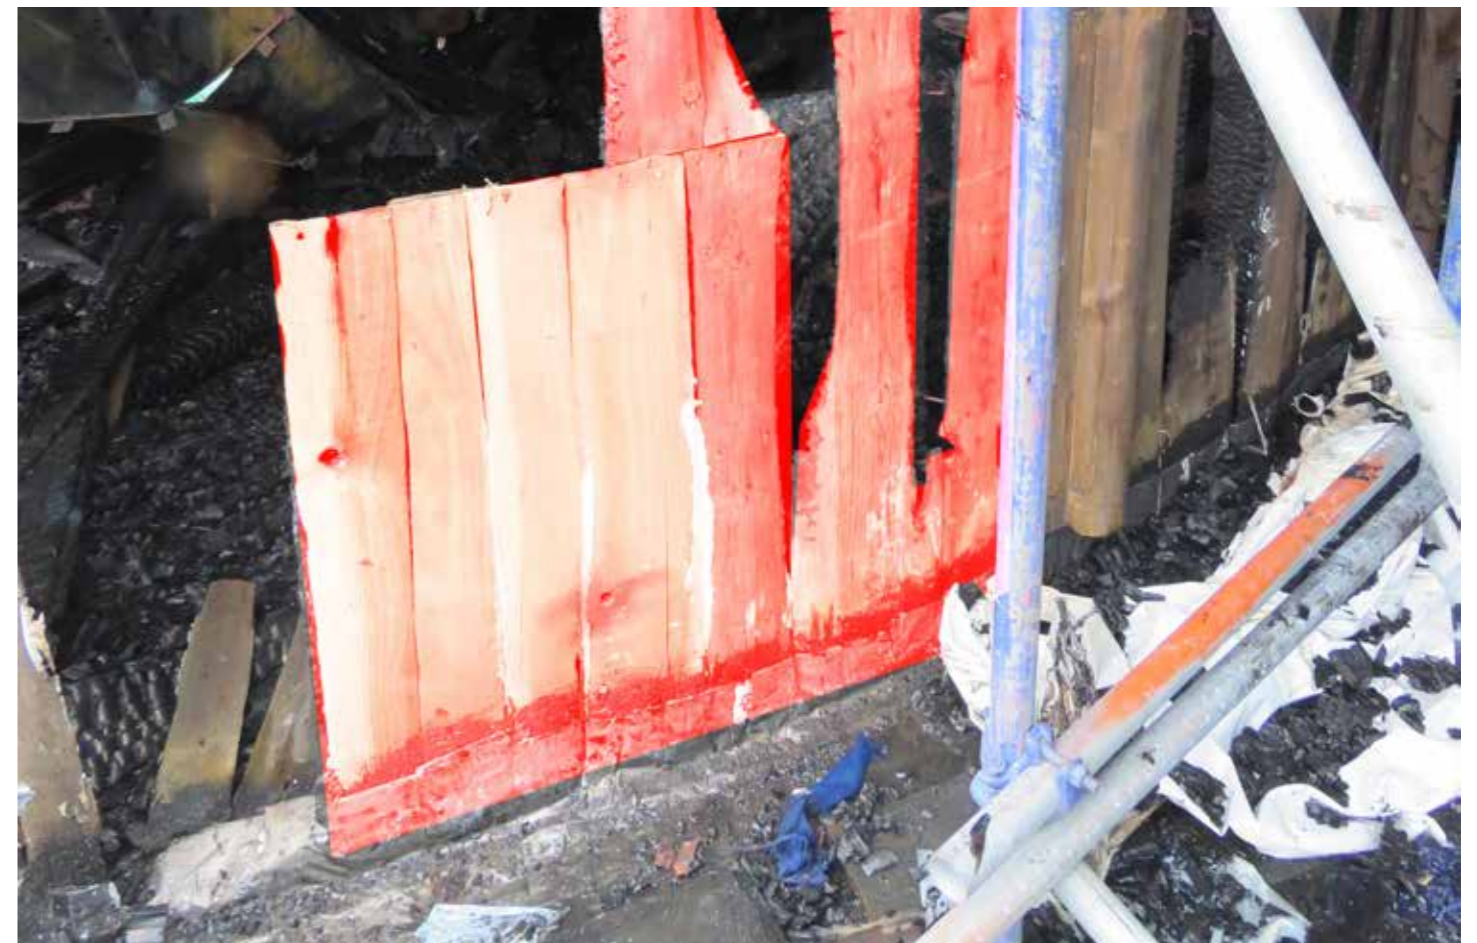
Figure 108: Wall boarding (H) in situ (exterior view) (2020) © SLHA

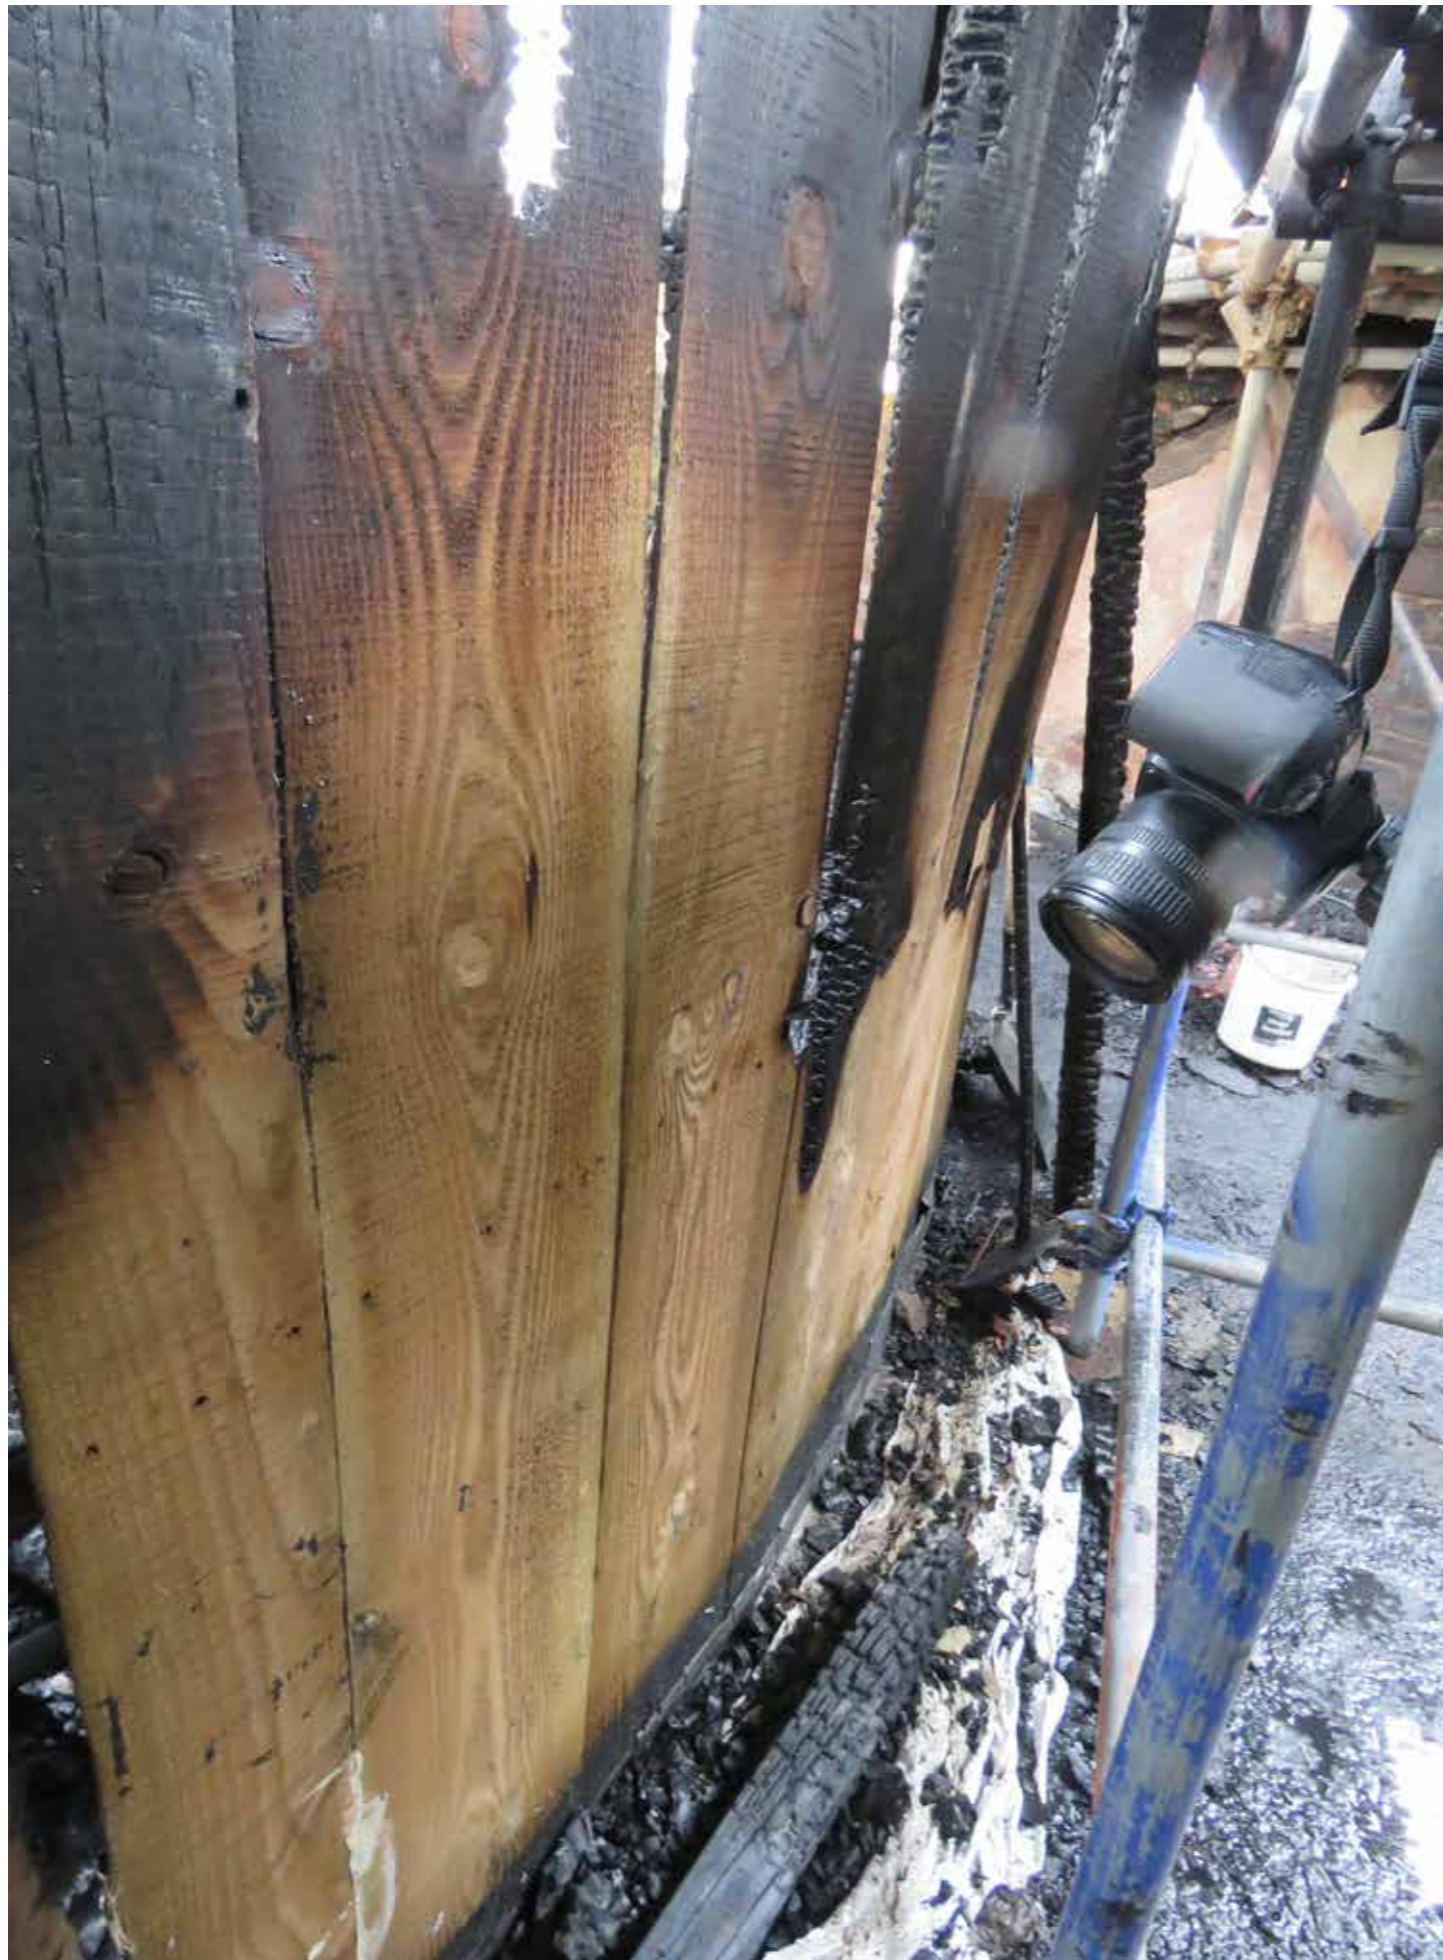
Figure 109: Wall boarding (H) in situ (exterior view) (2020) © SLHA

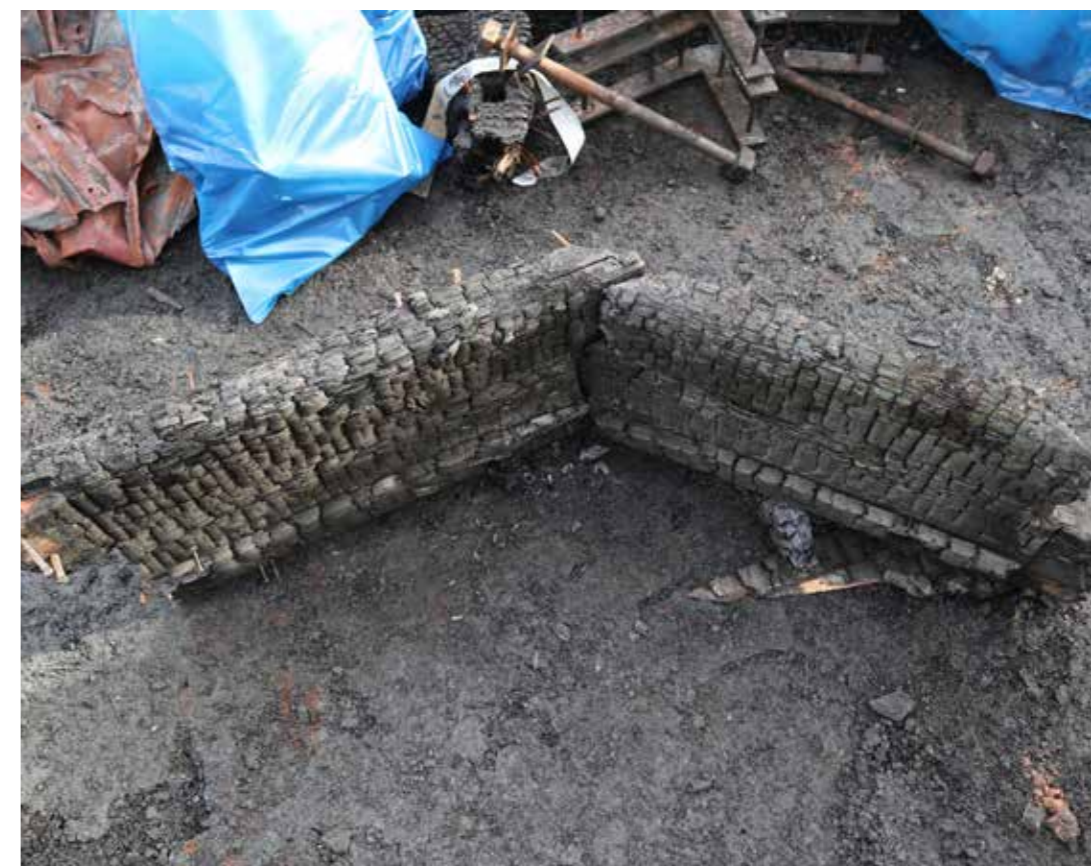
The inner apex ring beam was completely destroyed by fire and only a small fragment was discovered in the debris.

Figure 117: Inner apex ring beam (I) in situ (2020) © SLHA

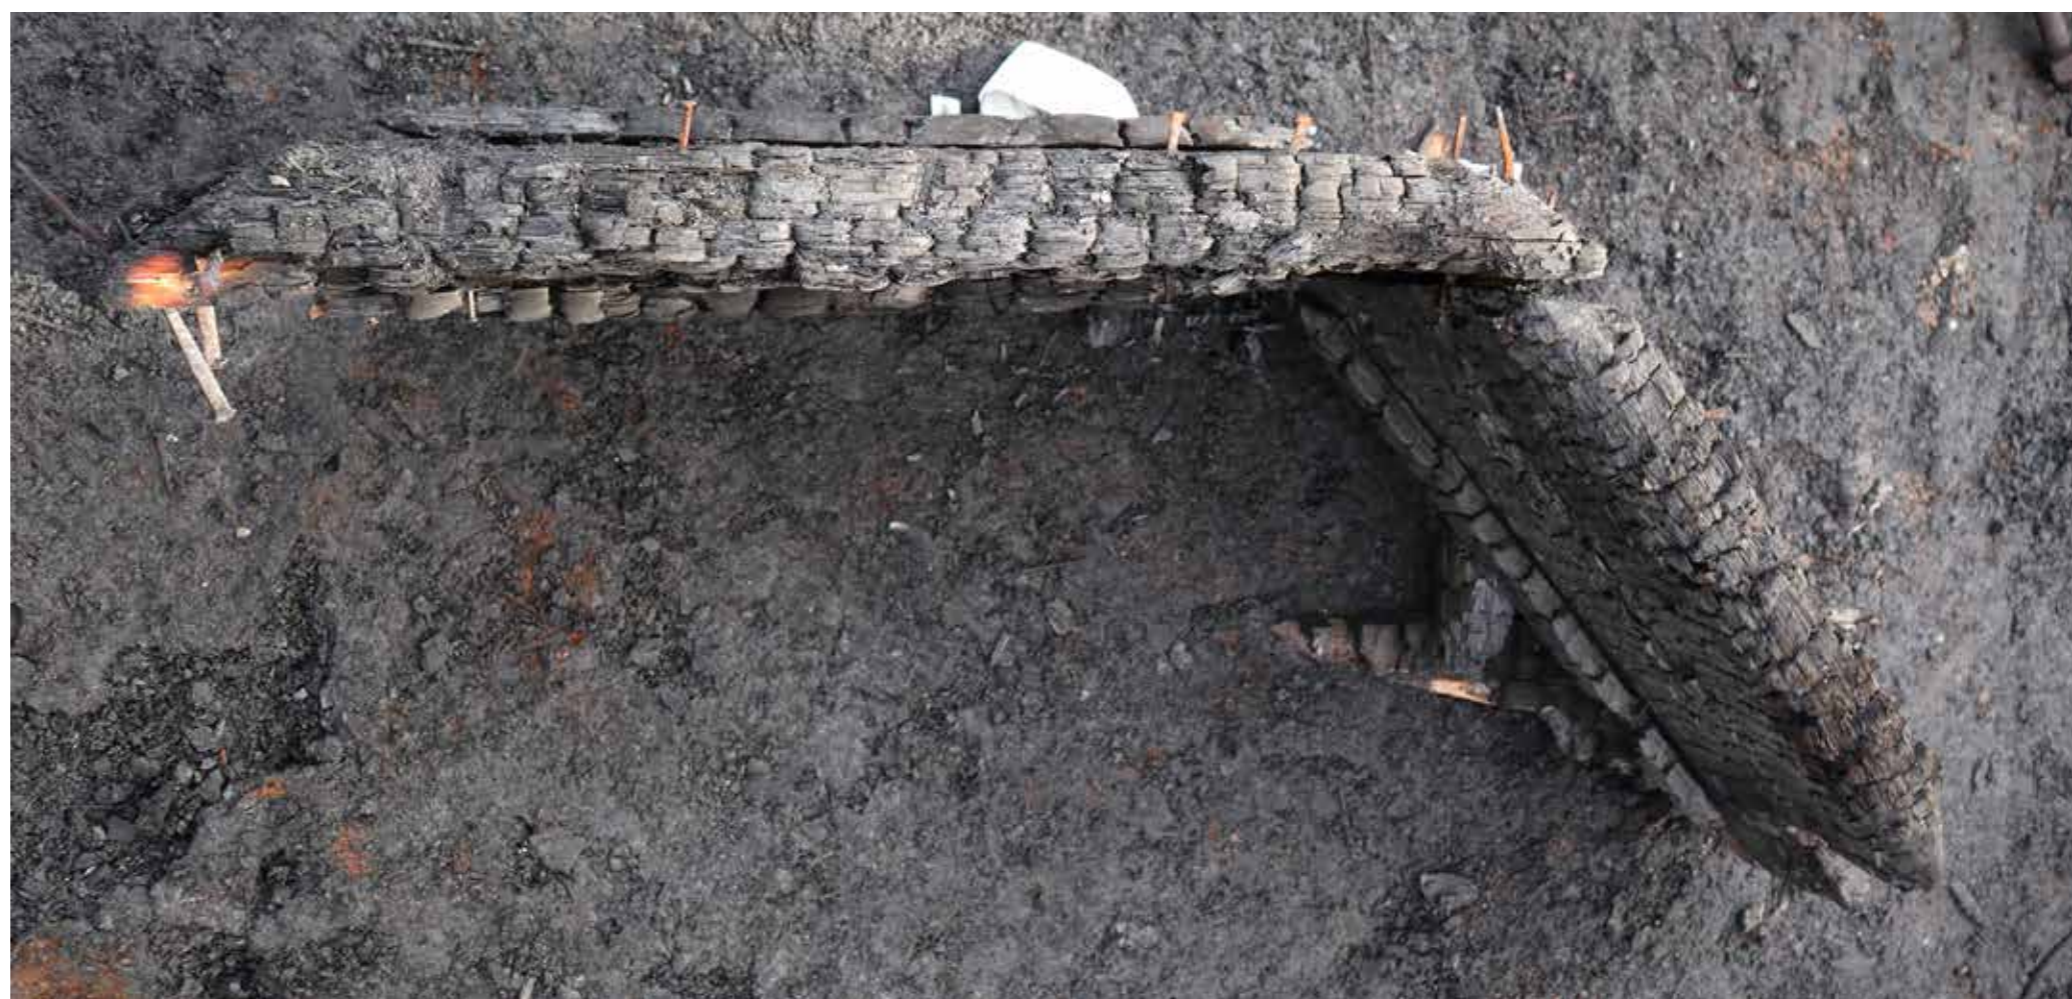
Figure 118: Inner apex ring beam (I) in situ (2020) © SLHA

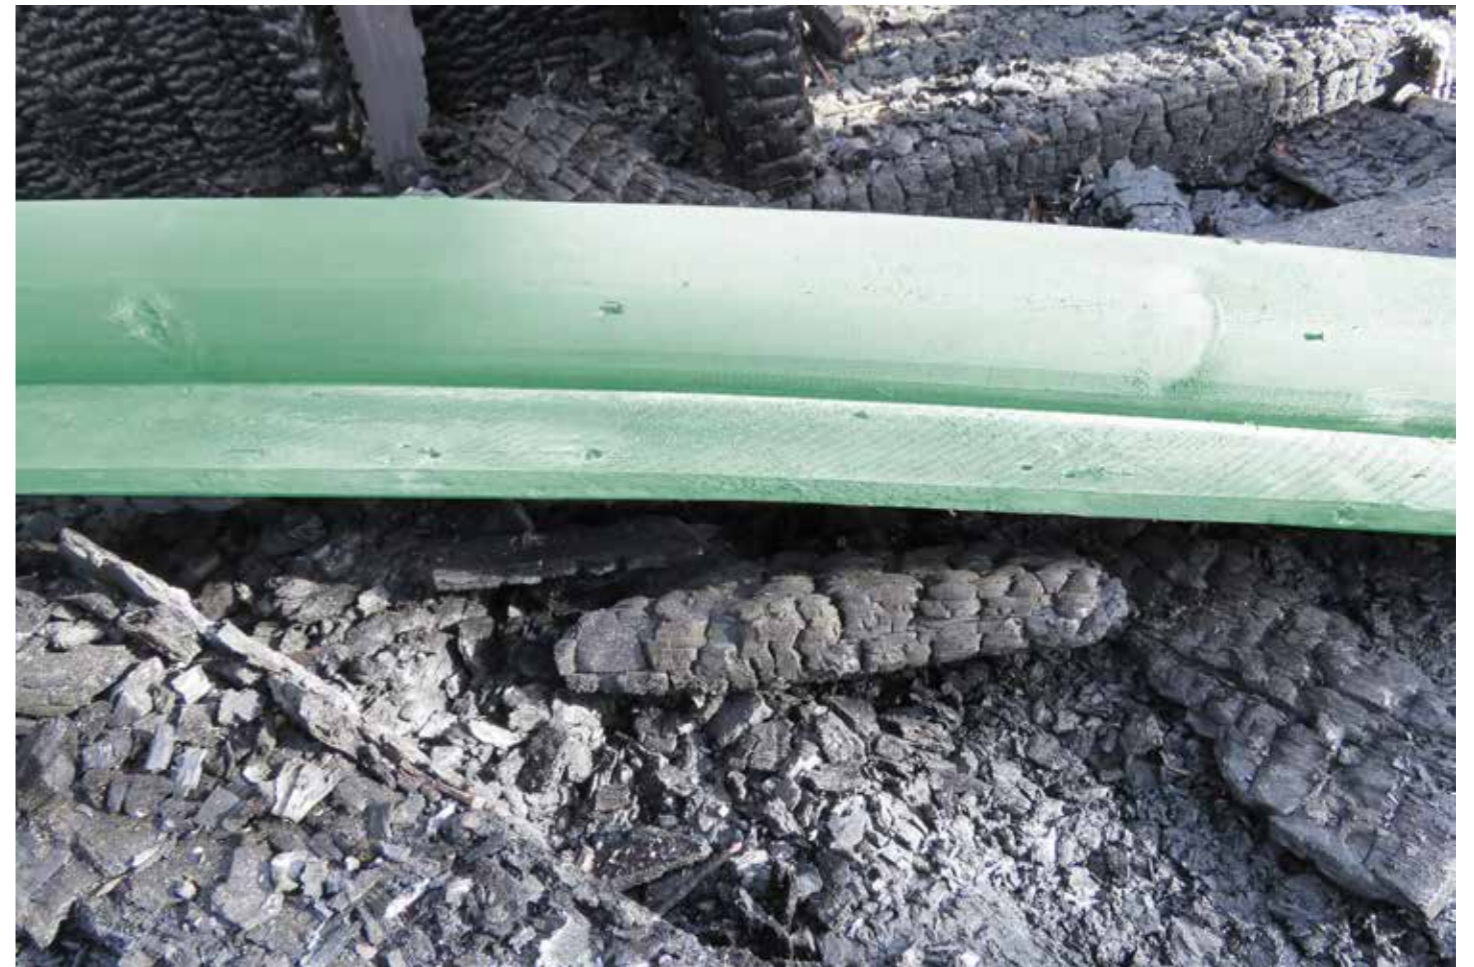
The roof rolls of the dome were significantly damaged by the fire and some were found within the debris.

Figure 126: Timber roof rolls (L) in situ (2020) © SLHA

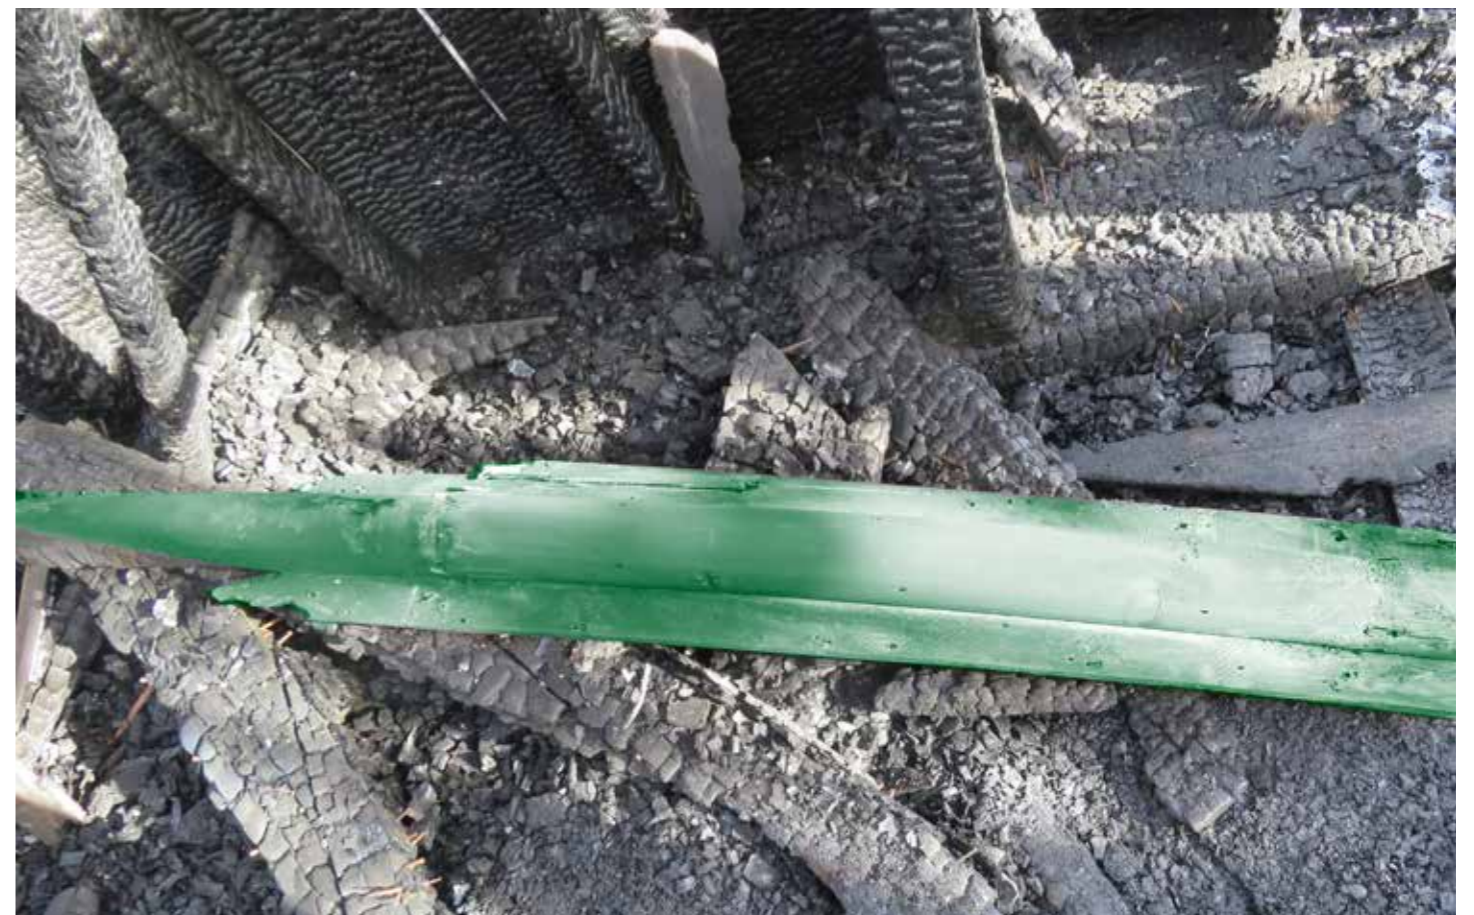
Figure 127: Timber roof rolls (L) in situ (2020) © SLHA

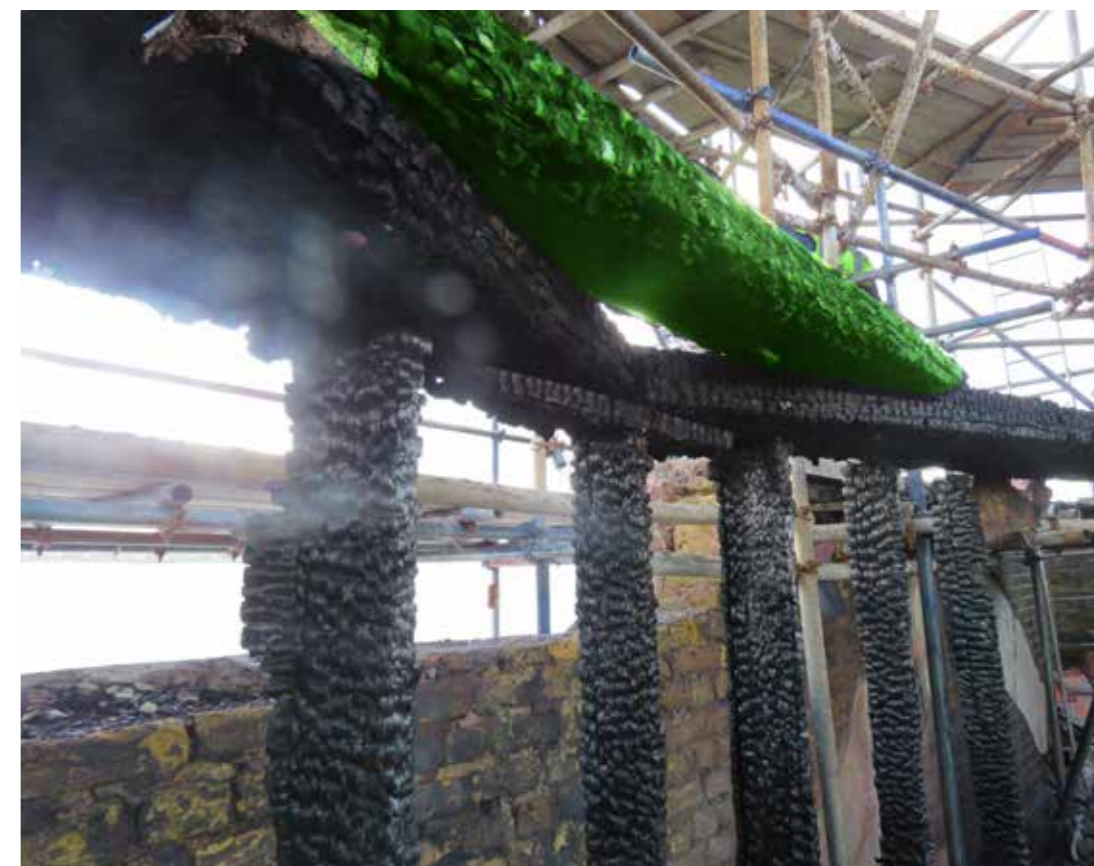
These elements have suffered similar damage as the upper rafter plate.

Figure 136: Horizontal rafter wall ties (M)s in situ (2020) © SLHA

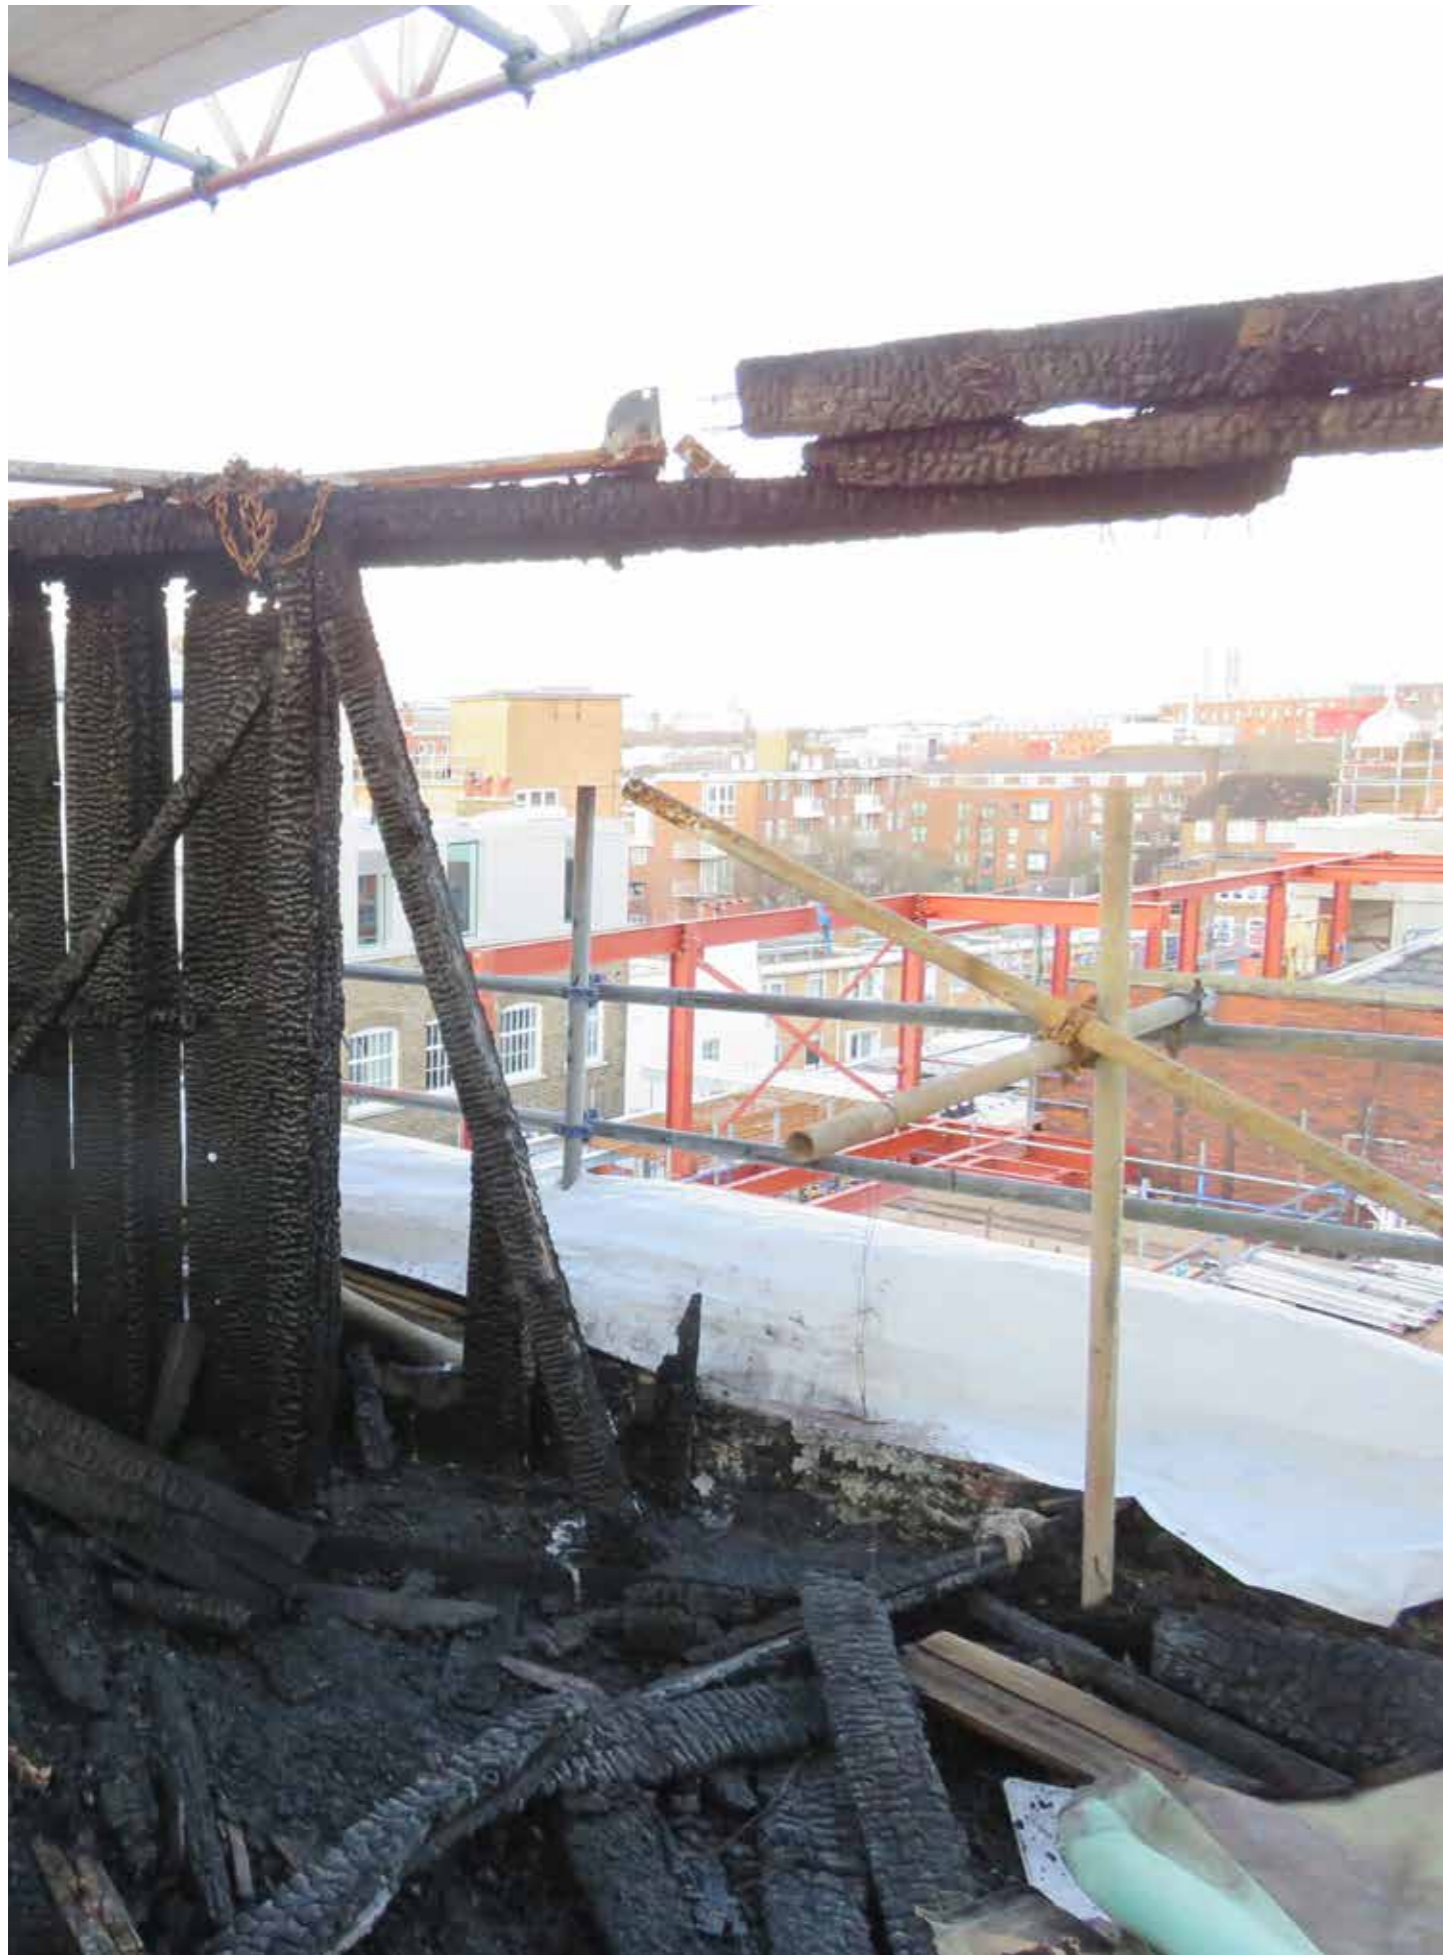
Figure 142: Horizontal rafter wall ties (M) east end condition (2020) © SLHA

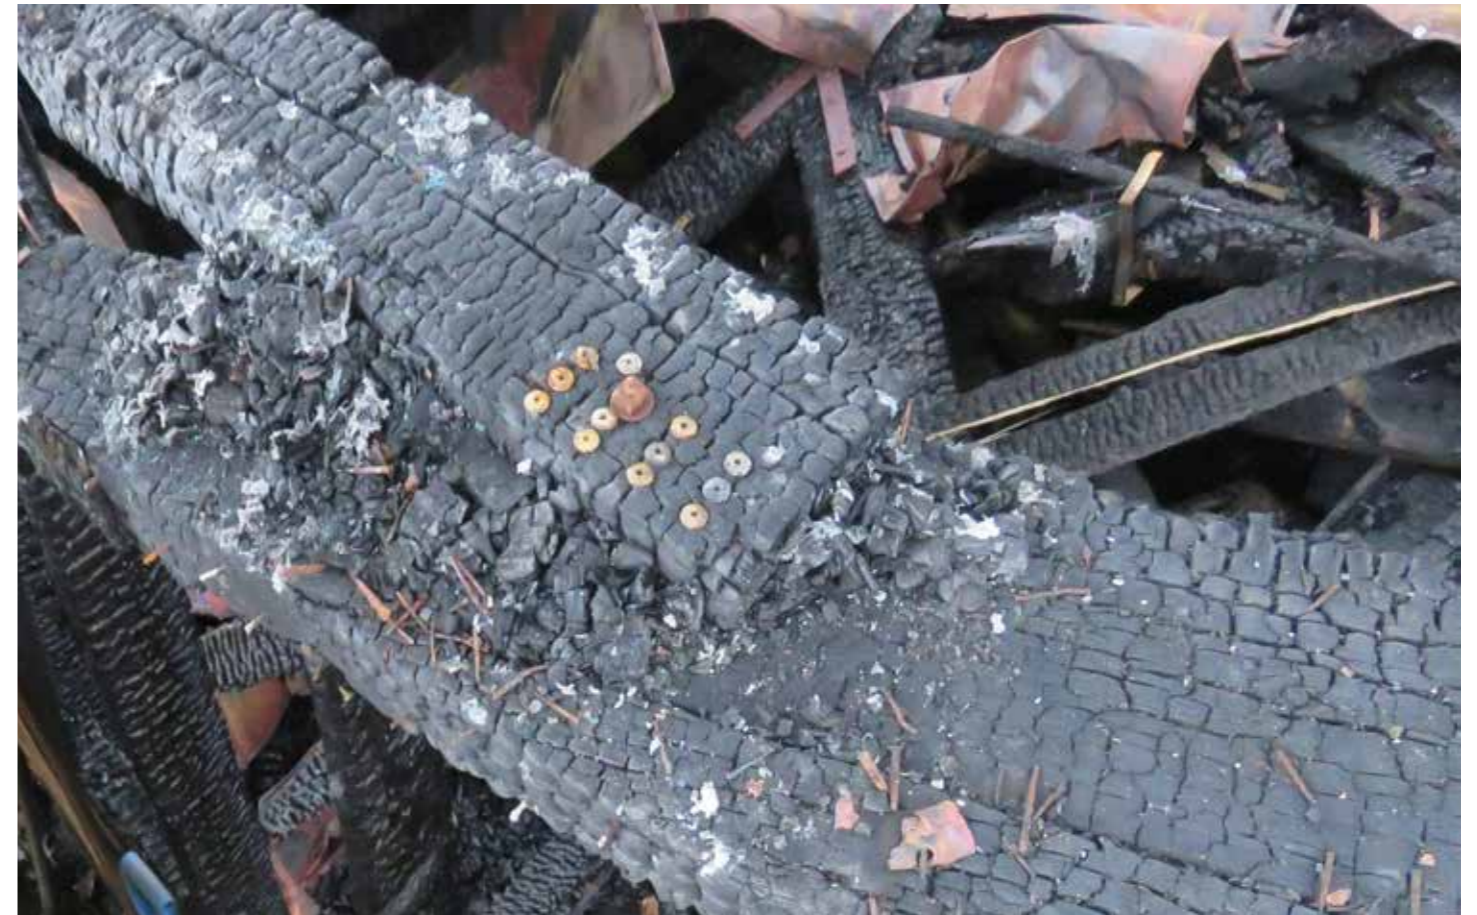
Figure 143: Horizontal rafter wall ties (M) with upper rafter plate (E) in situ. Note evidence of modern strengthening inserts used to connect them to the upper rafter plates. (2020) © SLHA

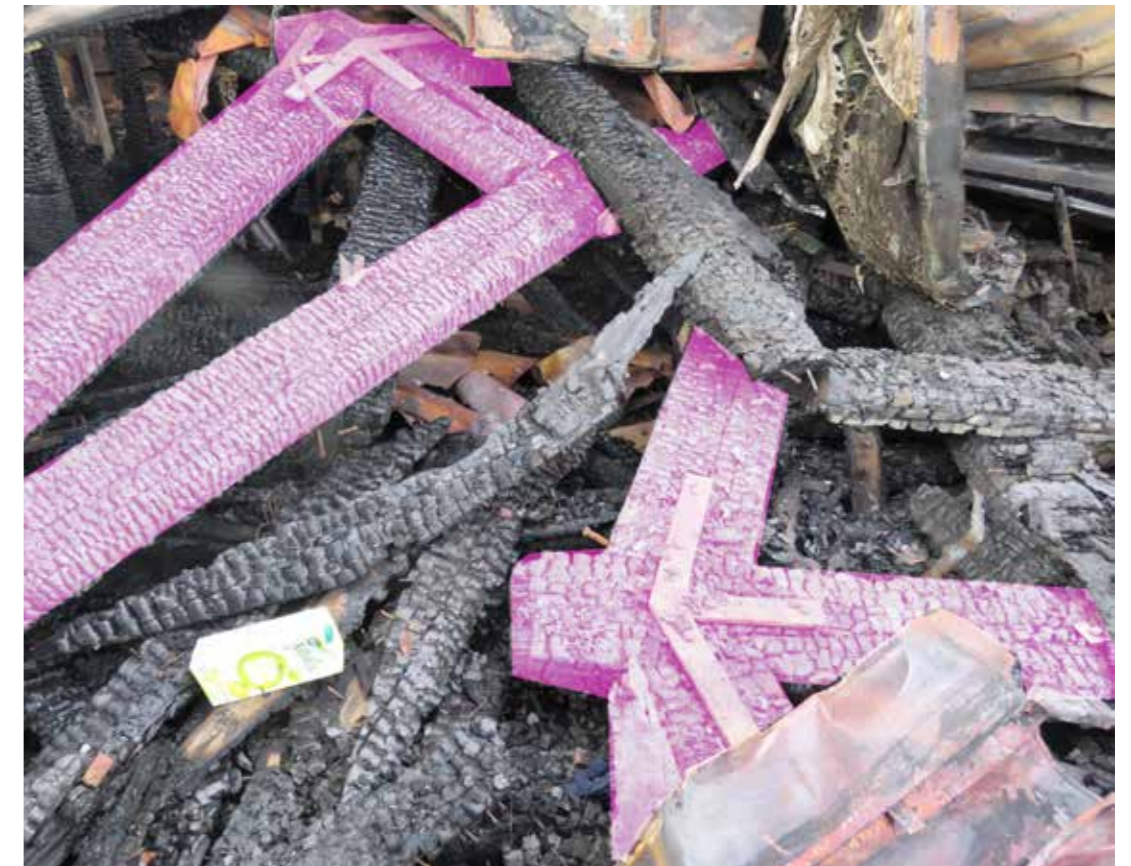
Though trusses did not disassemble during the fire, they collapsed and were discovered as whole elements.

Figure 149: Trusses (T) found in debris (2020) © SLHA

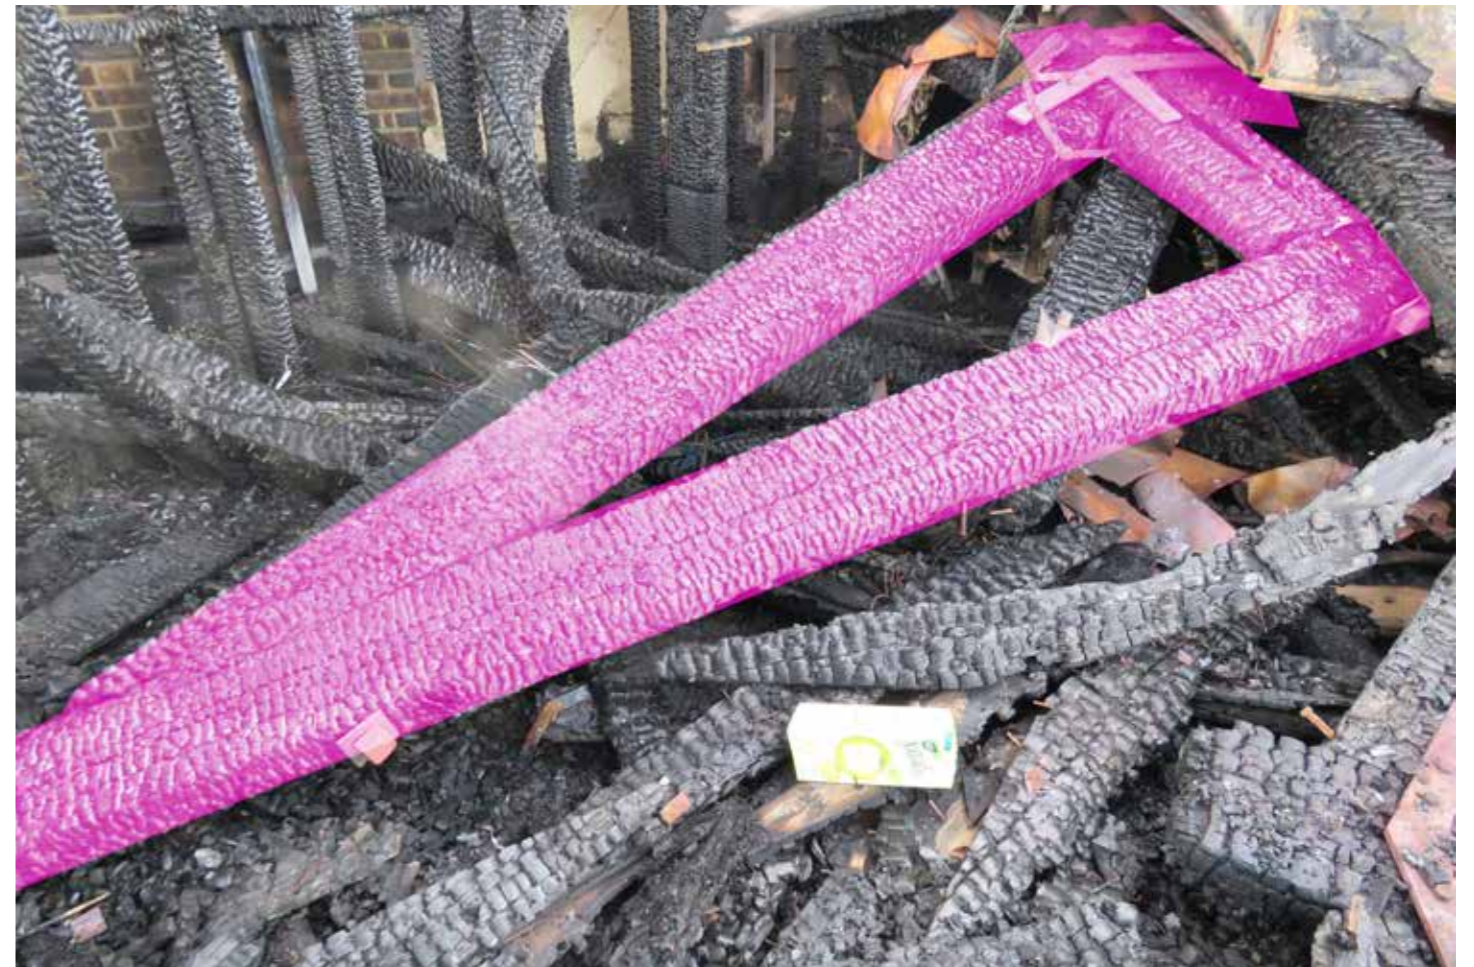
Figure 152: Trusses (T) found in debris (2020) © SLHA
