6. DOME INVENTORY - PRINCIPAL TIMBER ELEMENTS DETAILS

6.6 H - Wall boarding

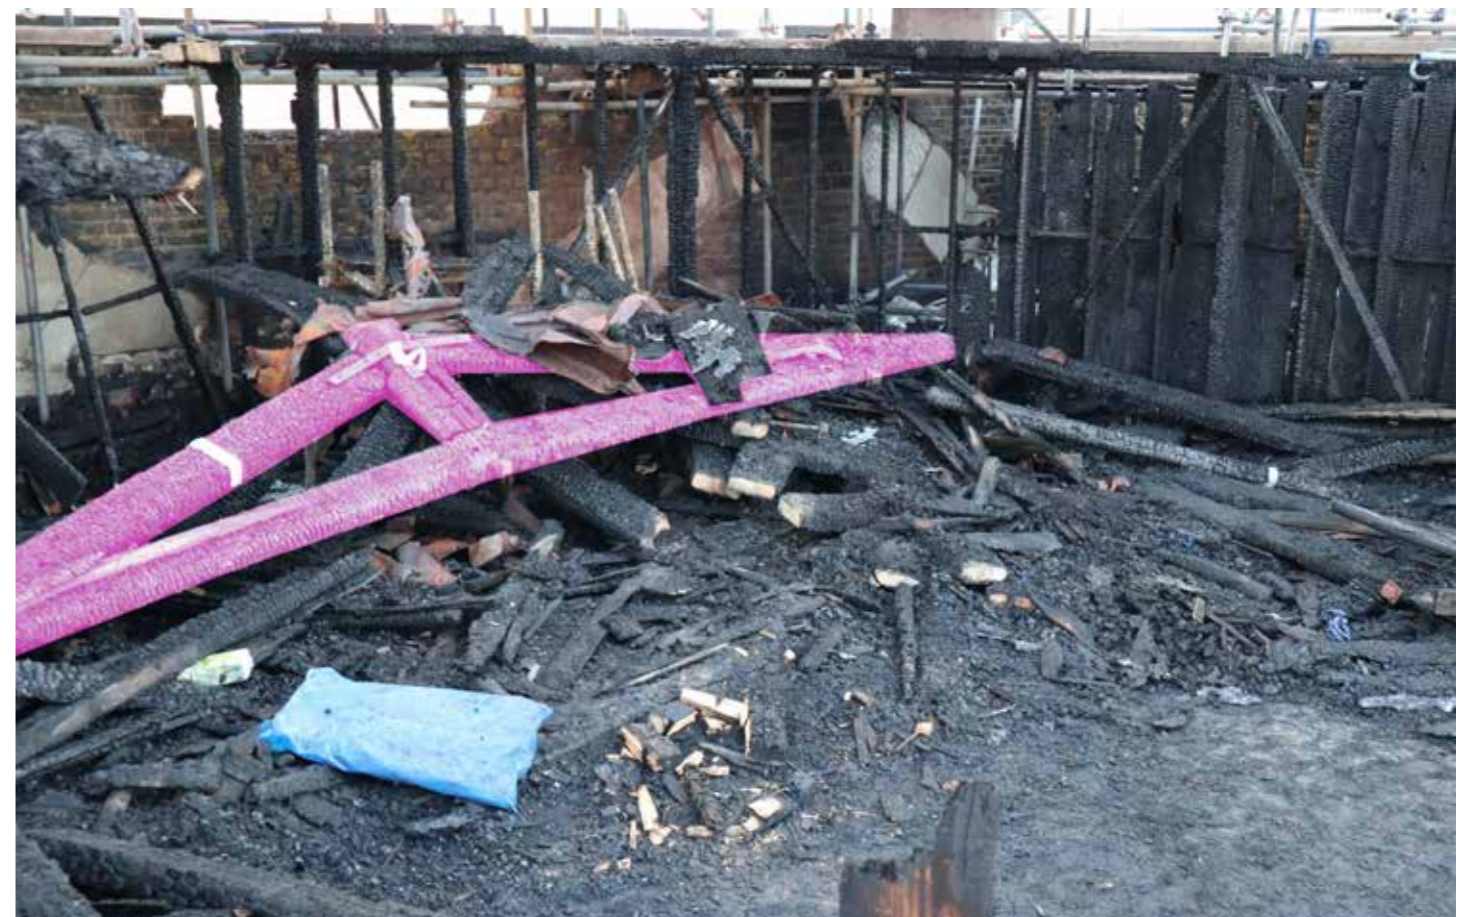
Though trusses did not disassemble during the fire, they collapsed and were discovered as whole elements.

Figure 153: Trusses (T) found in debris (2020) © SLHA

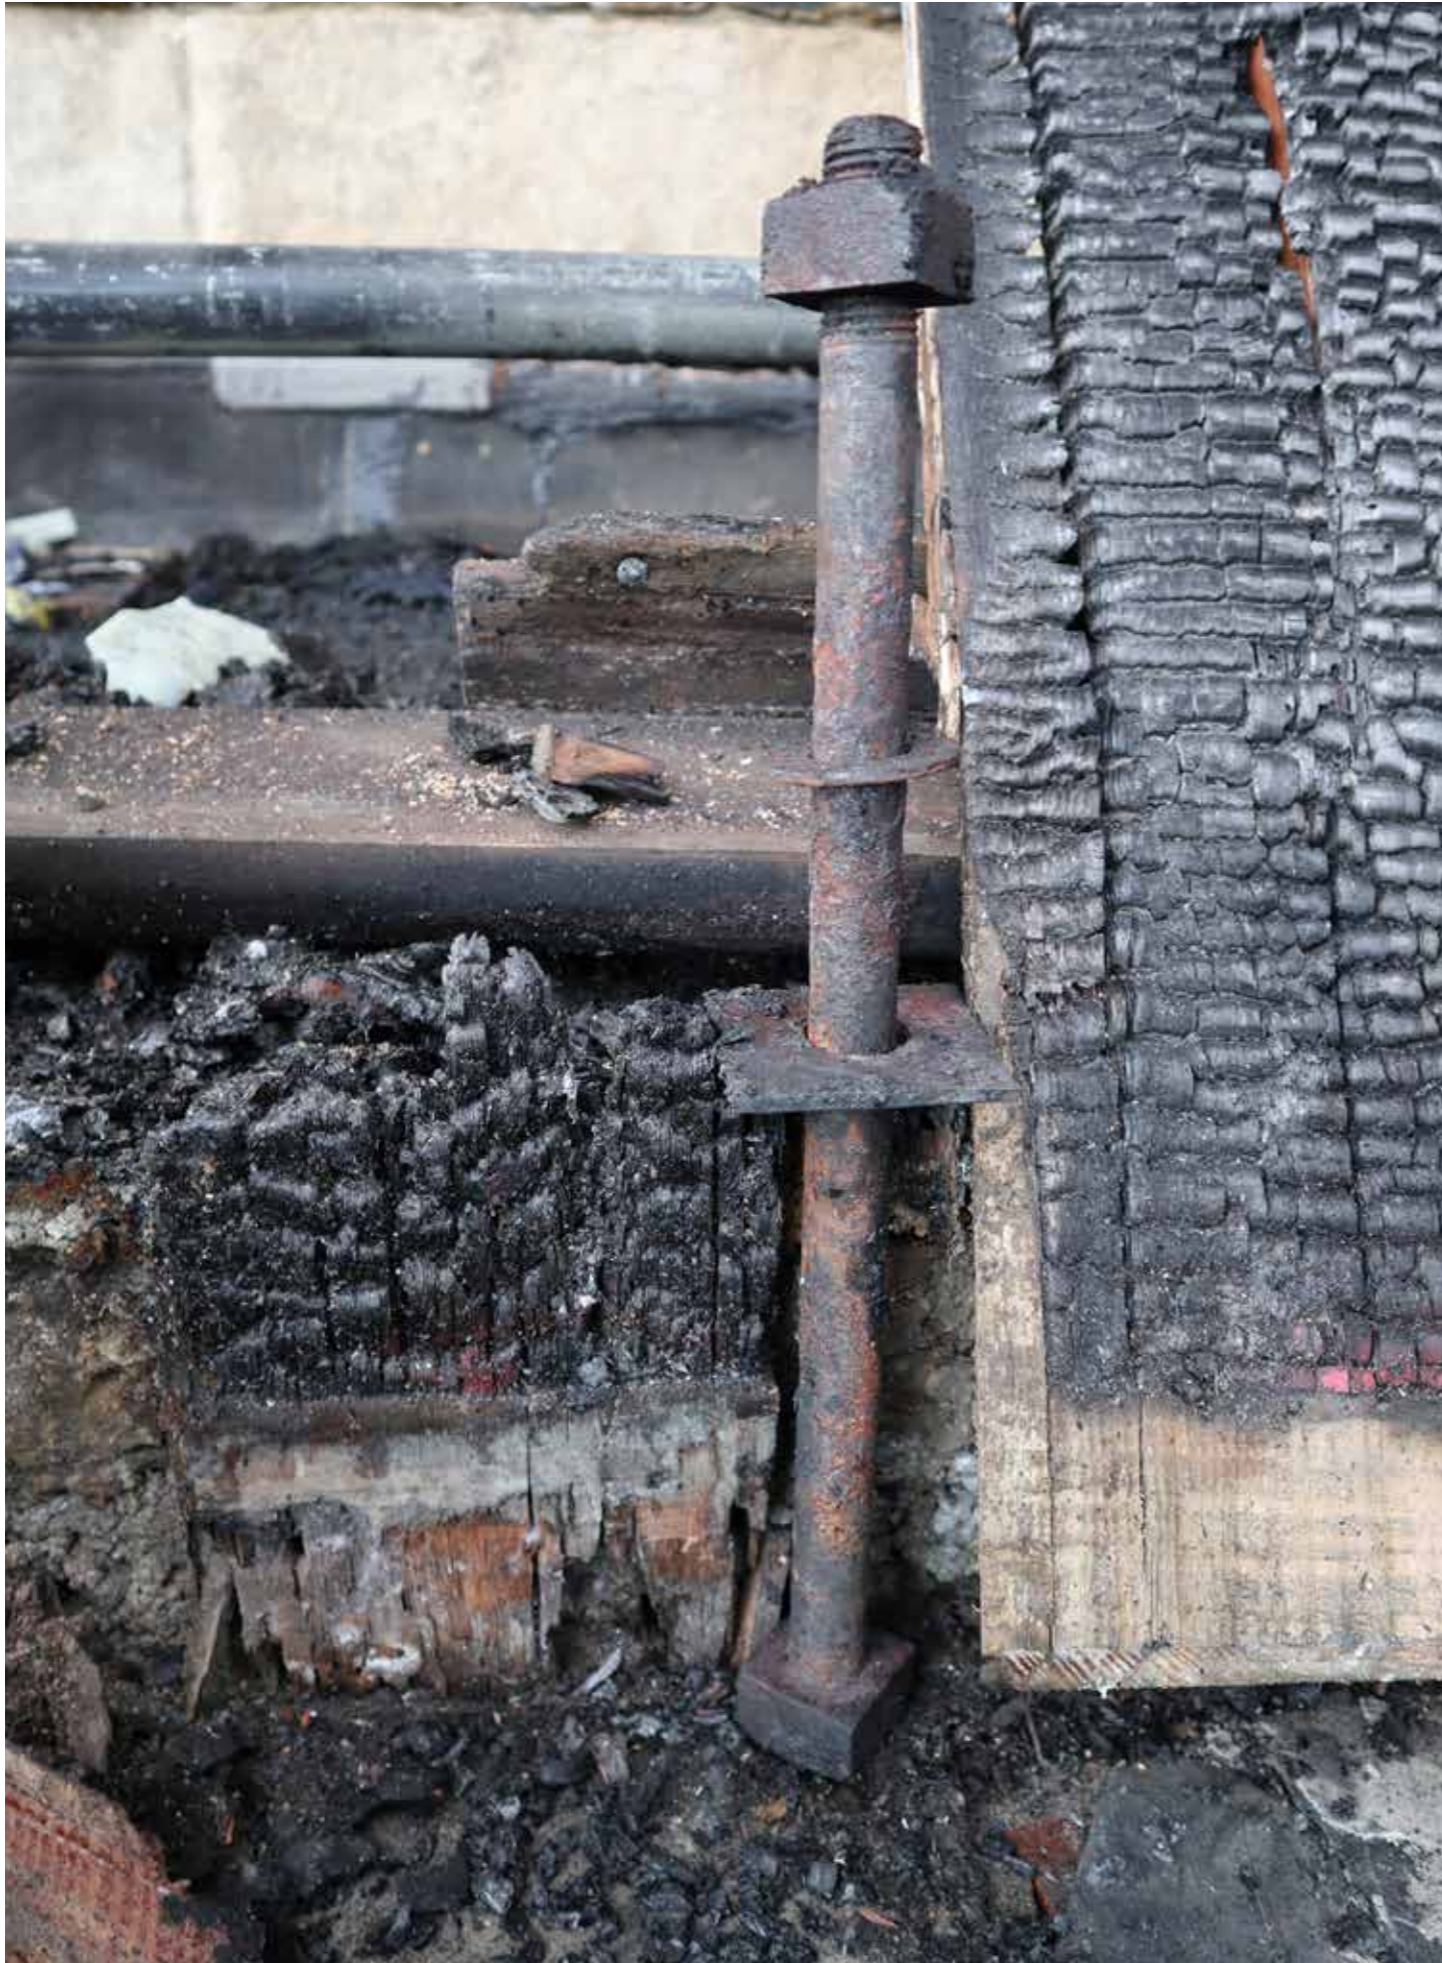
Figure 154: Sample #22 - Bolted metal brace (T4) (2020) © SLHA

Further bracing has been applied to connect the principal rafter to the tie beam by a bolted arrowhead metal braces (T4). These braces metal braces are made of iron and they are intended to be tested, cleaned and re-used (if viable) for proposed reinstatement.

One whole truss was salvaged and has been catalogued. All bolted arrowhead braces have been salvaged and are proposed to be reused during the dome's reinstatement.
