KOKO
Camden, London

Dome:
Historic Timber Structure -
Post-fire Inventory Report

April 2020

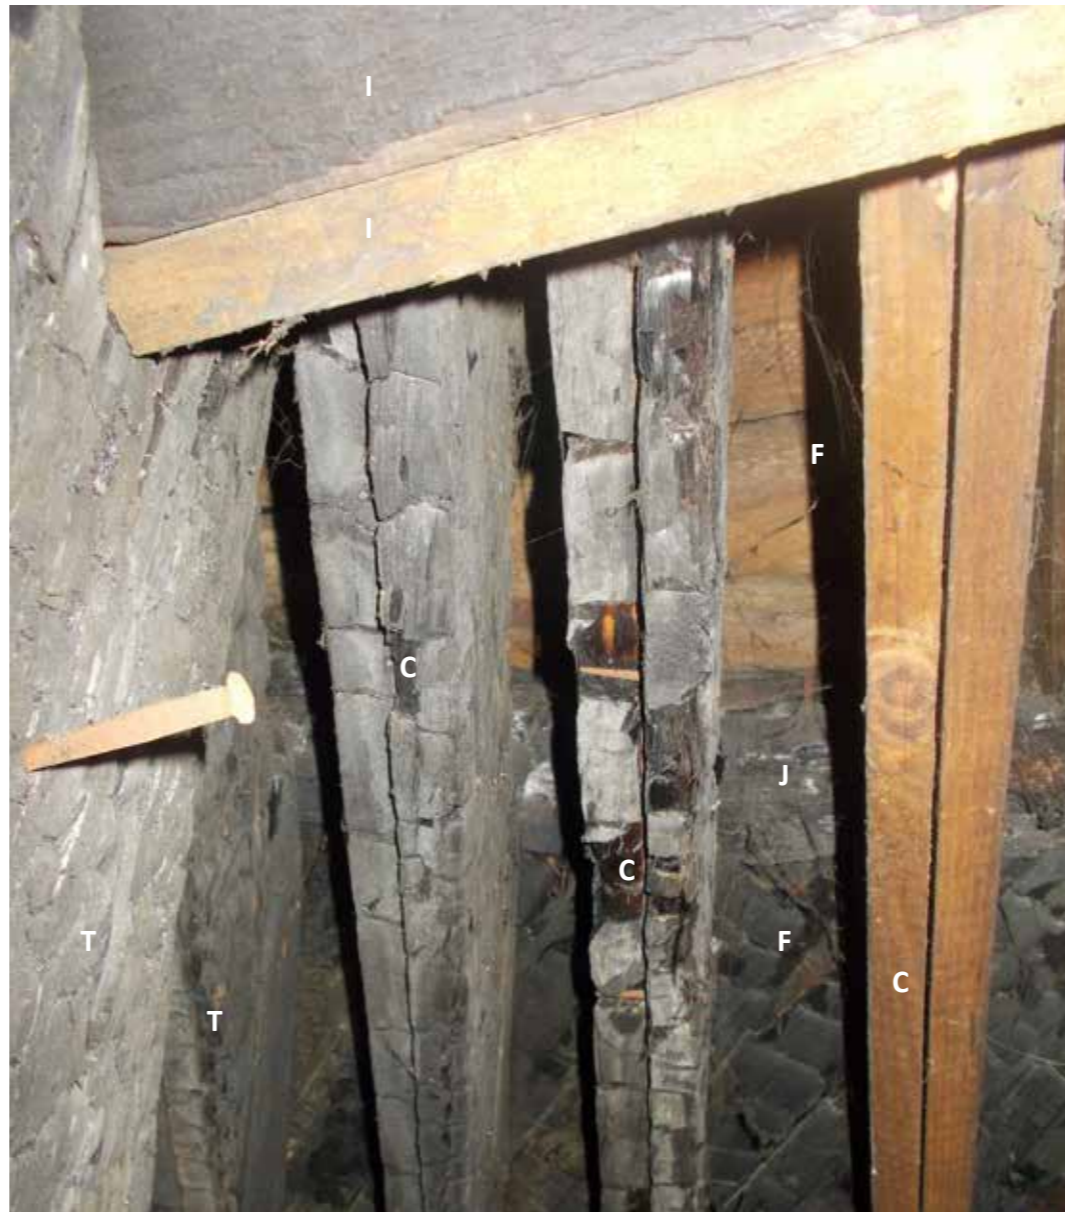
Figure 10: 2-part timber ribs at apex junction & birds-mouth (shown on the left corner) joint from end tie beam of truss. Note previous fire damage (possibly in the early 20th C). (2019) © H&R

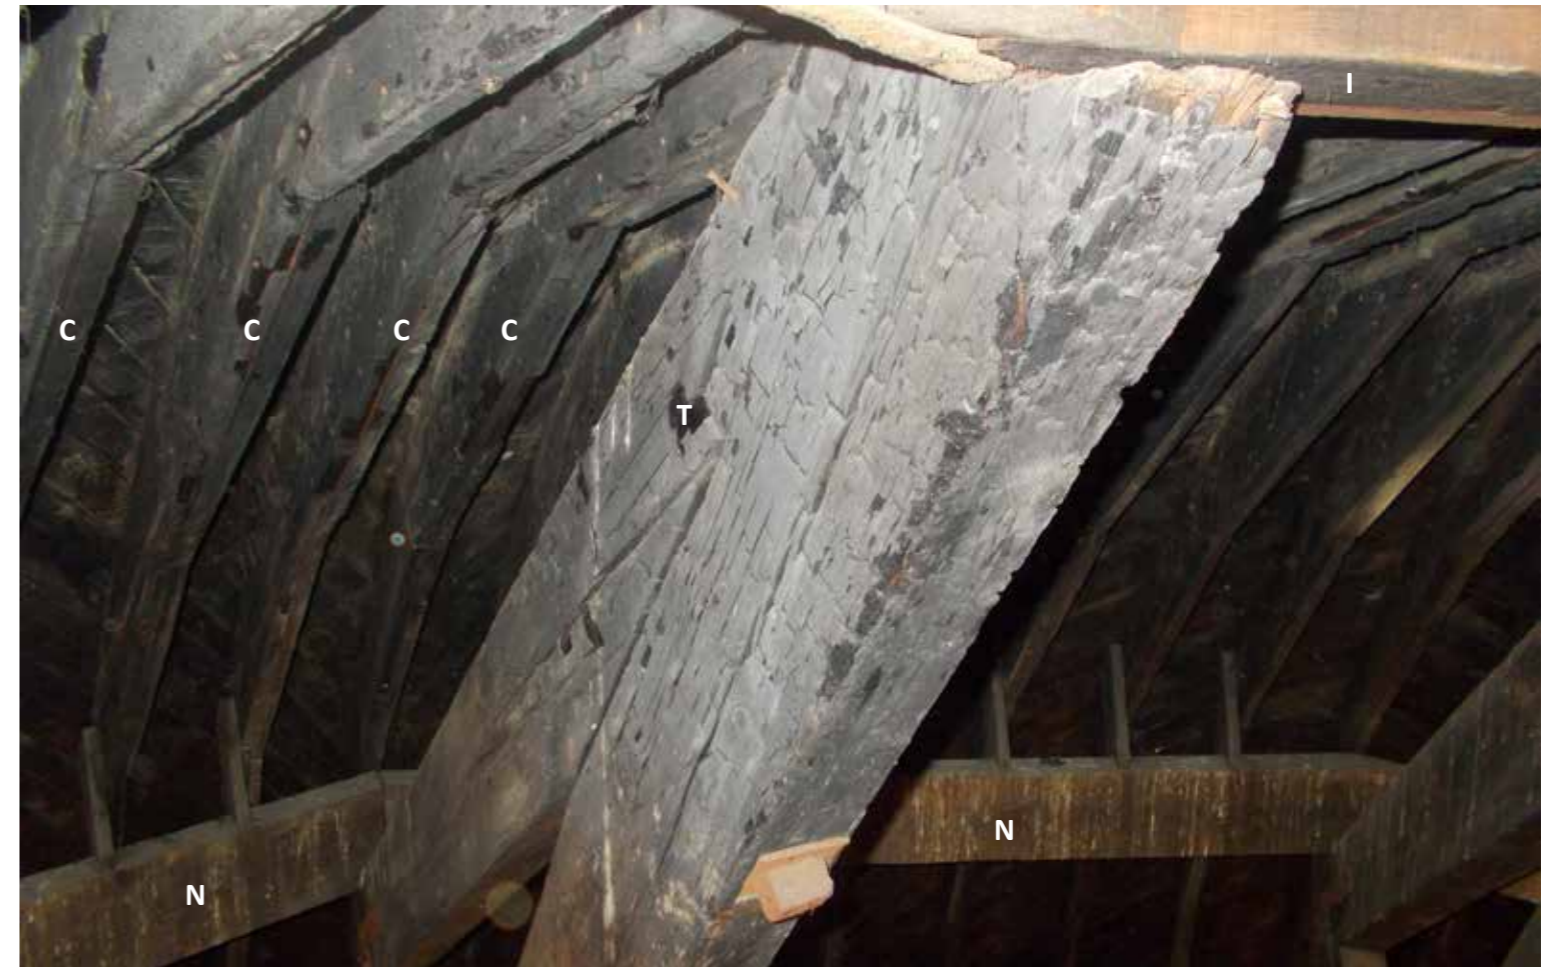
Figure 15: Birds-mouth joint between the truss and inner apex ring beam. Note previous fire damage (possibly in the early 20th C). (2019) © H&R

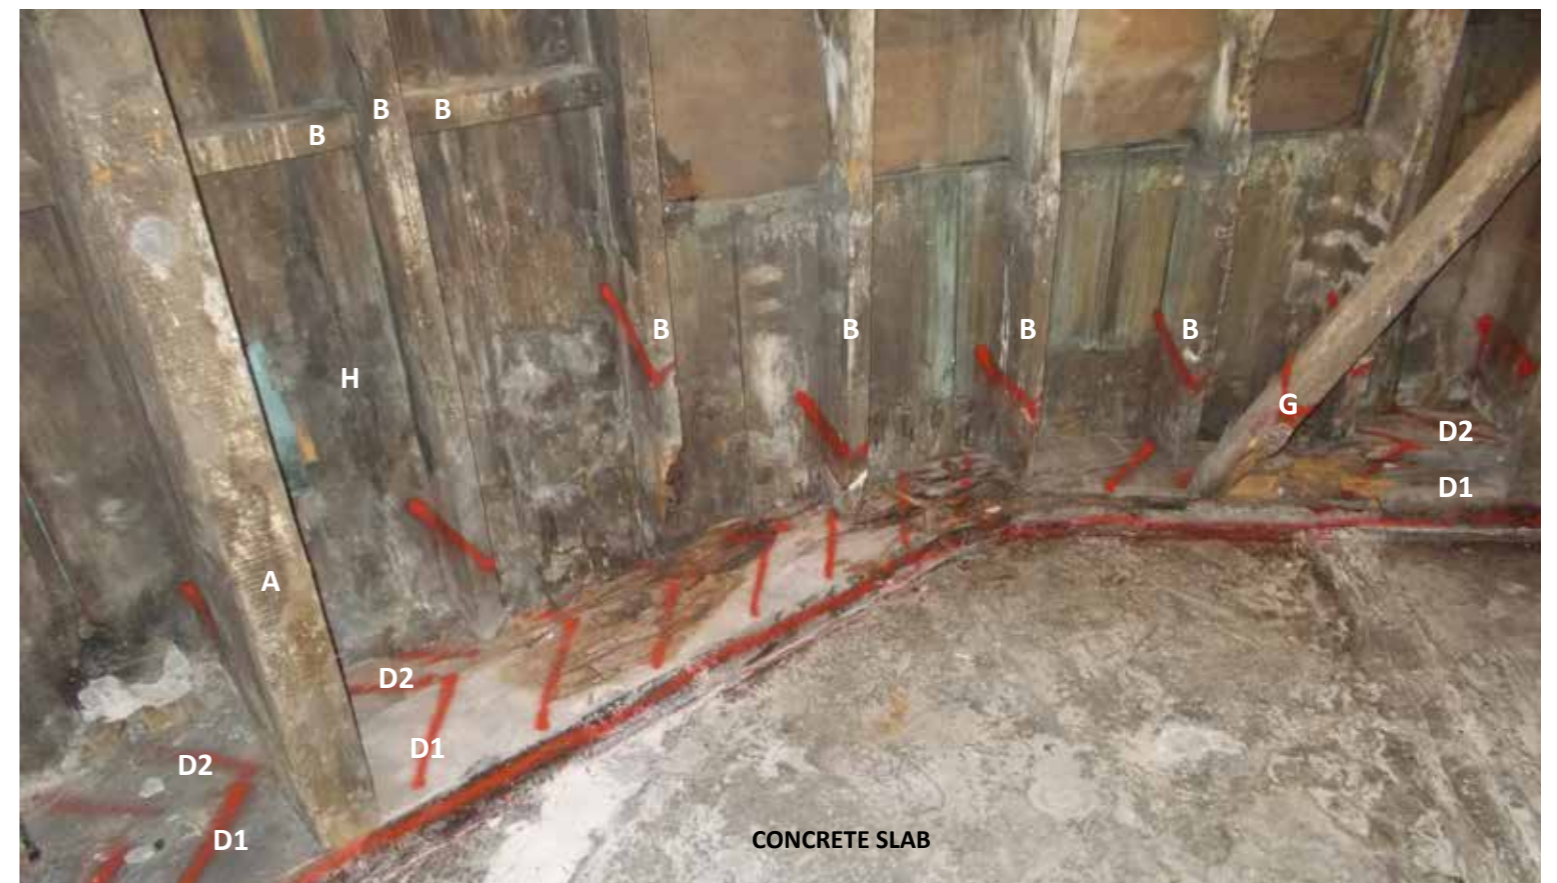
Figure 16: Lower stud wall plate at the base of the dome. The highlighted red marks are areas of structural timber decay. (2019) © H&R

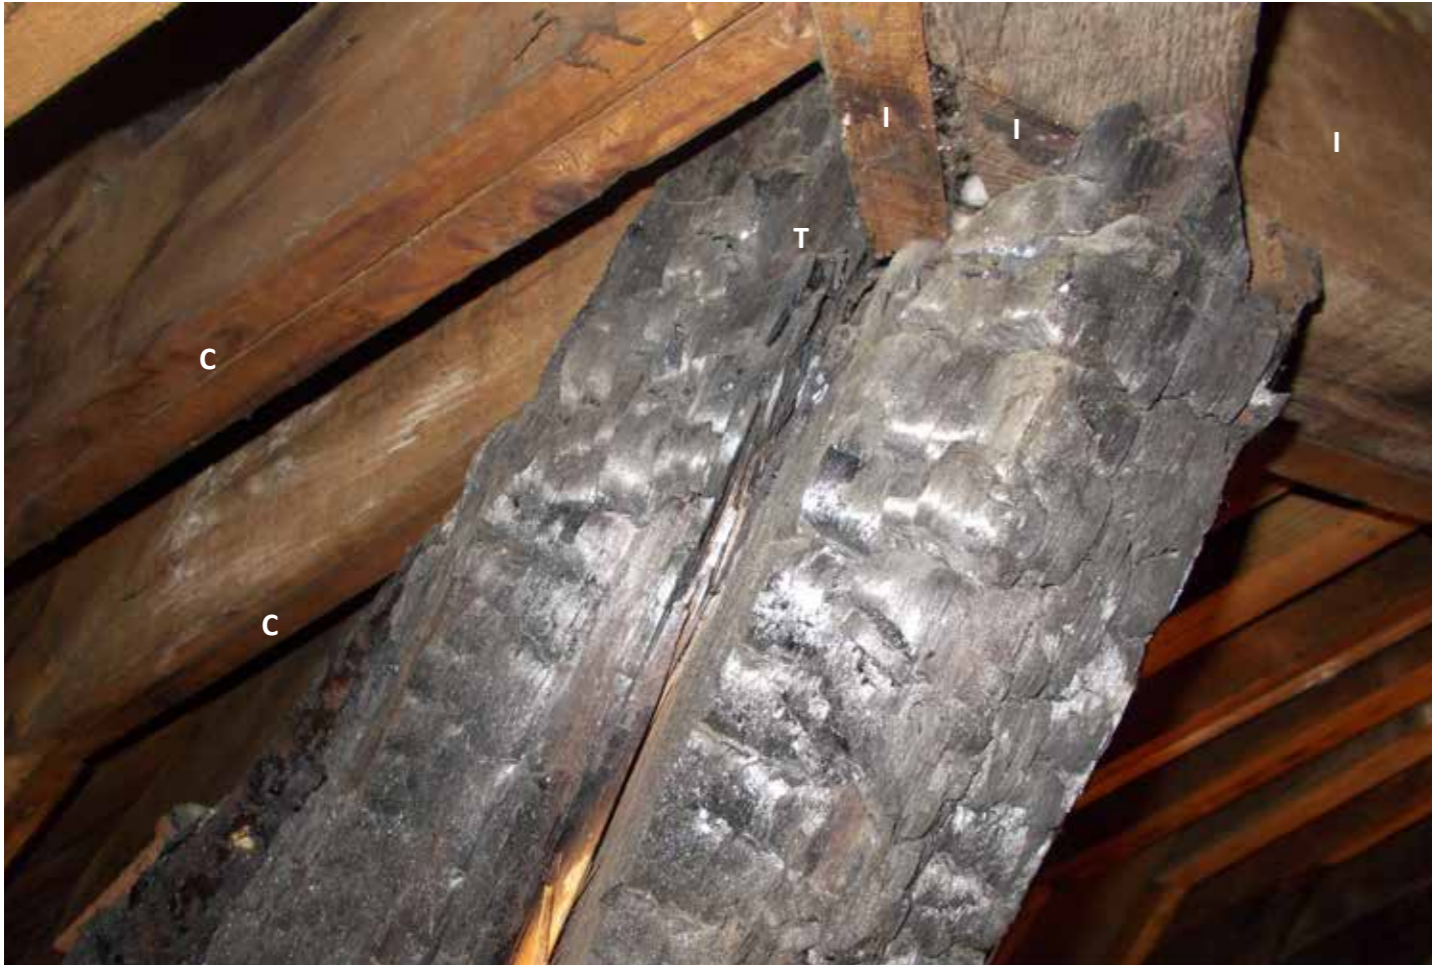
Figure 17: View of junction between the trusses tie beam, 2-part ribs and the inner apex ring beam. Note previous fire damage (possibly in the early 20th C). (2019) © H&R

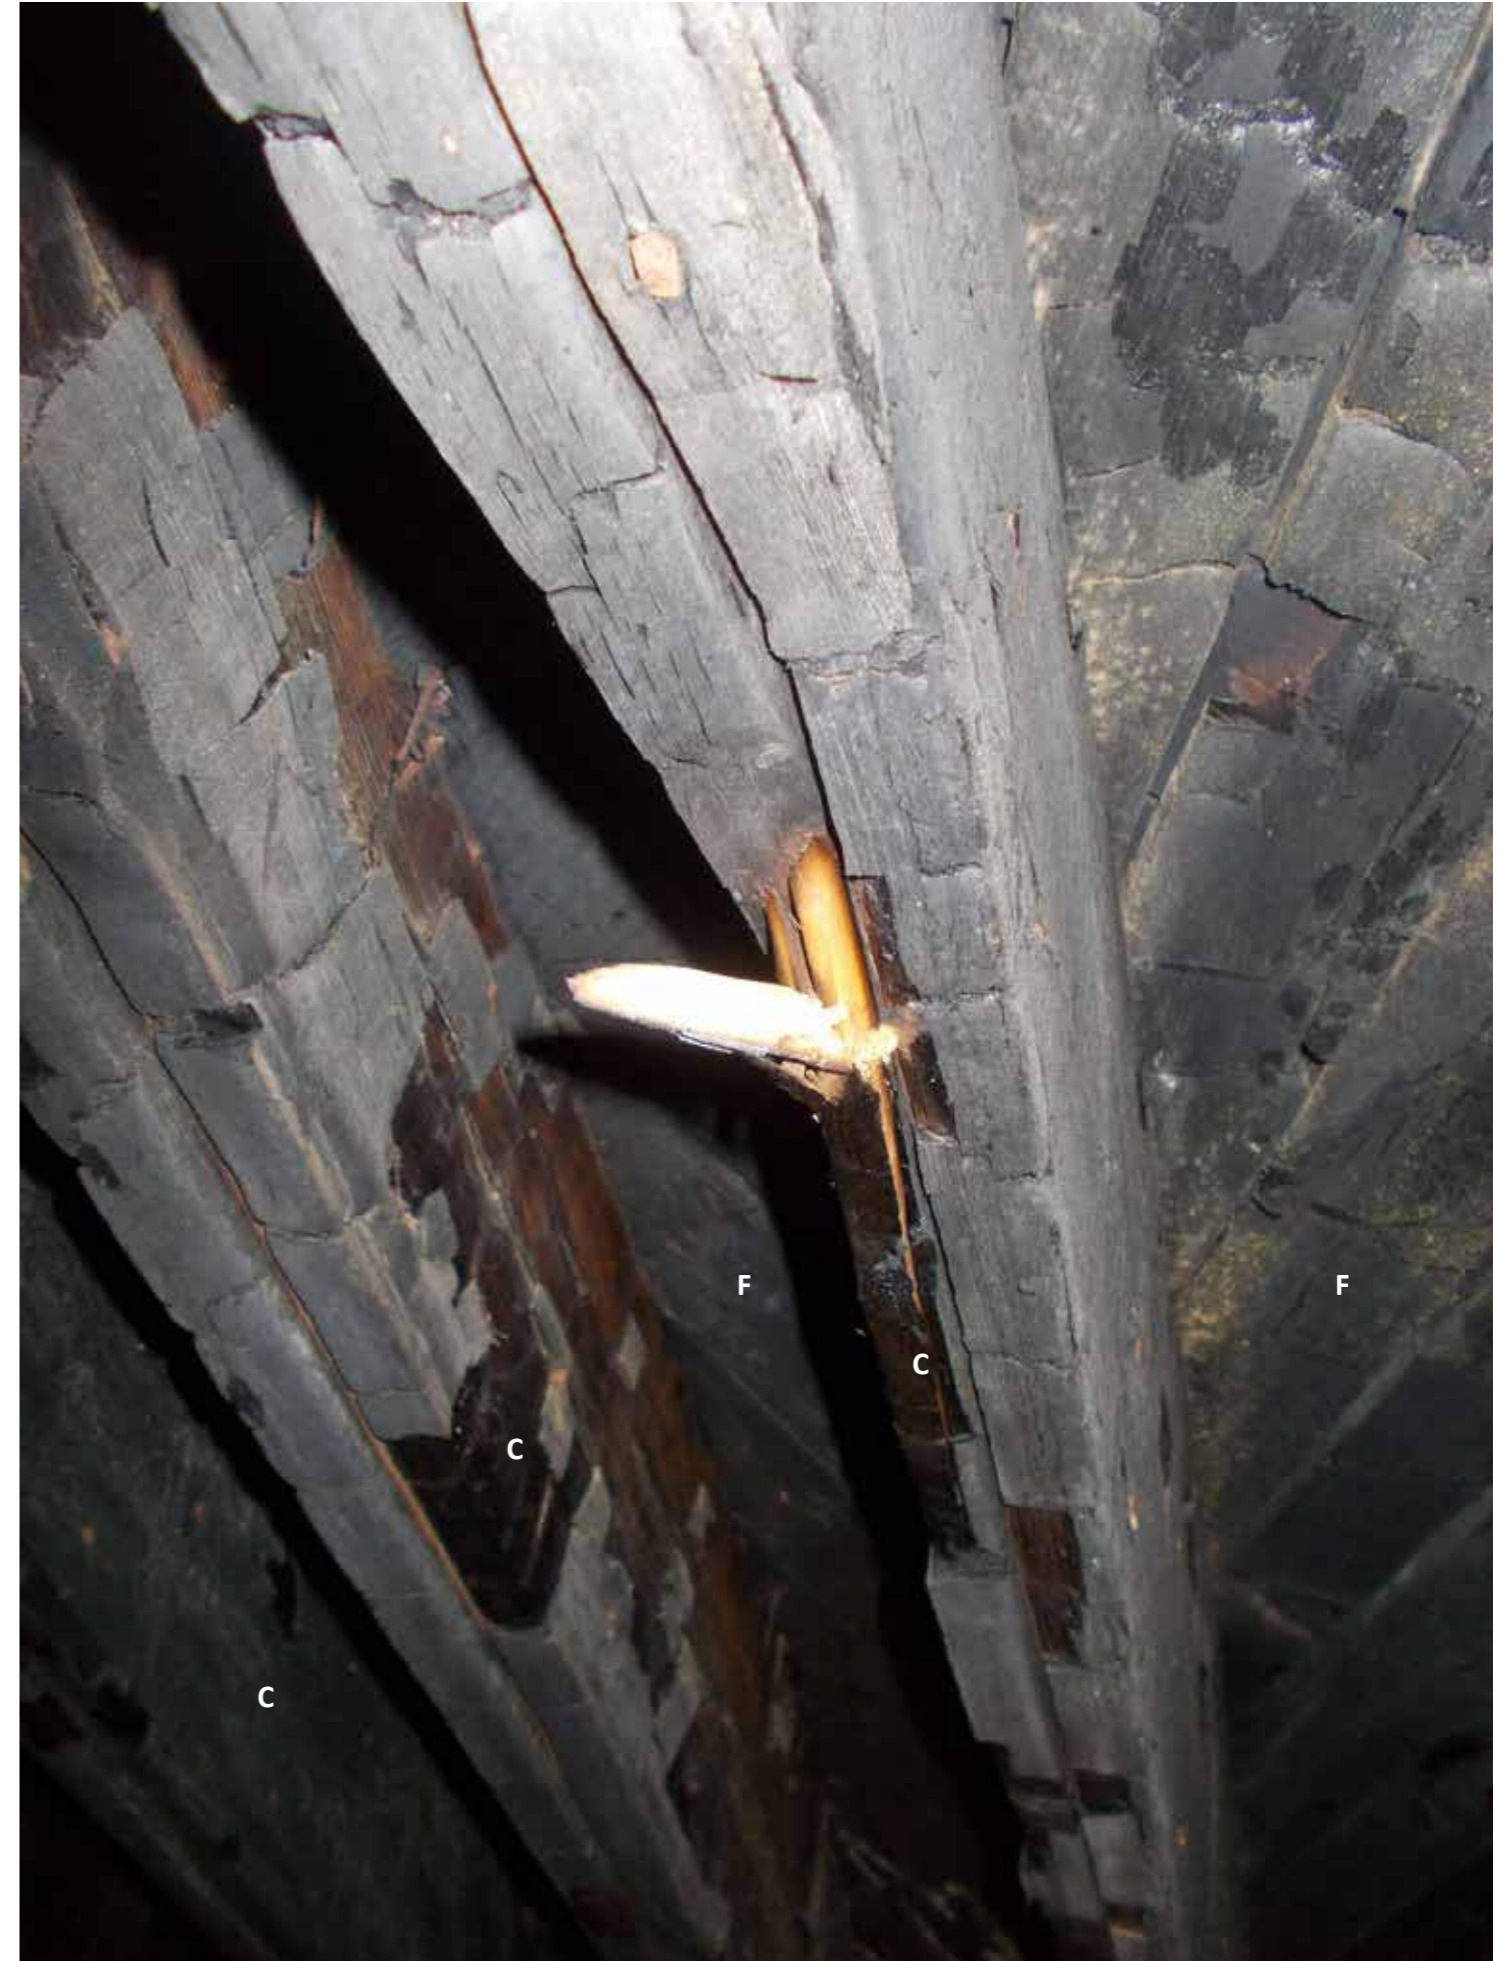
Figure 19: 2- part timber ribs and roof boarding. Note previous fire damage (possibly in the early 20th C). (2019) © H&R

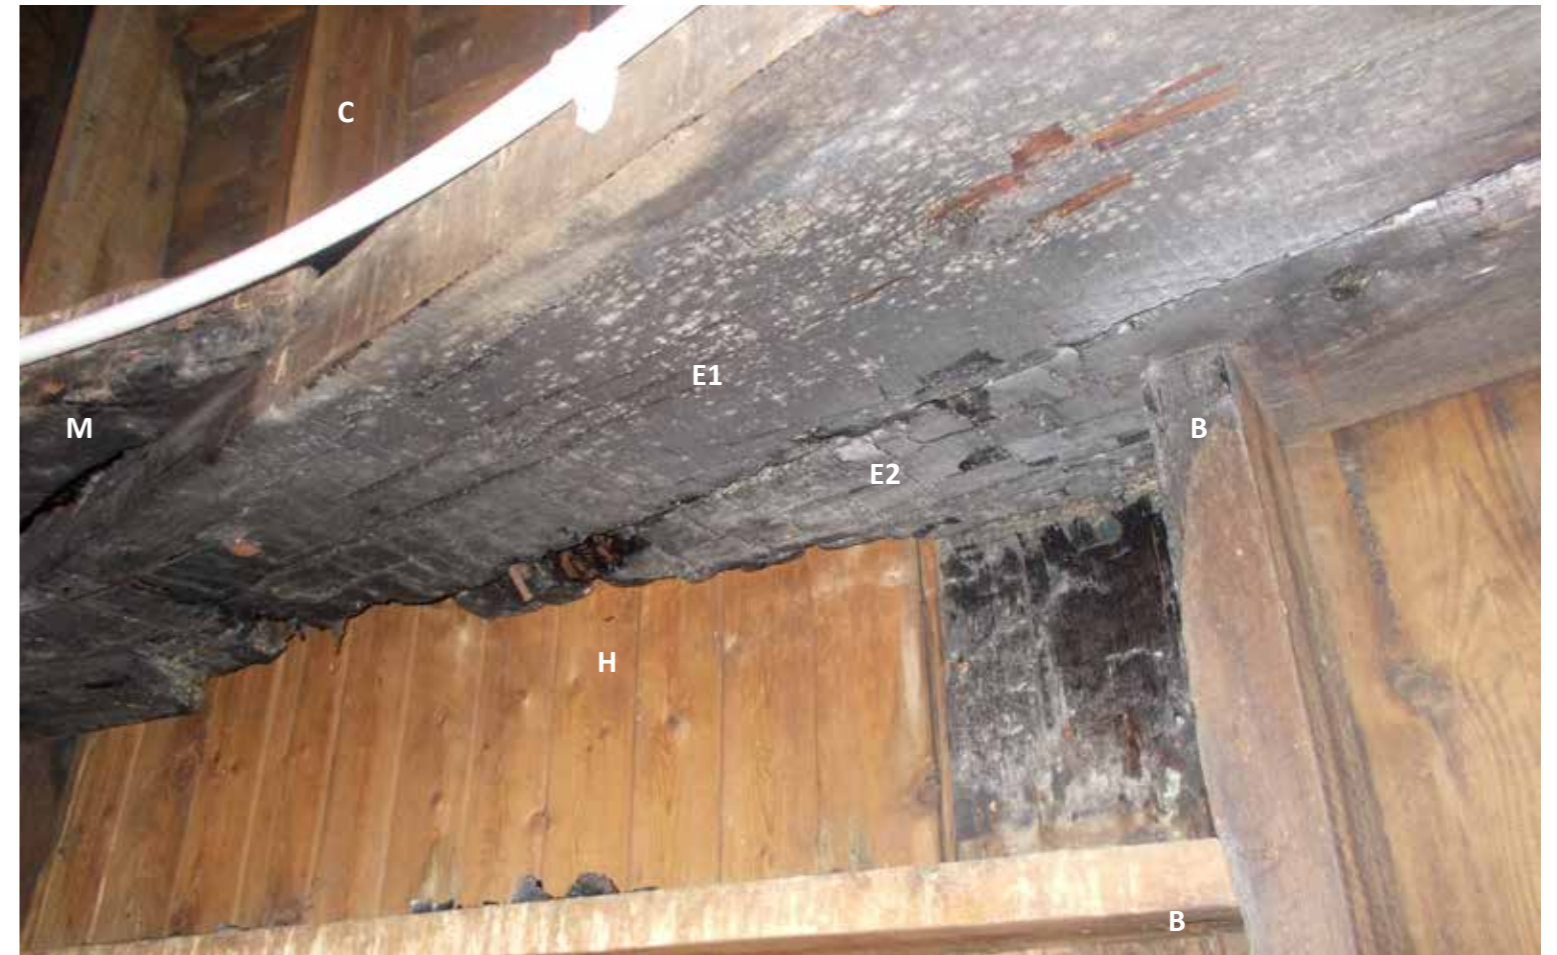
Figure 21: Bottom view of upper rafter plate. Note previous fire damage (possibly in the early 20th C). (2019) © H&R

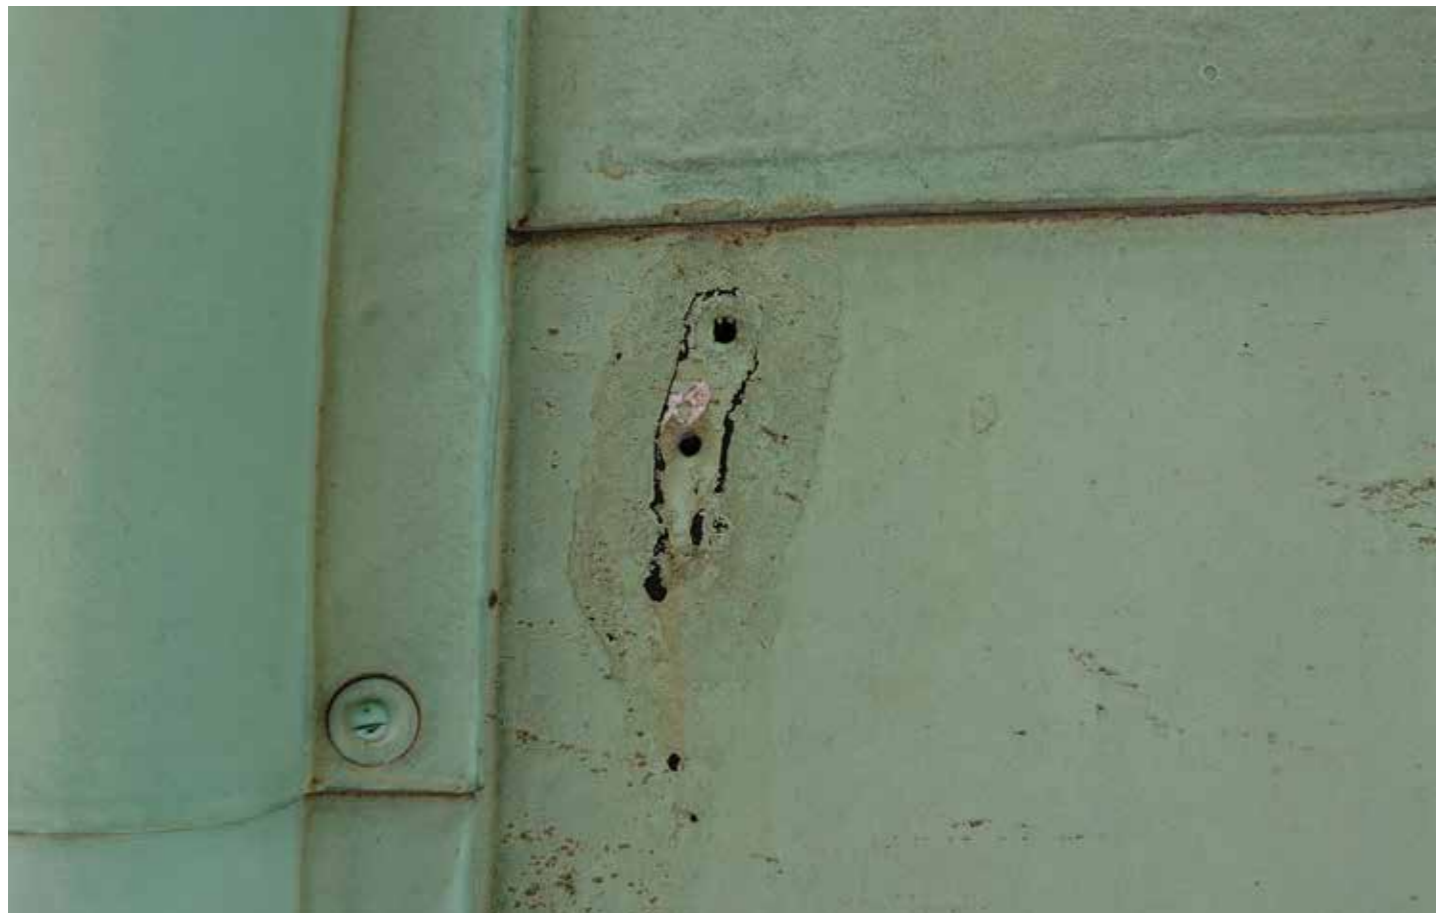
Figure 24: Exterior copper roof cladding detail and damage (2019) © H&R
