**TECHNICAL REPORT ON A SUBSIDENCE CLAIM**

**33 Priory Terrace  
London  
NW6 4DG**

**SUBSIDENCE CLAIM**

DATE 2<sup>nd</sup> January 2020

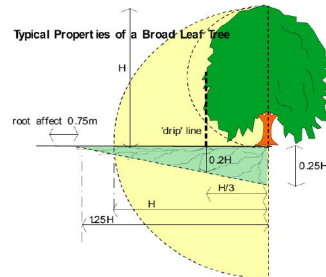
Typical proportions of a broadleaf tree. Note the potential root zone. It must be noted that every tree is different, and the root zone will vary with soil type, health of the tree and climatic conditions.

However heavy pruning of any tree should be avoided if possible, as it stimulates the formation of dense masses of weakly attached new branches which can become dangerous if not re-cut periodically to keep their weight down.

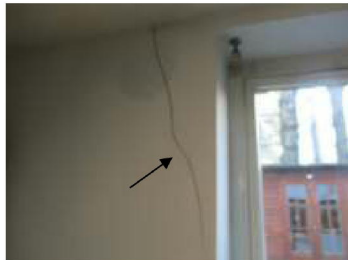
Cracking to rear wall in kitchen

**Flat 33a Kitchen Extension** - 3mm diagonal tapering crack to left hand side of patio doors continues around wall / ceiling junction in rear left hand corner and along left hand flank wall, wall / ceiling junction cracking along right hand flank.

In structural terms the damage falls into Category 2 of Table 1, Building Research Establishment<sup>4</sup> Digest 251, which describes it as **"slight"**.

The pattern and nature of the cracks is indicative of an episode of subsidence. The cause of movement appears to be clay shrinkage.

The timing of the event, the presence of shrinkable clay beneath the foundations and the proximity of vegetation where there is damage indicates the shrinkage to be root induced. This is a commonly encountered problem and probably accounts for around 70% of subsidence claims notified to insurers.

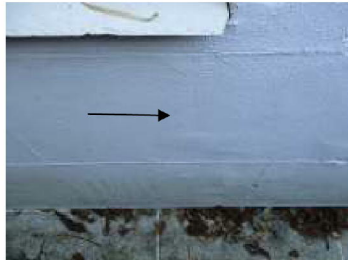
**Rear Extension (Directions as facing)** - 4mm diagonal tapering crack to right hand side of patio doors, hairline diagonal crack above left hand side of patio doors, hairline vertical crack below right hand side of flank window.

Cracking below flank window

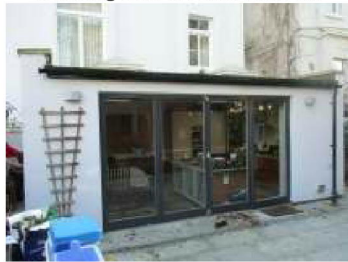
View of rear extension

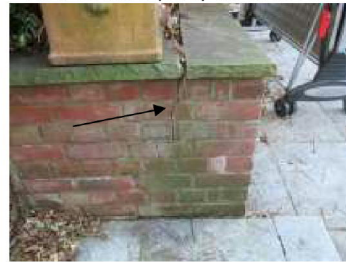
Raised Garden Planter Wall - 6mm tapering stepped crack to front corner - Not subsidence related damage.

At the time of our inspection damage was noted to the raised garden planter wall. The pattern and location of this damage is not indicative of that associated with foundation movement and the cracking appears to be the result of a combination of a build-up of lateral earth pressure within the retained soil and possible physical root growth from the planted vegetation. The repair of this particular area of damage will therefore fall outside the scope of this claim.

View of unrelated damage to garden wall
