## Arboricultural Appraisal Report

### Subsidence Damage Investigation at:

33 Priory Terrace  
London  
NW6 4DG

CLIENT: Crawford & Company  
CLIENT REF: [REDACTED]  
MWA REF: [REDACTED]  
MWA CONSULTANT: Andy Clark  
REPORT DATE: 12/05/2020

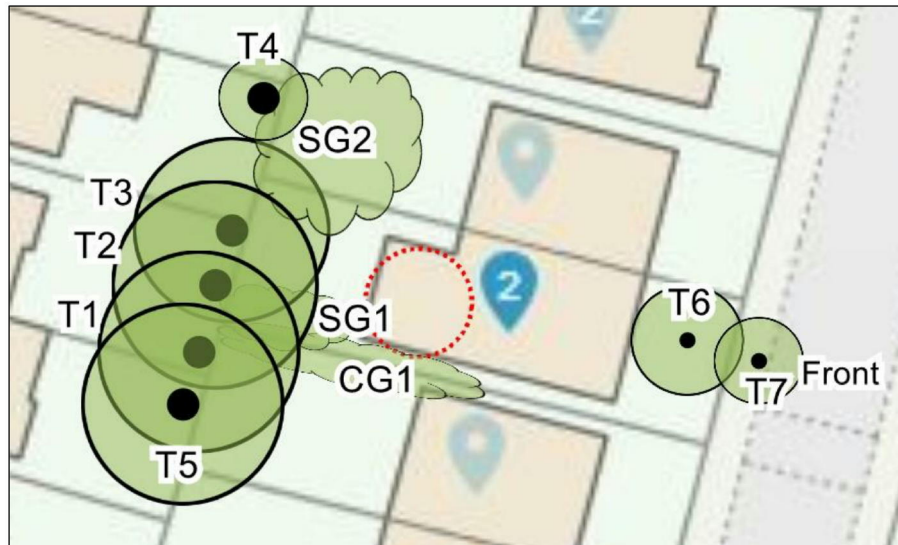
Site Plan

Approximate areas of damage

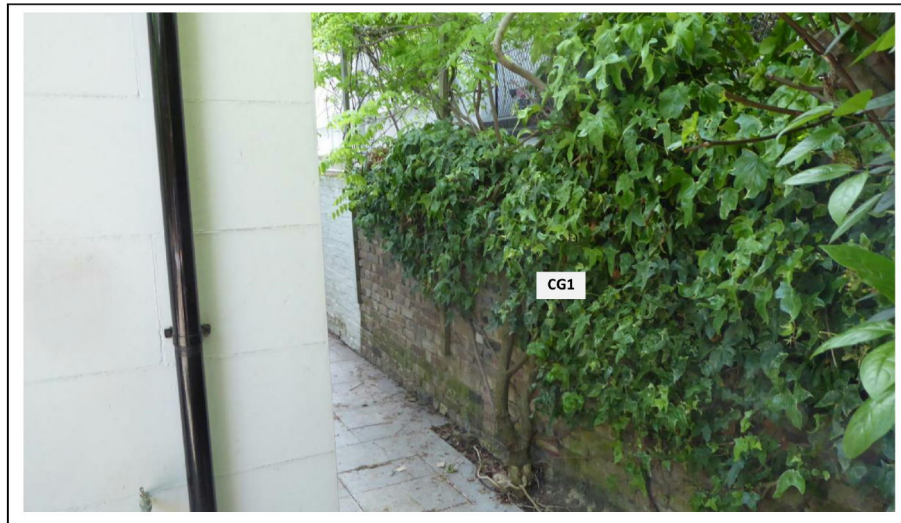
Our survey has identified vegetation within influencing distance of the building with a current potential to influence soil volumes below foundation level; the most significant of which in relation to the current damage are the large Horse Chestnut and Lime trees beyond the rear boundary [T1 – T5]. There is also a likely localised contribution from the CG1 Wisteria and Ivy group adjacent to the left hand flank of the rear addition.

View of CG1 Wisteria and Ivy group

Recommendation		Re-pollard to previous points at approx. 6.0m and thereafter do not allow re-growth to exceed 3yrs age.					
CG1	Wisteria and Ivy	4.5	50 Ms *	9.0	1.2	Younger than Property	Policy Holder
Management history		No significant past management noted.					
Recommendation		Remove (fell) all within 4.0m of the extension to near ground level and treat stumps to inhibit regrowth.

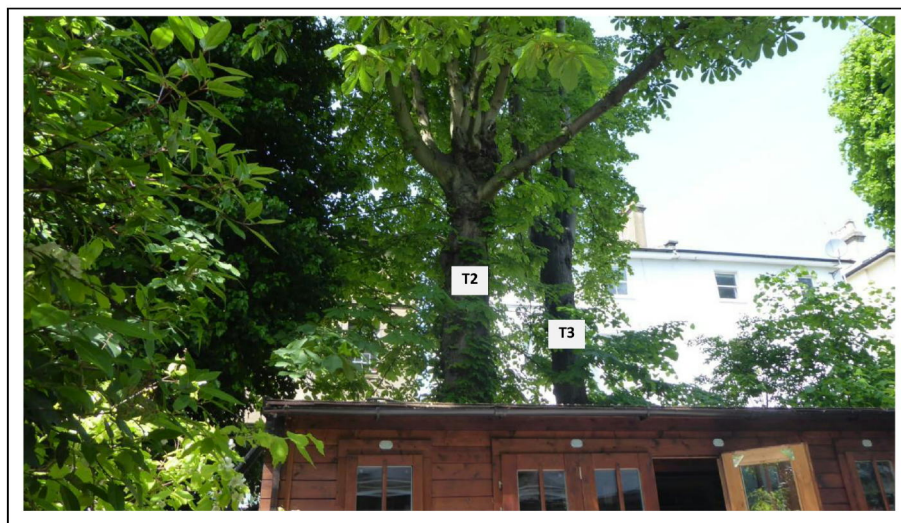
View of T2 Horse Chestnut and T3 Lime beyond rear boundary

If an arboricultural solution is to be implemented to mitigate the influence of the trees/shrubs considered to be responsible for the damage we recommend that T1 and T2 Horse Chestnuts and T3 Lime are pollarded combined with removal of nearby elements of CG1 climber group. Other vegetation recorded presents a potential future risk to building stability and management is therefore recommended.

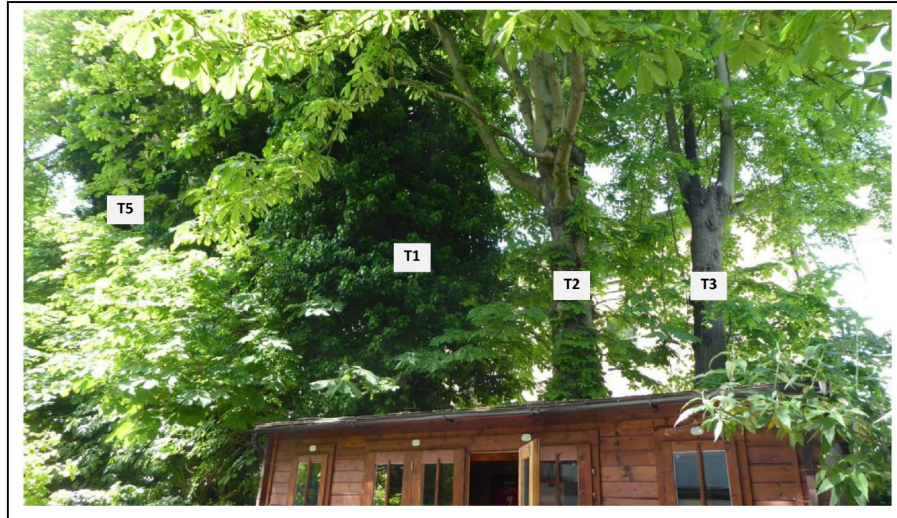
View of T1 to T3 and T5 stems beyond rear boundary

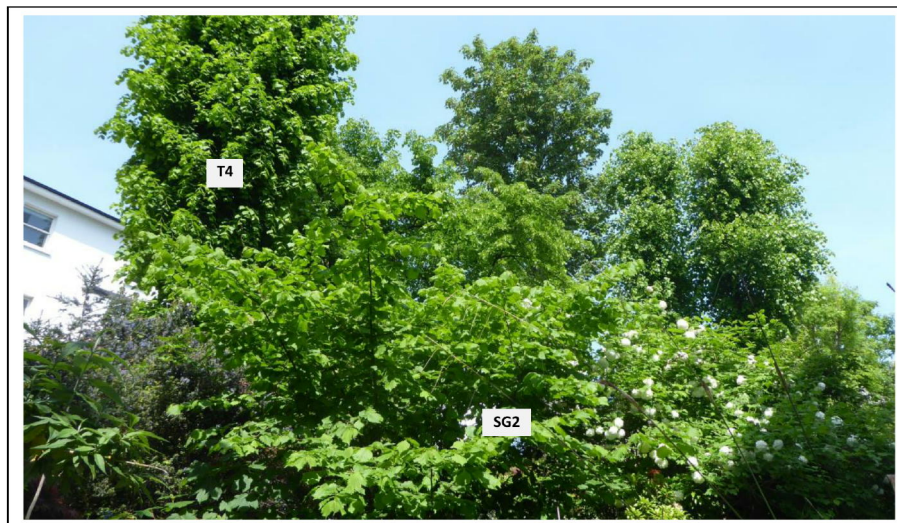
View of T4 Lime with additional pollarded Limes [not recorded] continuing at greater distance and SG2 group to foreground

Tree No.	Species	Ht (m)	Dia (mm)	Crown Spread (m)	Dist. to building (m)	Age Classification	Ownership
T4	Lime	10.0 *	600 *	4.5	13.0	Older than Property	Third Party 40 Priory Road NW6 4SJ
Management history		Subject to past management/pruning - previously pollarded at approx. 8.0m (regrowth appears <5yrs age).					
Recommendation		Maintain broadly at no more than current dimensions by periodic [triennial] re-pollarding.					
T5	Horse Chestnut	18.5	800 *	13.5	12.0 *	Older than Property	Third Party 36 Priory Road NW6 4SJ
Management history		No significant past management noted.					
Recommendation		No works required at present (subject to review if movement persists).					
T6	Cherry	5.0	230	8.5	3.2	Younger than Property	Policy Holder
Management history		No significant past management noted.					
Recommendation		Maintain broadly at no more than current dimensions by periodic pruning.					
T7	Birch	15.0	210	4.5	8.2	Younger than Property	Local Authority
