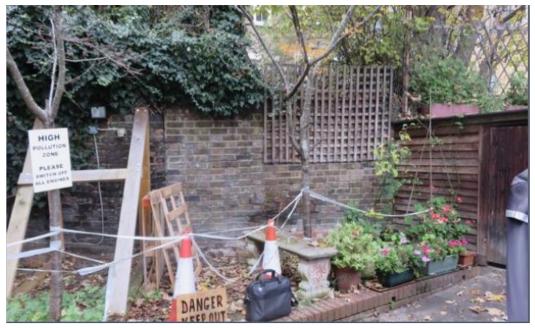
Img_6111 Chamberlian Right elevation

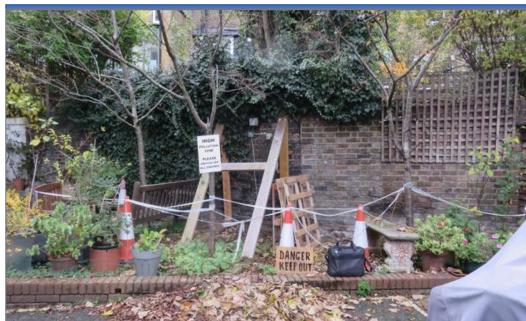
IMG_6117 Chamberlian Side full Elevation

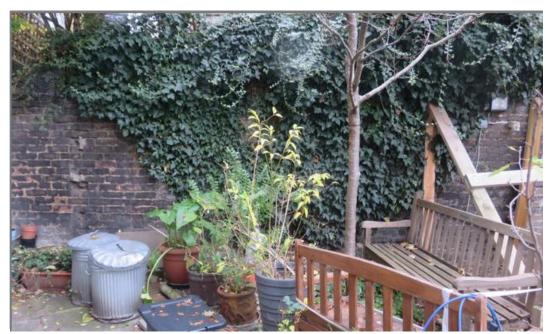
Img_6112 Chamberlian Left elevation

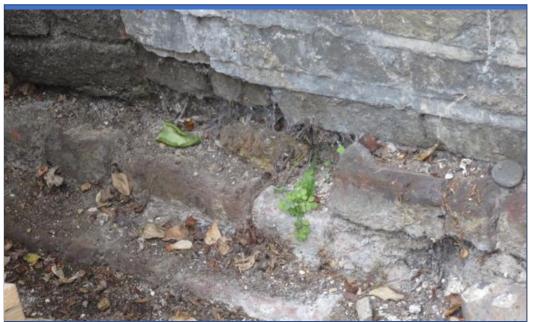
IMG_6118 Base of Party Fence Wall

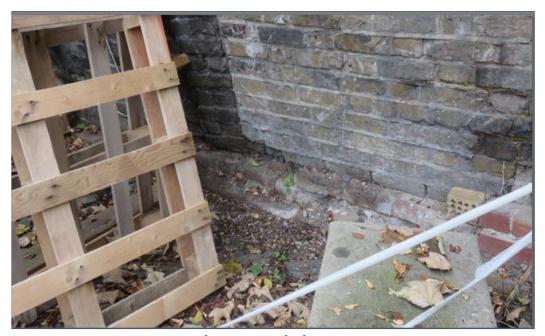
IMG_6120 Base with central division

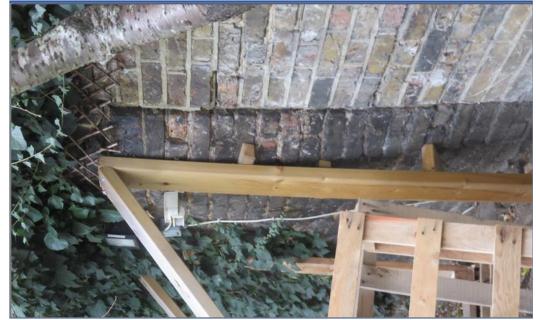
IMG_6128 Side shot of wall showing bulge

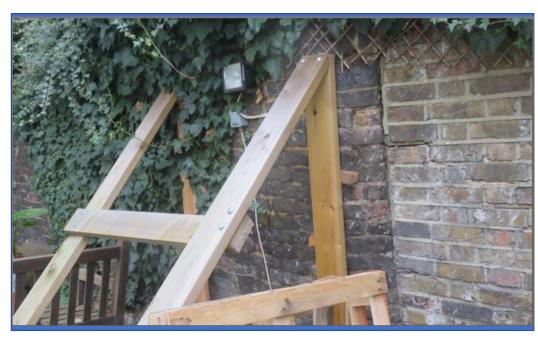
Img_6121 Temporary Support to wall
