MANHOLE INSPECTION DETAILS

LOCATION: SNOWMAN HOUSE AND CASTERBRIDGE

Abbey Area Phase 1 & 2

ABBEY ROAD PHASE 2

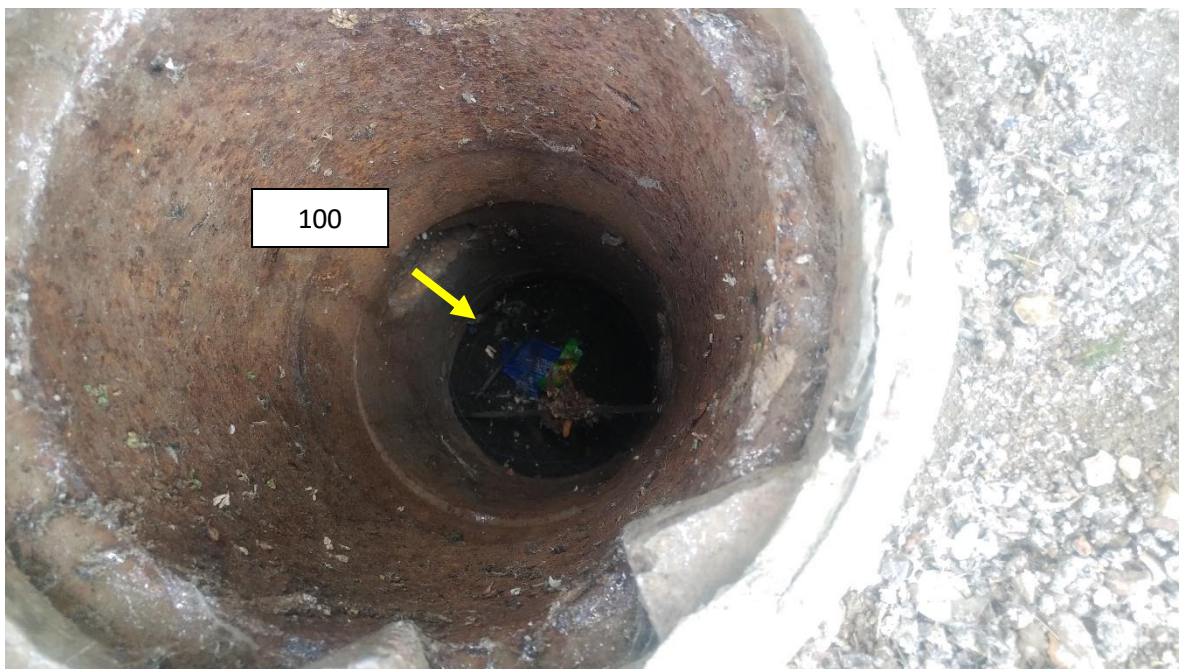
MH No: 42	DATE OF SURVEY: AUG 2019	PHOTOGRAPH No: 42A
-----------	--------------------------	--------------------

DEPTH TO INVERT
0.80

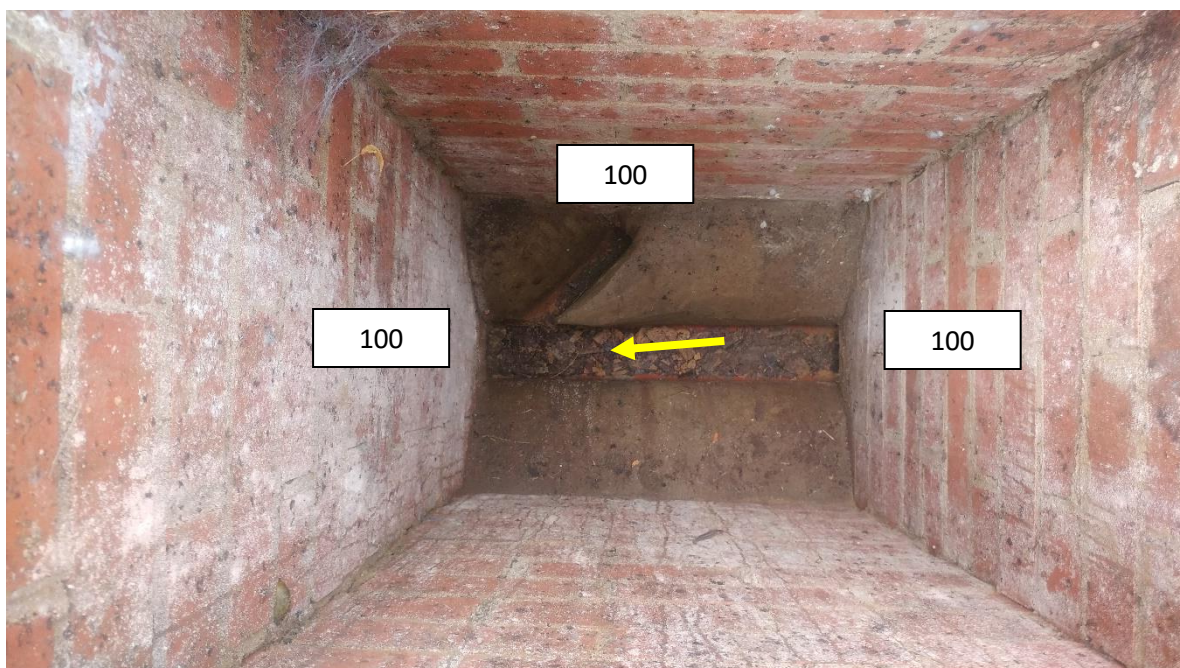
MH No: 43	DATE OF SURVEY: AUG 2019	PHOTOGRAPH No: 43A
-----------	--------------------------	--------------------

DEPTH TO INVERT
1.32

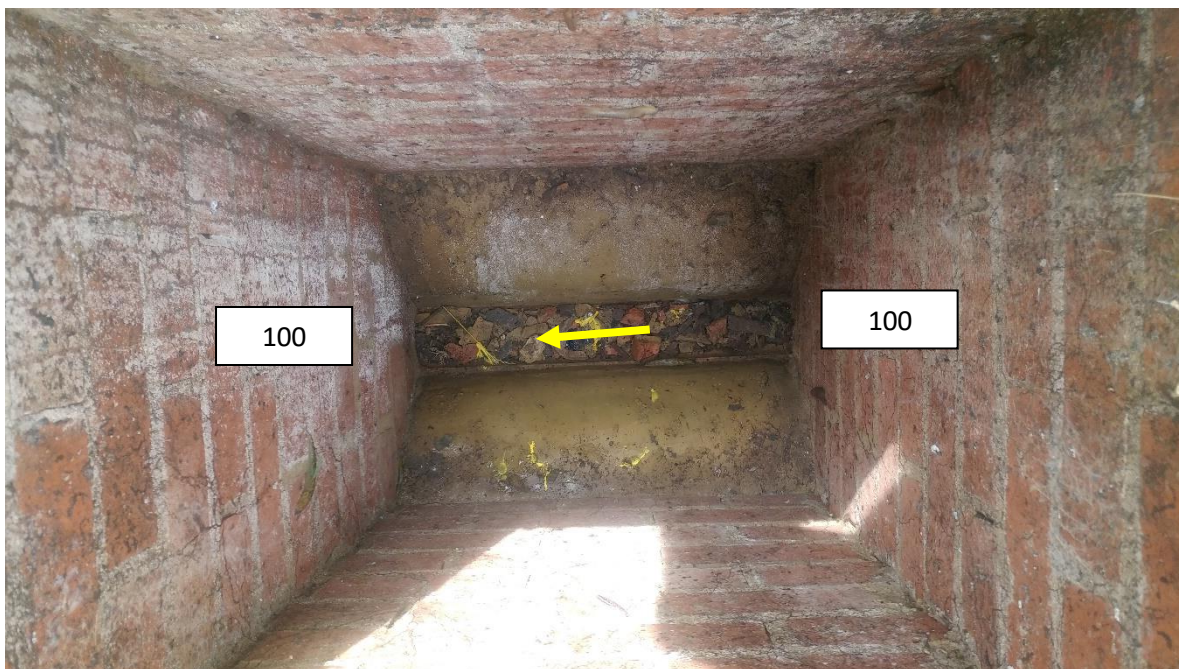
MH No: 44	DATE OF SURVEY: AUG 2019	PHOTOGRAPH No: 44A
-----------	--------------------------	--------------------

DEPTH TO INVERT
1.15

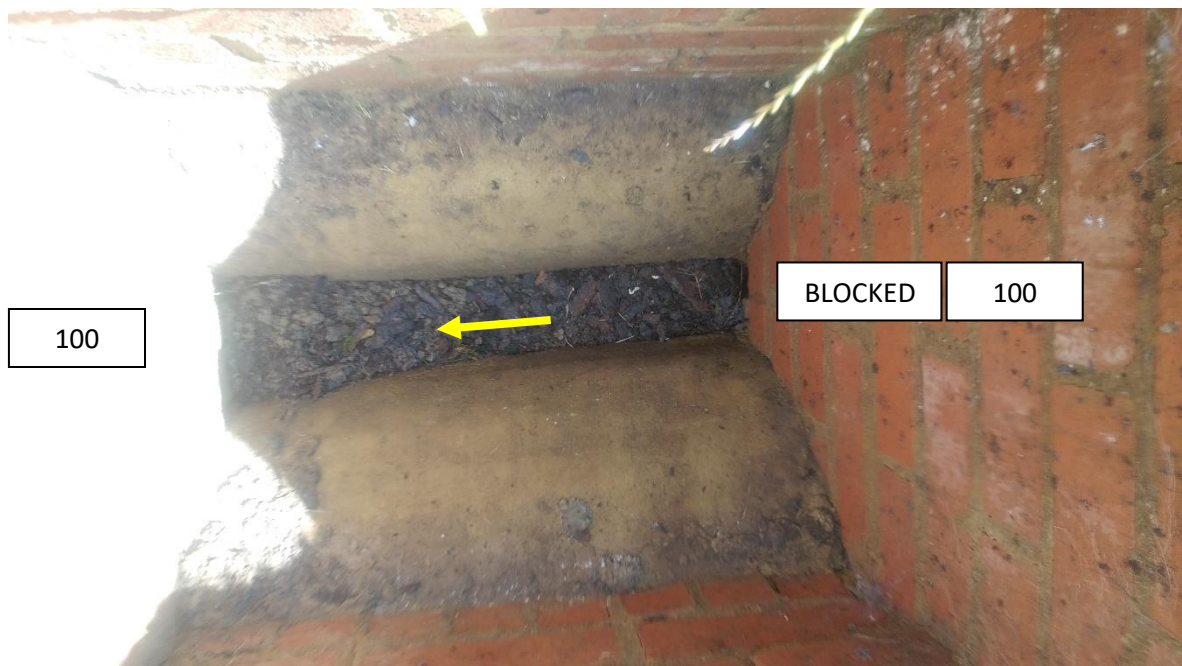
MH No: 45	DATE OF SURVEY: AUG 2019	PHOTOGRAPH No: 45A
-----------	--------------------------	--------------------

DEPTH TO INVERT
0.96

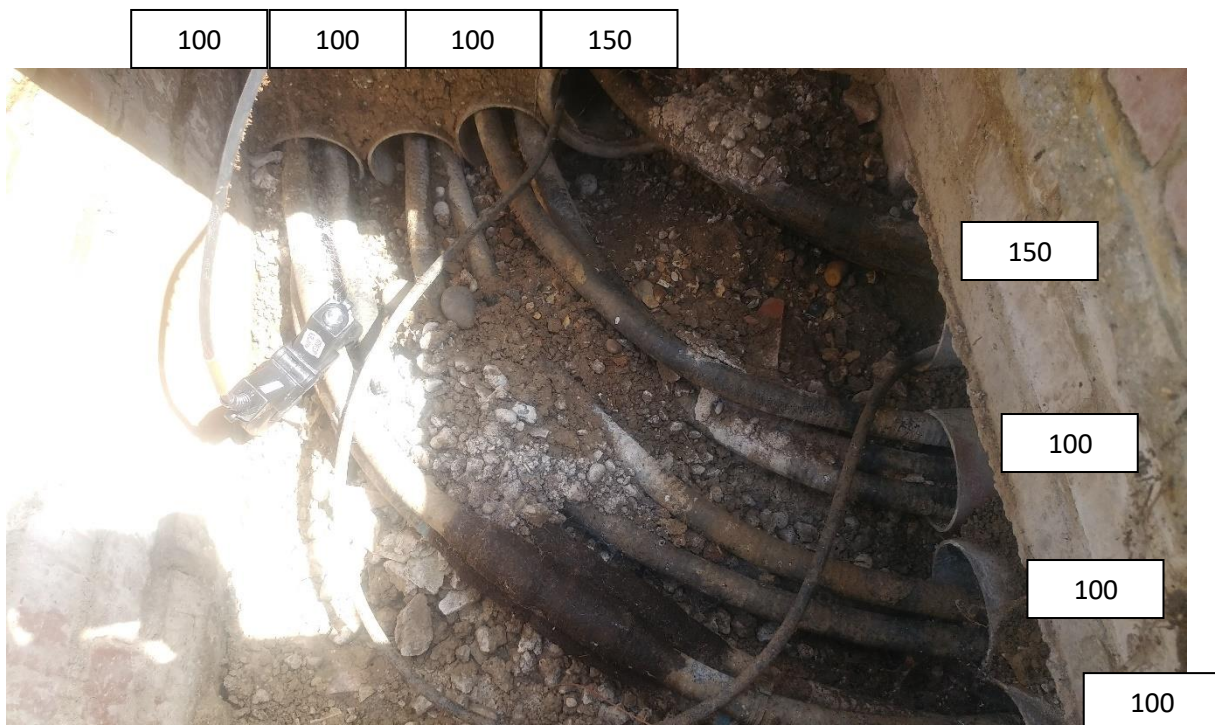
MH No: 46	DATE OF SURVEY: AUG 2019	PHOTOGRAPH No: 46A
-----------	--------------------------	--------------------

DEPTH TO INVERT
0.63

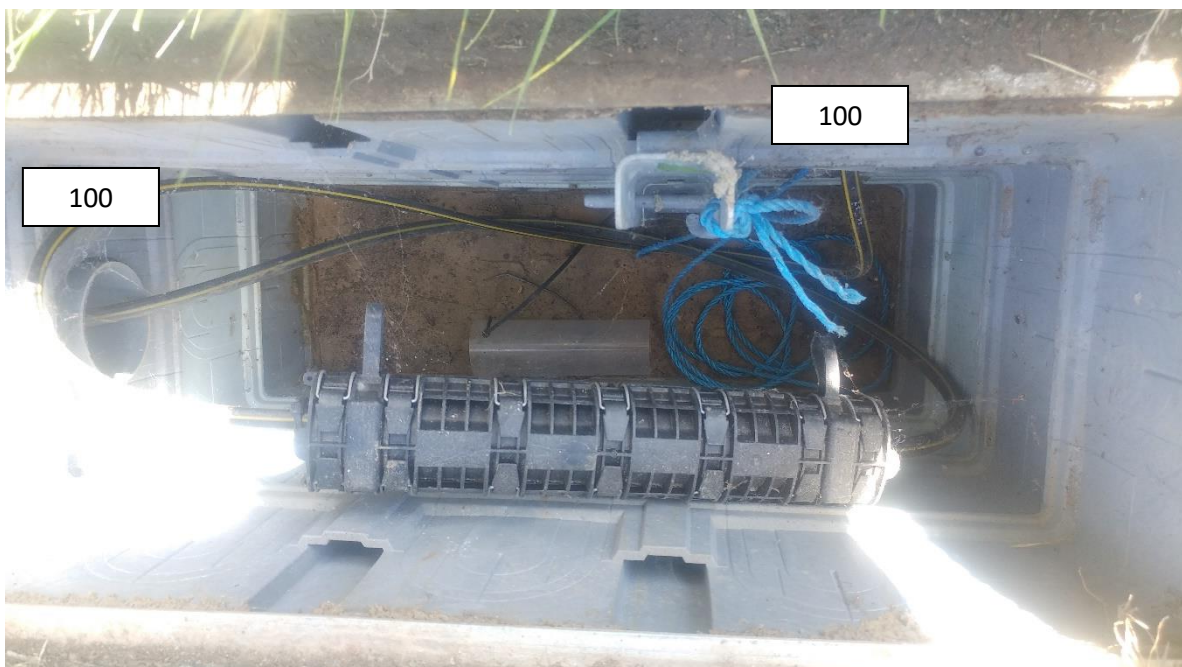
MH No: 47	DATE OF SURVEY: AUG 2019	PHOTOGRAPH No: 47A
-----------	--------------------------	--------------------

DEPTH TO INVERT
0.69

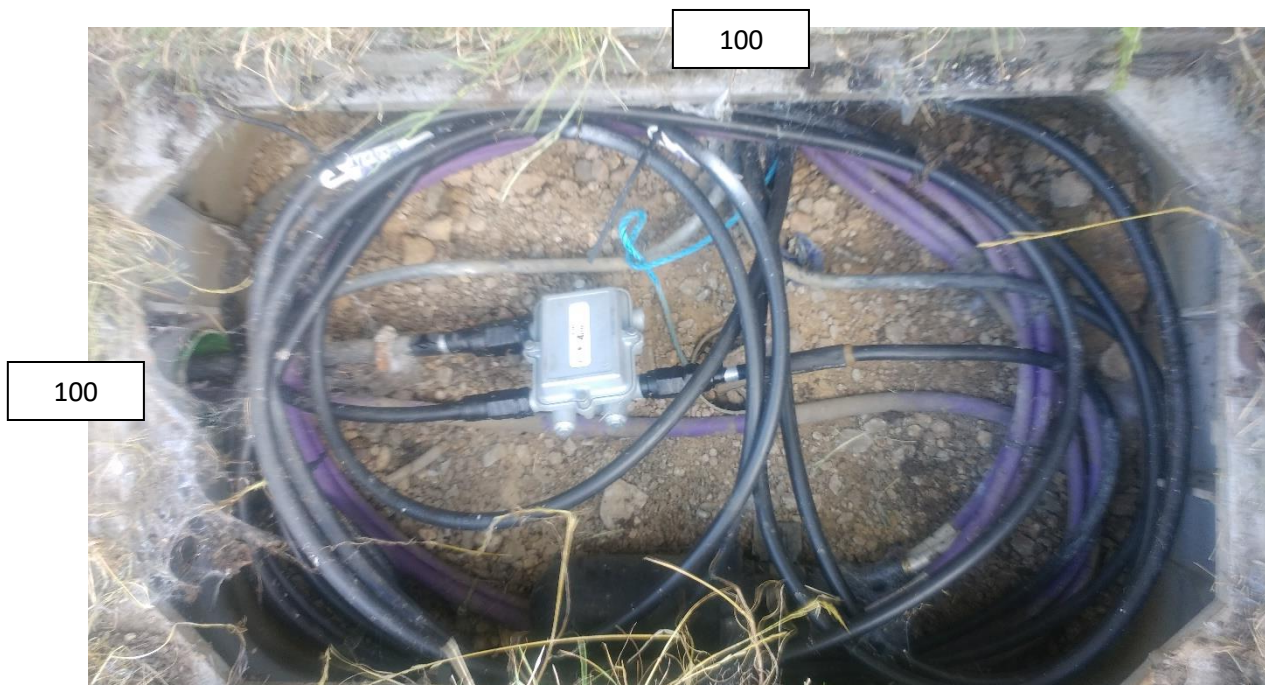
MH No: 48	DATE OF SURVEY: AUG 2019	PHOTOGRAPH No: 48A
-----------	--------------------------	--------------------

DEPTH TO INVERT
0.37

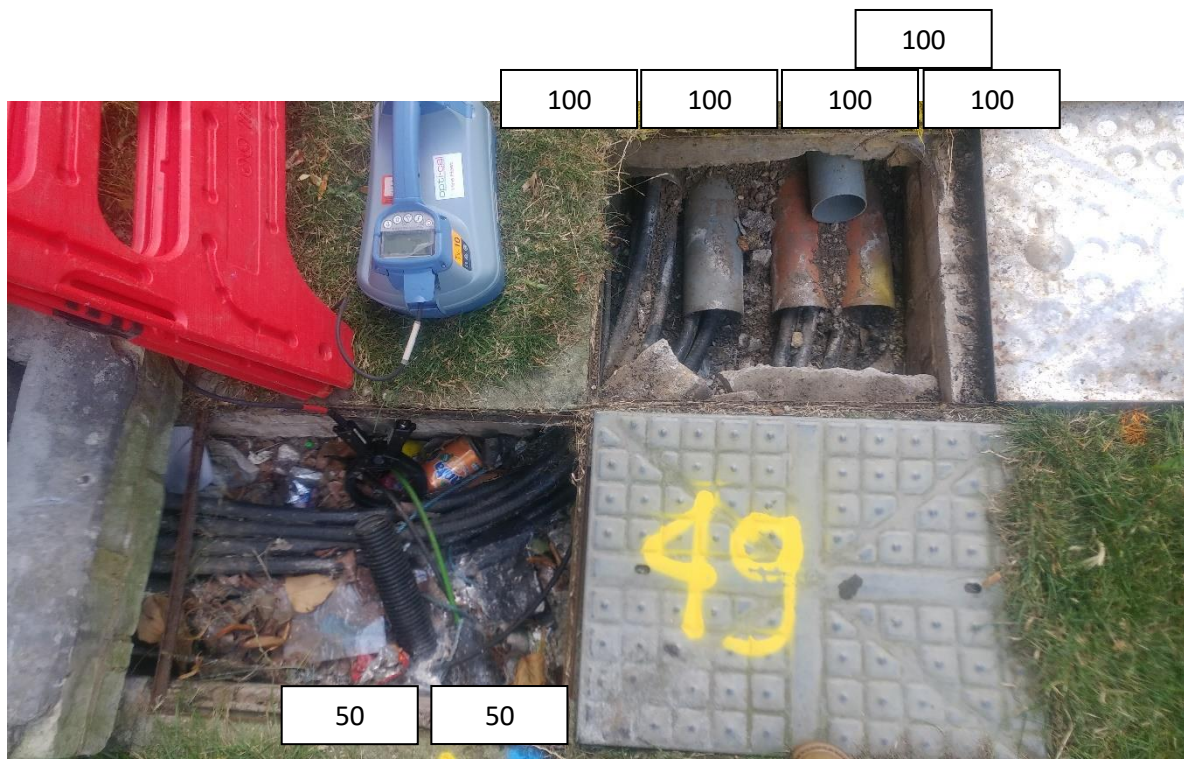
MH No: 49	DATE OF SURVEY: AUG 2019	PHOTOGRAPH No: 49A
-----------	--------------------------	--------------------

COVER TYPE	Circular	<input type="checkbox"/>	Square	<input type="checkbox"/>	Rectangle	<input checked="" type="checkbox"/>	Other: _____	<input type="checkbox"/>
	Heavy Duty	<input type="checkbox"/>	Medium Duty	<input checked="" type="checkbox"/>	Light Duty	<input type="checkbox"/>		
CONDITION	Good	<input checked="" type="checkbox"/>	Worn/Old	<input type="checkbox"/>	Unstable	<input type="checkbox"/>		
	Reset	<input type="checkbox"/>	Replace	<input type="checkbox"/>				
INTERNAL CONDITION	Good	<input checked="" type="checkbox"/>	Worn	<input type="checkbox"/>	Work Required	<input type="checkbox"/>		
			Opening				3 COVERS, 1 CHAMBER

DEPTH TO INVERT
0.21

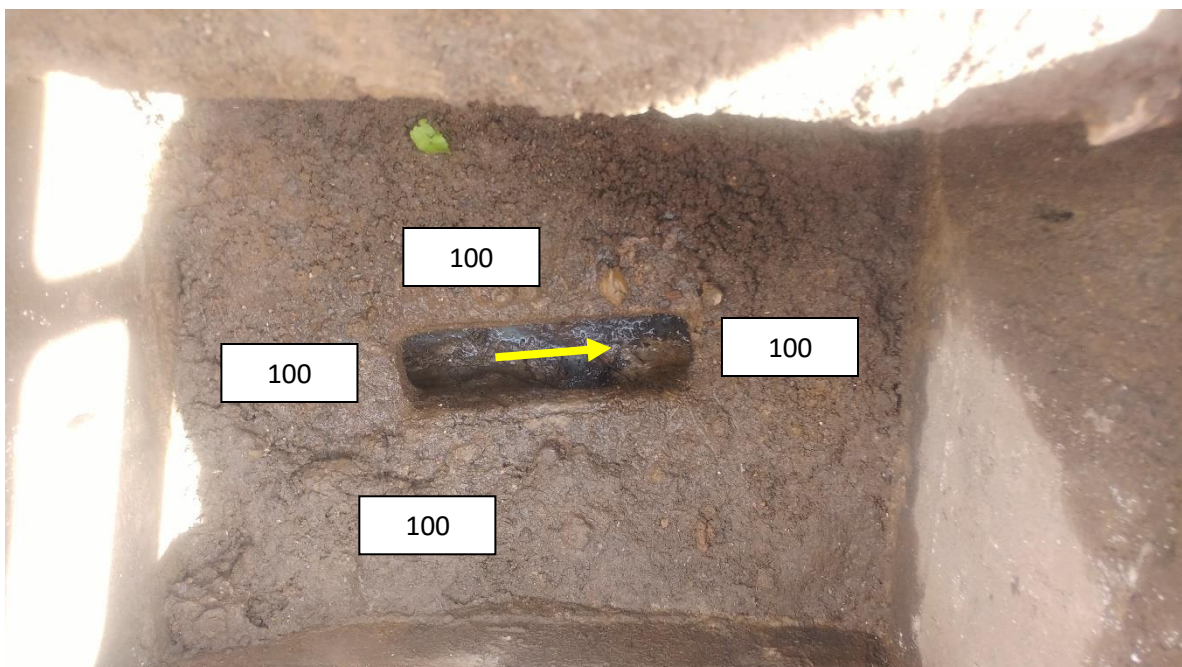
MH No: 50	DATE OF SURVEY: AUG 2019	PHOTOGRAPH No: 50A
-----------	--------------------------	--------------------

DEPTH TO INVERT
0.80

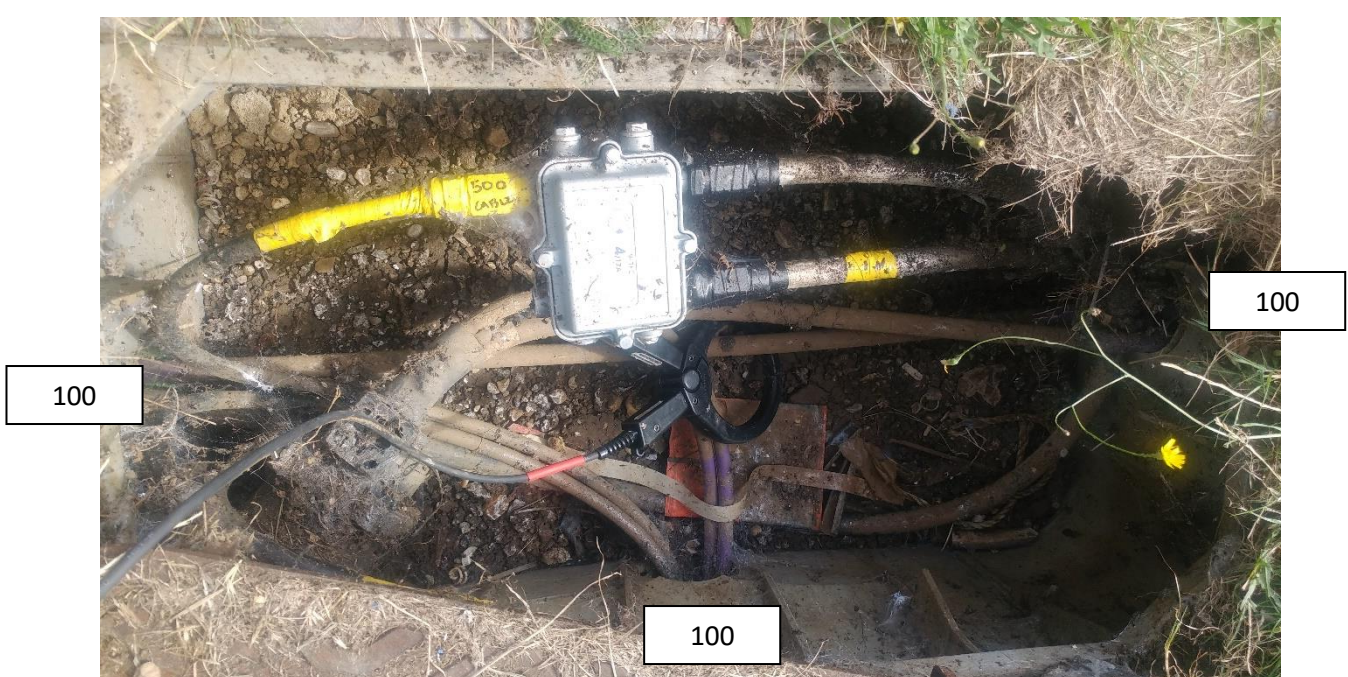
MH No: 51	DATE OF SURVEY: AUG 2019	PHOTOGRAPH No: 51A
-----------	--------------------------	--------------------

DEPTH TO INVERT
0.40

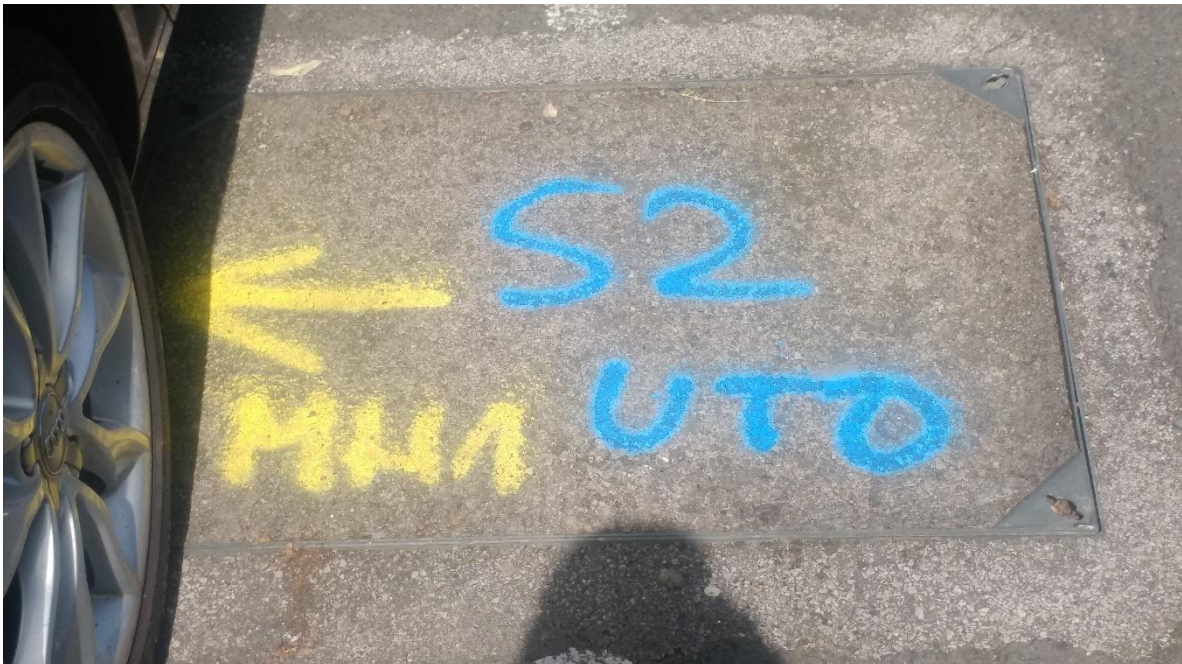
MH No: 52	DATE OF SURVEY: AUG 2019	PHOTOGRAPH No: 52A
-----------	--------------------------	--------------------

DEPTH TO INVERT
N/A

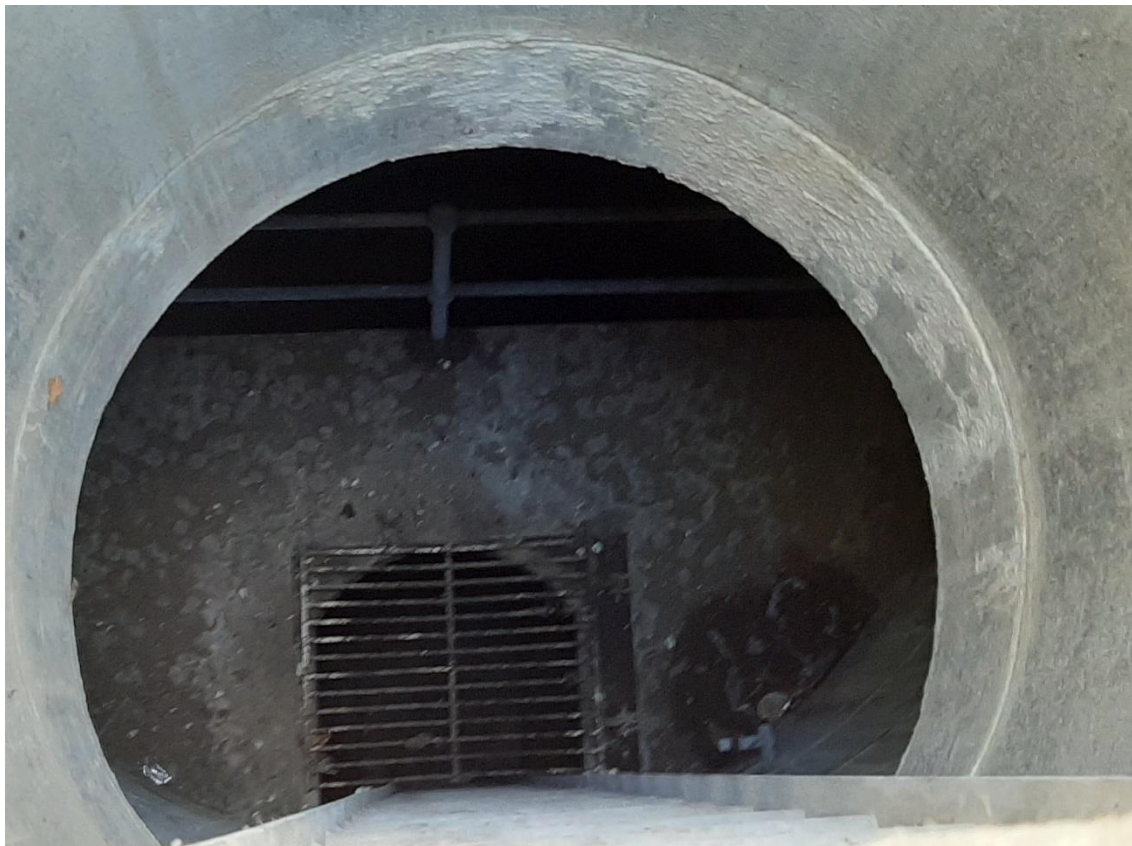
MH No: 53	DATE OF SURVEY: SEP 2019	PHOTOGRAPH No: 53A
-----------	--------------------------	--------------------

DEPTH TO INVERT
10.59
