**Window/Door Report**  
**40 Chester Terrace**  
**London**  
**NW1 4ND**

**BA Ref: P20-265**

**June 2020**

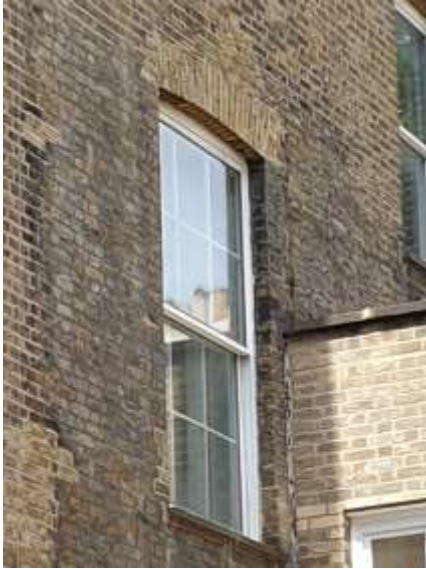
- 4.1.4 East elevation windows require the most attention. Most are in fair to poor condition but require varying levels of remedial work. The double glazing and particularly the fake glazing bars to W1.05 detract from the appearance of the building and consideration should be given to replacement with appropriate materials/design.

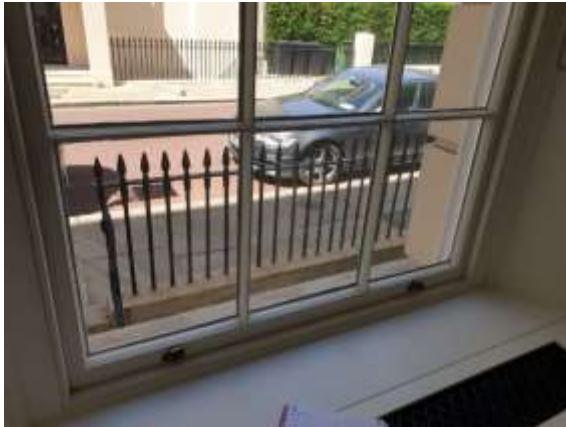
WG.02  
Reception/sitting room  
All windows in good condition  
Evidence of previous refurbishment  
including insertion of brush draught  
proofing and replacement glass.

- 4.1.2 West and North elevation windows require overhaul generally and isolated treatment of timber rot by splicing in new timber or careful use of proprietary epoxy resin repair system.

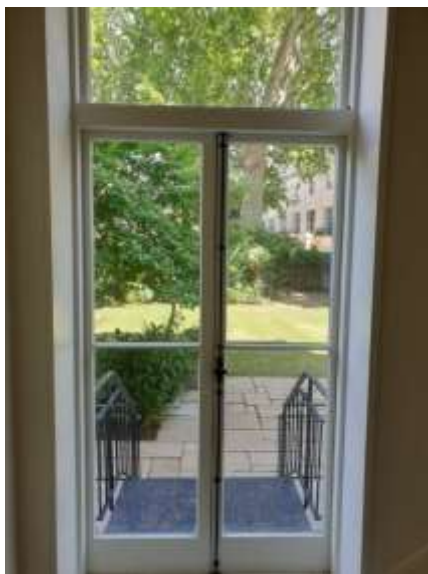
WG.08  
Entrance Hall  
Doors in fair condition but poorly  
fitting in frame.  
Evidence of previous alteration  
/replacement and replacement glass.

- 4.1.3 North elevation doors require major overhaul. Consideration should be given to replacement with more sympathetic design, glazing bars to match elsewhere and appropriate ironmongery.

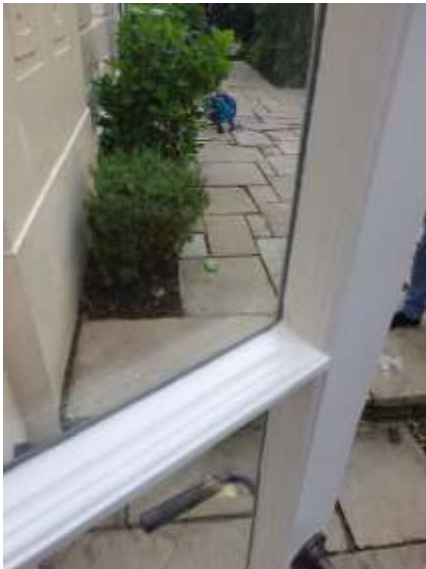
The double doors to the garden (WG.04) are painted timber with slim lambs tongue glazing bars and modern float glass. The door leaves themselves are worn and there are daylight gaps where the two leaves meet.

WG.04  
Dining  
Doors in fair condition but poorly fitting in frame.  
Evidence of previous alteration /replacement and replacement glass.

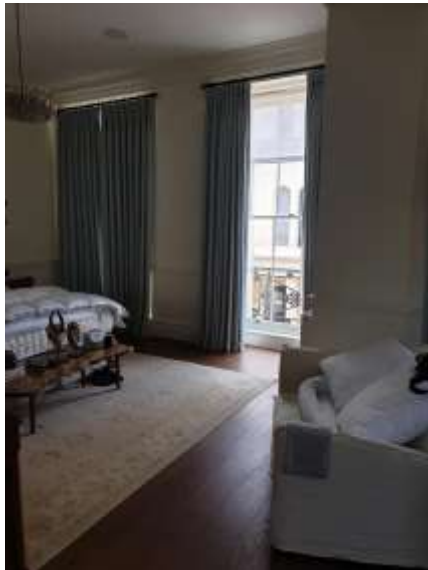
W1.02 / W1.03  
Internal view Master Bed  
All windows in good condition  
Evidence of previous refurbishment  
including insertion of brush draught  
proofing and replacement glass.

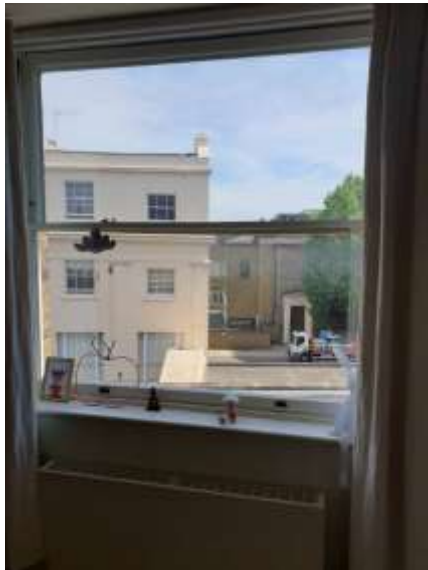
W2.04  
Guest Bedroom 2  
Slimlite Double Glazed upper  
Double glazed Alum spacer bottom

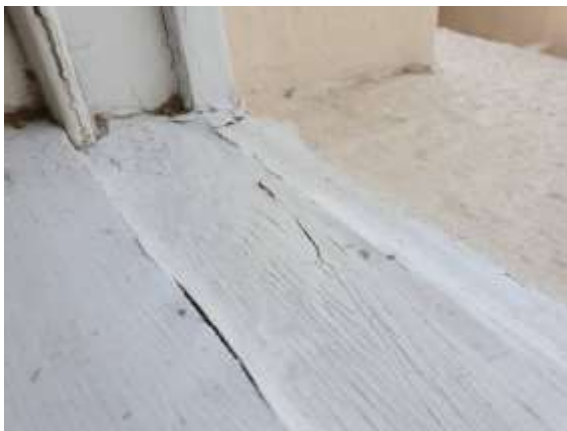
W2.04  
Guest Bedroom 2  
Some rot to cill and lower frames

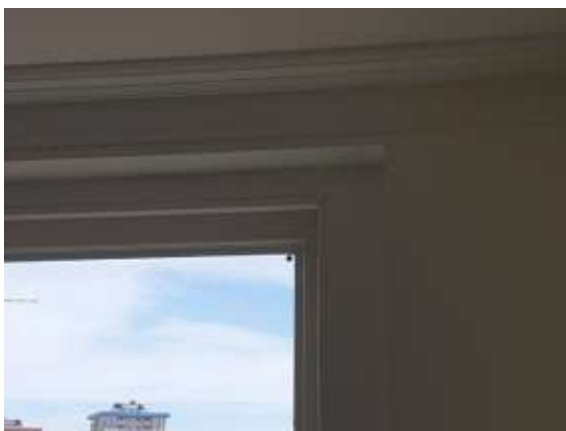
W3.05  
Stairwell Rear  
Slimlite Double Glazed upper  
Double glazed Alum spacer bottom

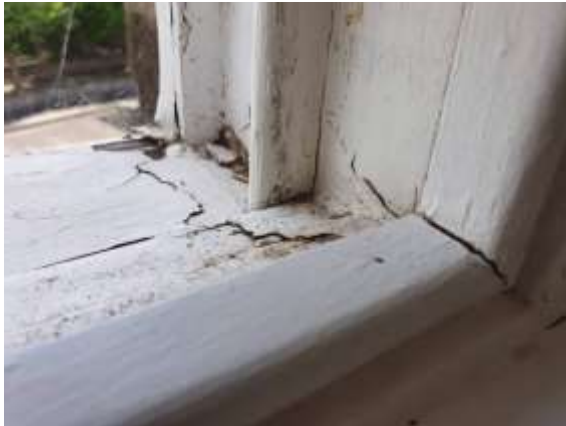
W3.04  
Back Bedroom  
Some rot to cill and lower frames

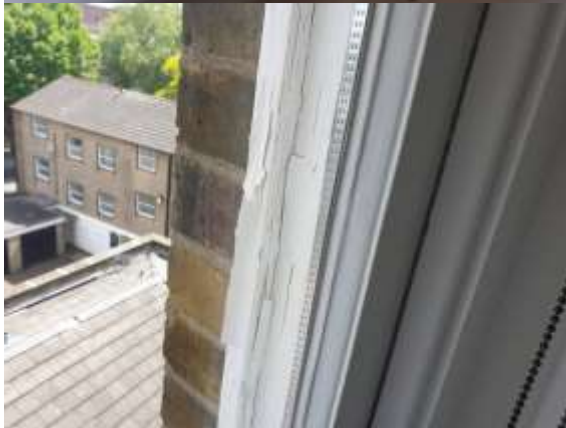
W3.04  
Back Bedroom  
Slimlite Double Glazed upper  
Double glazed Alum spacer bottom

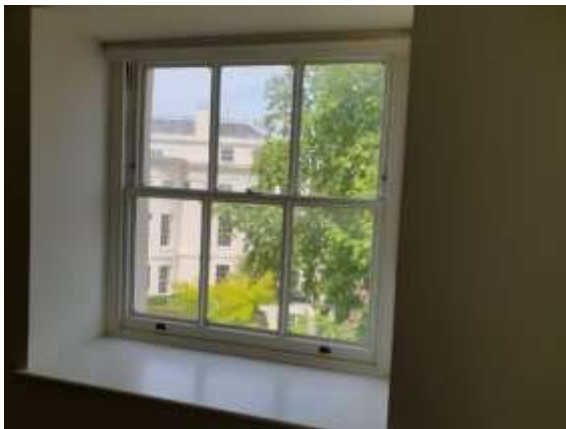
W3.06  
Hallway 3 (Facing North)  
Slimlite Double Glazed

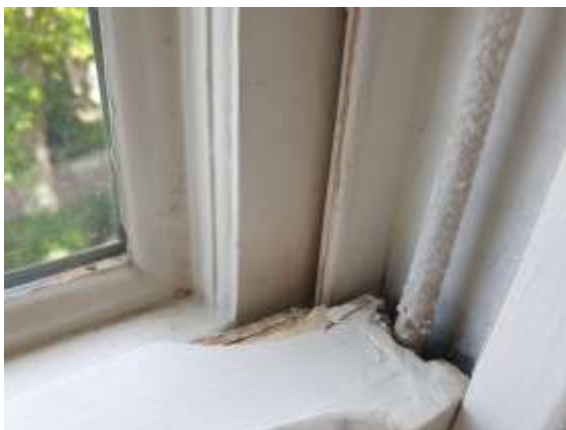
W3.06  
Hallway 3 (Facing North)  
Small amount of rot.  
Requires overhaul.

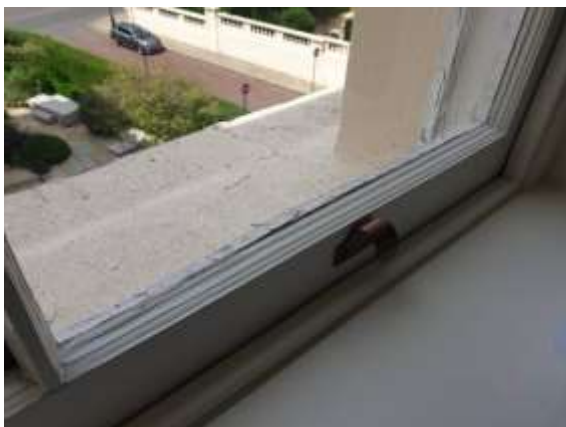
W3.03  
Front Bedroom  
Worn sashes  
Extensive rot to cill and lower box  
frames

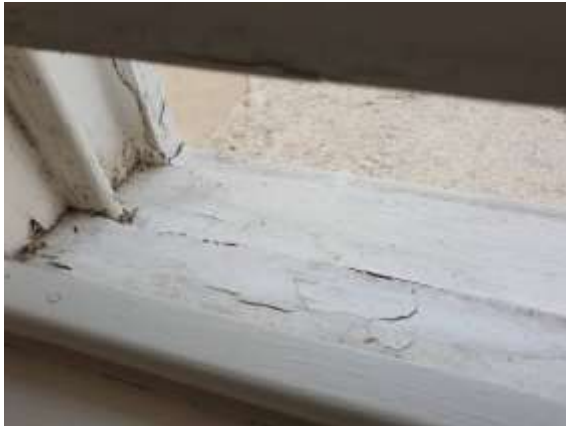
W3.03  
Front Bedroom  
Worn sashes  
Extensive rot to cill and lower box  
frames

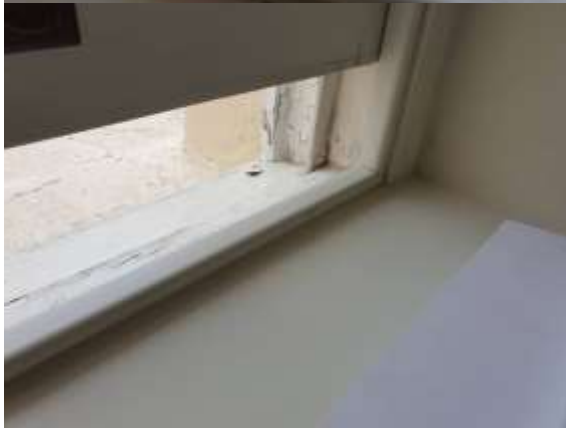
W3.03  
Front Bedroom  
Worn sashes  
Extensive rot to cill and lower box  
frames

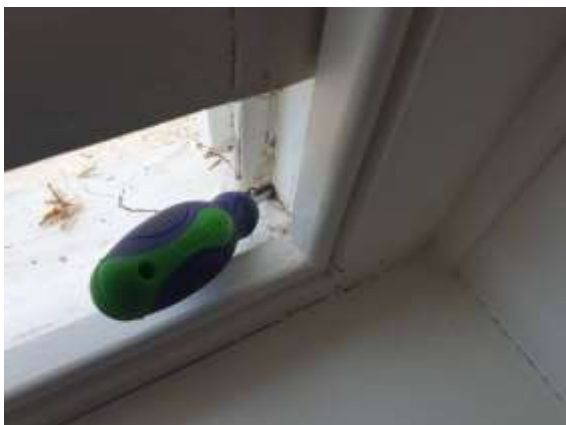
W3.02  
Front Bedroom  
Worn sashes  
Extensive rot to cill and lower box  
frames

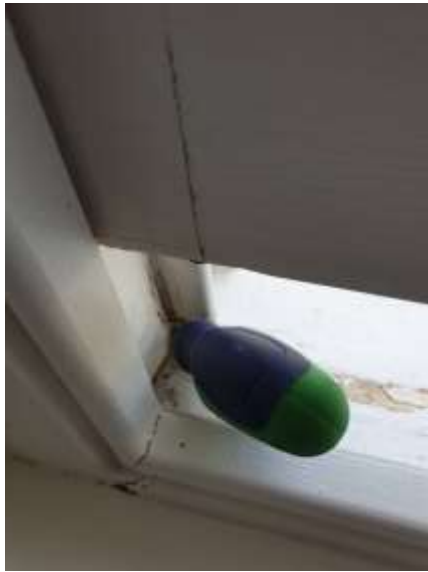
W3.02  
Front Bedroom  
Worn sashes  
Extensive rot to cill and lower box  
frames

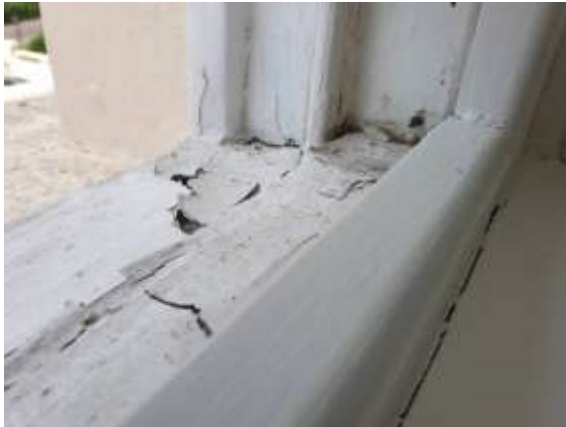
W2.03  
Front Bedroom  
Worn sashes  
Extensive rot to cill and lower box  
frames

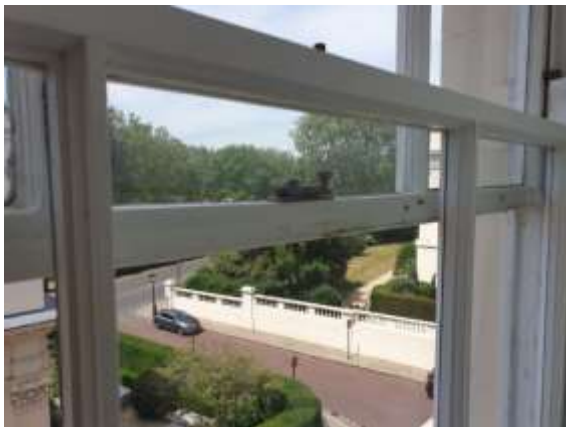
W2.03  
Front Bedroom  
Worn sashes  
Extensive rot to cill and lower box  
frames

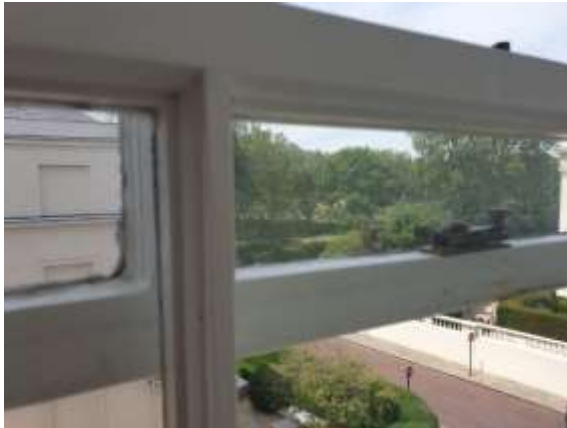
W2.02  
Front Bedroom  
Worn sashes  
Minor rot. Defective/flaking paint

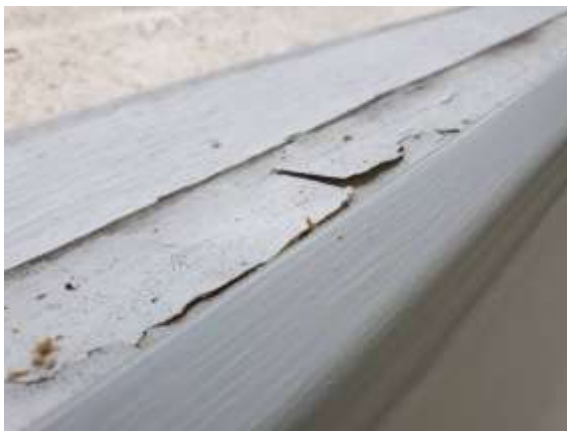
W2.02  
Front Bedroom  
Worn sashes  
Minor rot. Defective/flaking paint

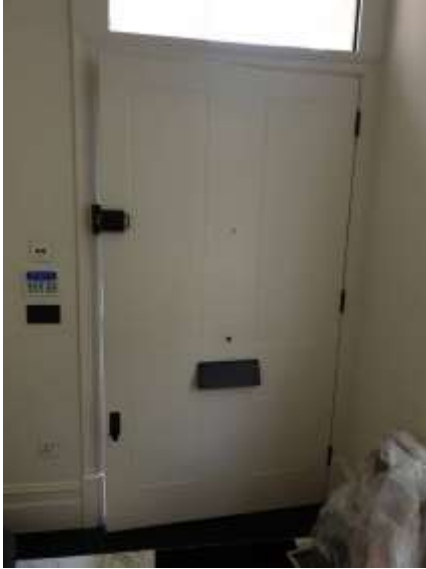
DG.01  
Front door – internal  
Original – good condition. Minor  
repairs/redec only.
