Wheatsheaf Yard, 50c Red Lion Street, London WC1R 4PF

Structural Engineer's Report for Planning Application

An assessment of timber at

50C, RED LION STREET, WC1R 4PF

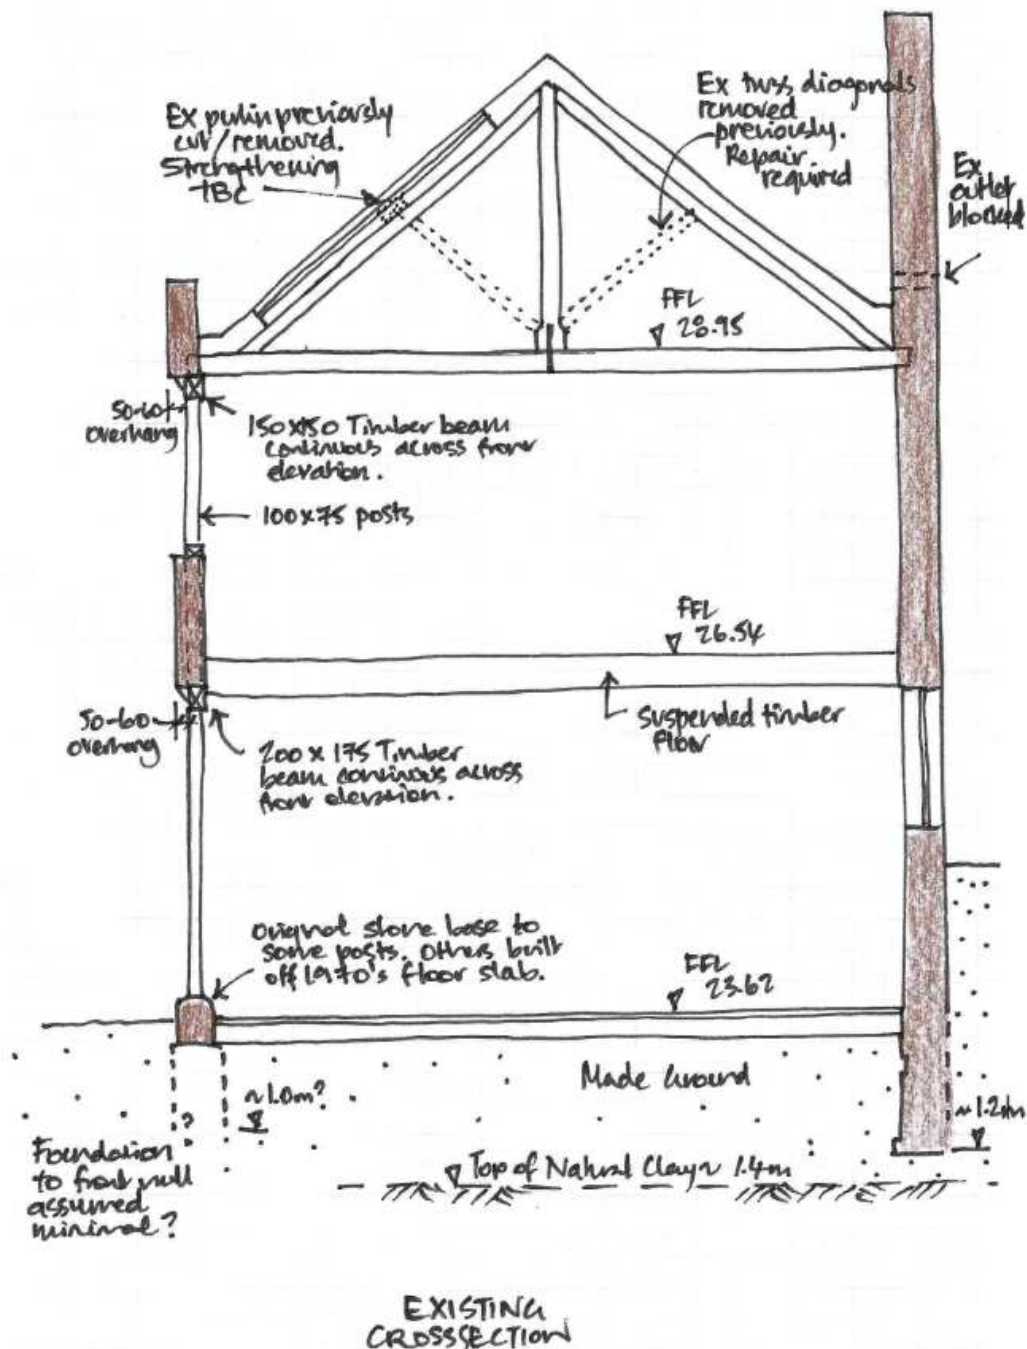
Figure 1 – Principal Structural Elements

The timber framing of the front elevation is visible internally and appears to be Baltic Pine which is in reasonably condition based on a superficial visual inspection. It is made up of a beam on a series of posts and beams with infill spandrel panels. Figure 1 shows the sizes and relative positions of the principal elements.

The front elevation has an unusual arrangement of brick spandrel panels supported on a series of Baltic Pine beams and posts. The brickwork overhangs the timber supports at Roof and First Floor levels, so the front wall relies on the internal timber floor and roof for lateral stability. The timber beams are strapped to the Party Walls, but this arrangement is much less robust than if the front wall were entirely masonry and bonded into its returns. Façade retention is usually applied to reasonably robust masonry buildings but it is not clear how successful it would be to perform a façade retention on the hybrid brick and timber of the existing front elevation.

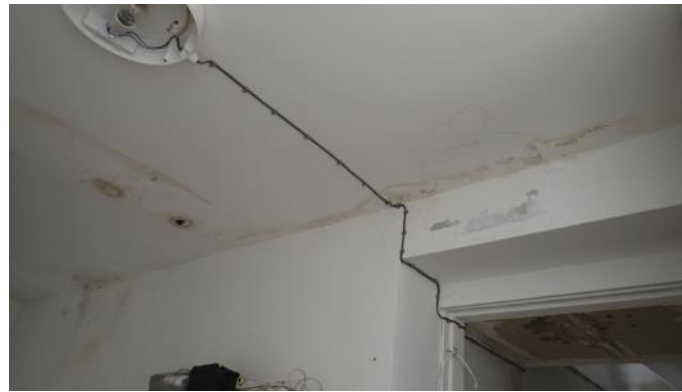
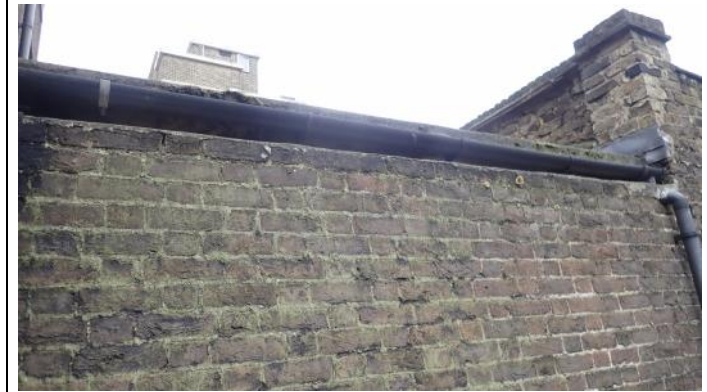
Signs of water ingress through roof. Far photo showing the detail externally. There are signs of Peziza growth – a plaster fungus – just below the gutter line, indicating saturated masonry.

As such there is a probability of concealed decay of timber elements adjacent to the wall head.

There were no overt signs of active or damaging decay. There may be concealed decay to elements of the building associated with defects/blockages of the valleys to the W (obs 1 and 8).

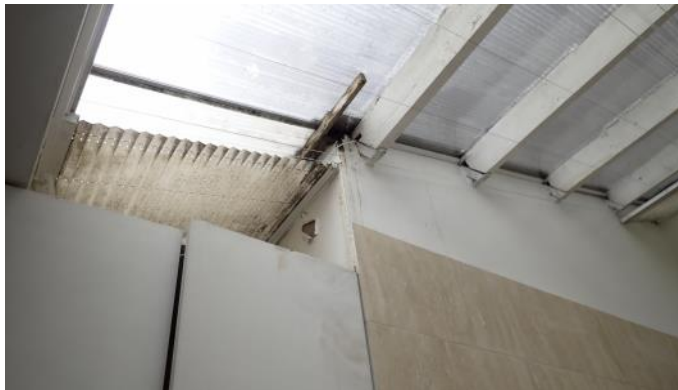
2

An awkward detail has been formed in the roof, which is allowing slow ingress of water. Adjacent (inaccessible) timber elements in the immediate vicinity are likely to have been wet up and possibly decayed locally.

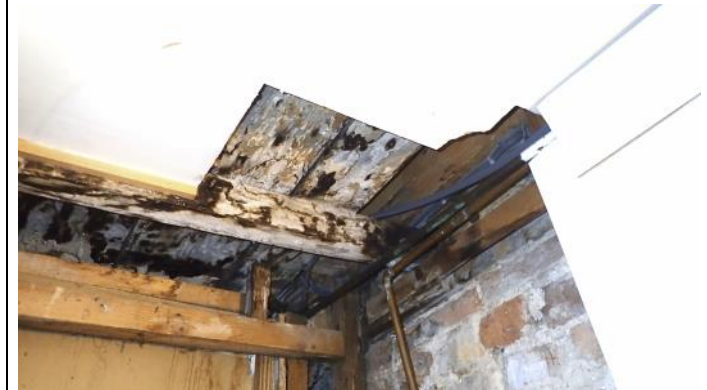
3

Historic water staining from enclosed valley gutter above. All timber is sound.

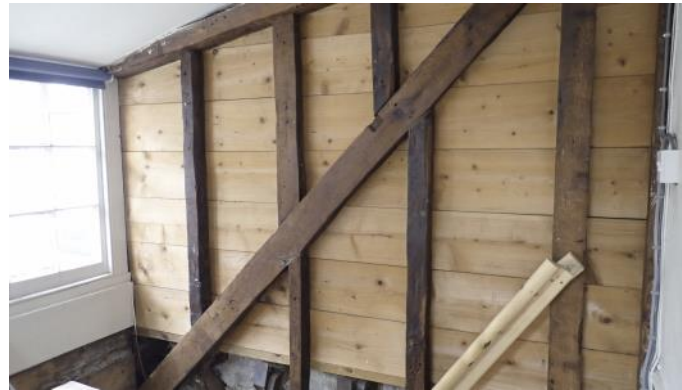
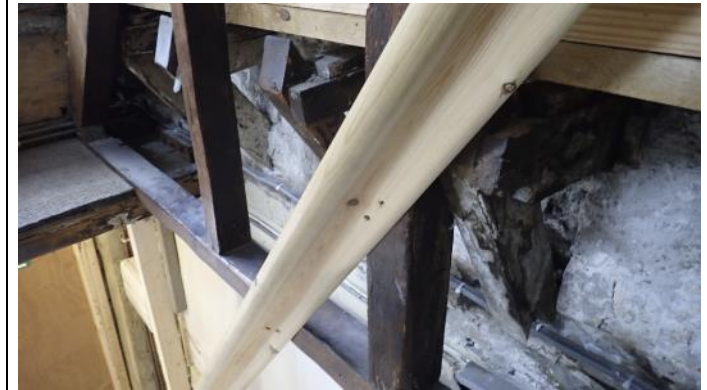
4

Vertical framing and panelling – possibly not of great age – found to be dry and in good condition.

Directly below – far photo – the underside of a valley gutter which has been previously repaired, with some remaining damage to 2 gutter brackets. However, the arrangement seems generally watertight.

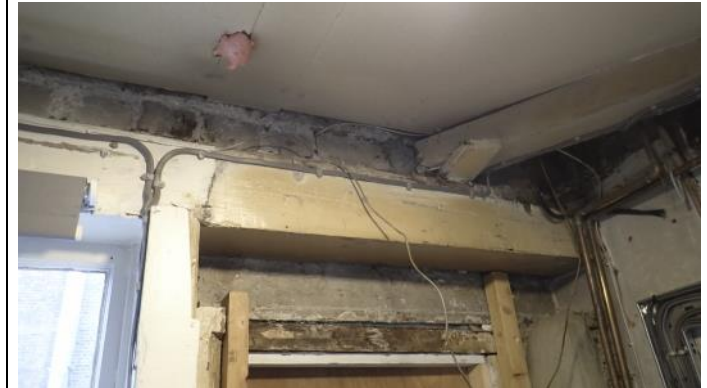
5
The S bearing of the rafter plate was microdrilled and found to be sound in its bearing.

A dragon tie reinforces this corner

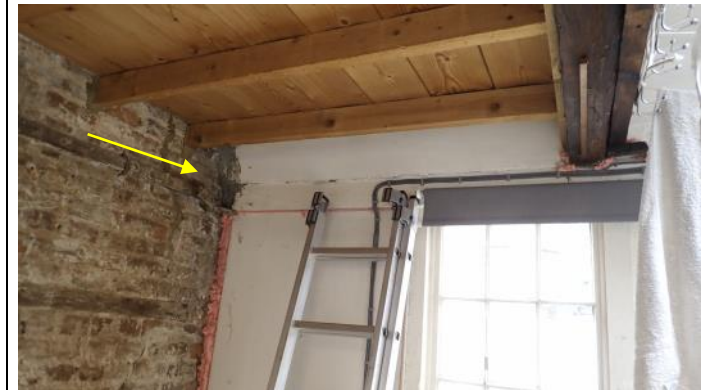
6
Showing the rafter plate restrained by a metal bracket – arrowed – the end of which was found to be sound.

Embedded timbers in the N wall are generally sound.

As a whole, the rafter plate – and the principal vertical support posts - were found to be in good condition, converted from slow grown Baltic pine.

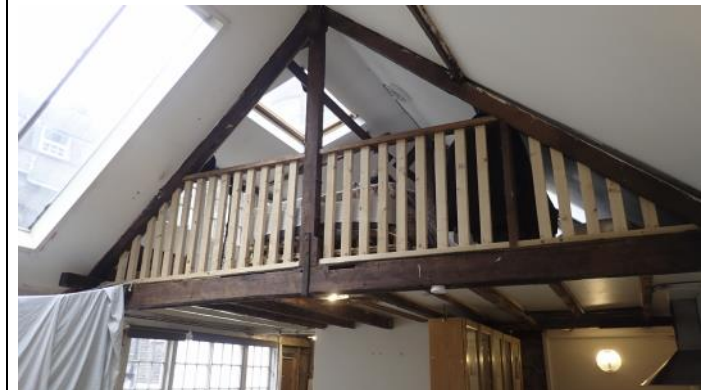
7
All accessible elements of the roof were found to be good quality Baltic pine. Historically there has been a reconfiguration of the elements (presumably related to installation of the roof lights) which will have affected the structural abilities of the roof – (structural engineer to advise).

With one exception, both bearings of the tie beams of all 3 trusses were microdrilled and found to be sound in the wall (to the W) and over the rafter plate (to the E). The W bearing of truss 1 was inaccessible.

All joists which form the mezzanine sections – or second floors – are also in good condition.

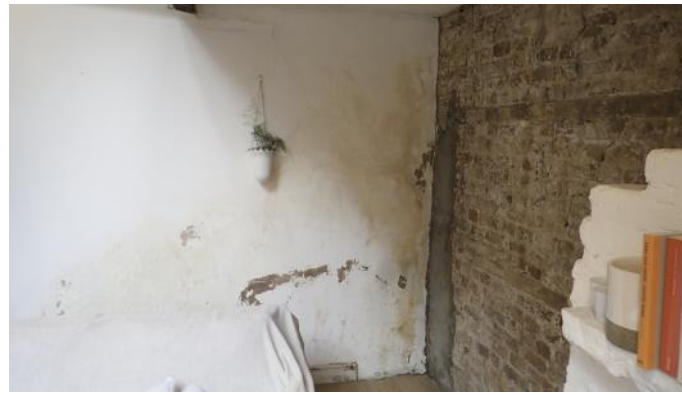
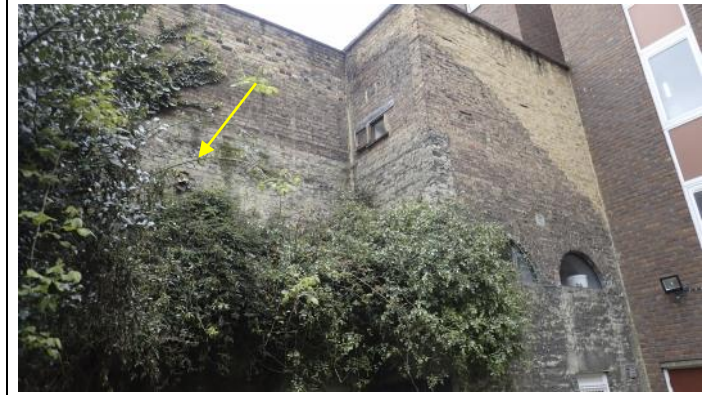
8

The W wall has been wet up - possibly from above by the defects associated with the enclosed valley gutter, possibly a damaged or blocked outfall - arrowed in far photo.

Much of this wall is concealed by plant growth.

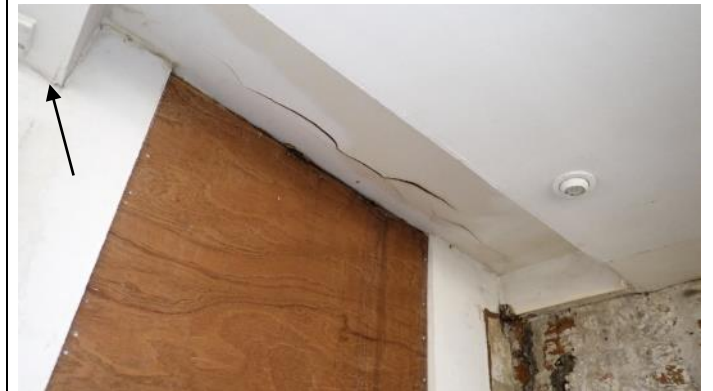
The photo shows the underside of the first floor structure directly below this point. It is probable there is a timber element trimming the floor structure over the window opening. There are signs of long term water staining at this point and it is possible there may be some concealed decay to the first floor structure.

The W bearing of the large section floor beam - arrowed opposite - was probed and found to be generally sound - although due to the concealed nature of much of the first floor structure, it is recommended that the boxing is removed to enable a more detailed inspection.

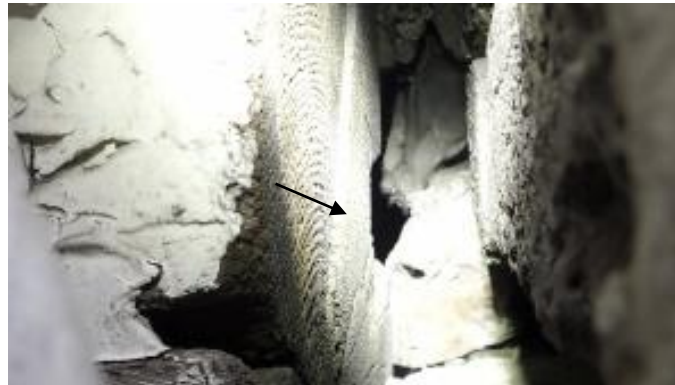
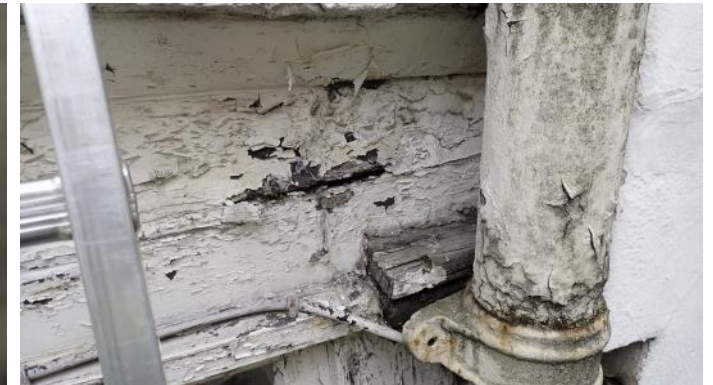
9

Showing the N end of the first floor plate externally. The end of the plate is sound and appears to have a tenon or notch cut in it (arrowed) - presumably originally a connection of some kind - possibly to an embedded timber for restraint.

The bearing is on the line of a downpipe - far photo. It is possible there was previous decay to the end of the plate - which is why it may have been cut and the support reconfigured. The accessible end section is in good condition and the end of this beam presumably now restrained by concealed connections internally. The remainder of this beam is sound - see discussion.

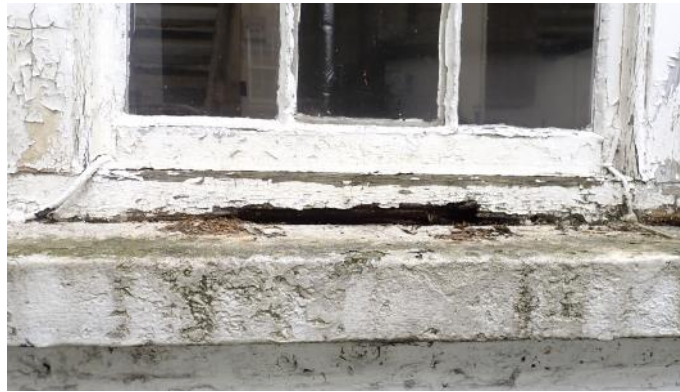
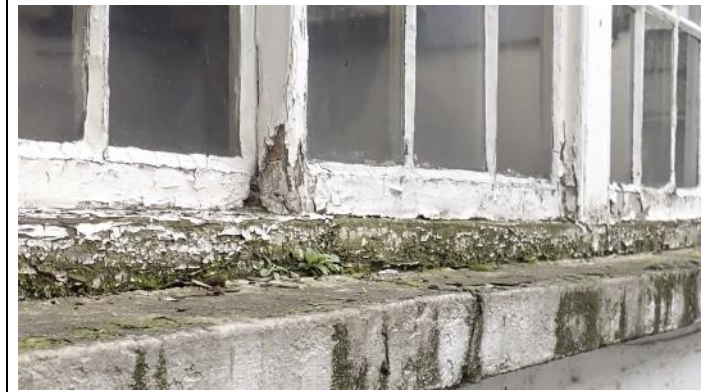
10

Photo showing representative damage to the sill. This is usual, where water and consequent decay have damaged the lower section of the sill for almost the full extent of the first floor windows.

Far photo showing the feet of many of the vertical (window) frame elements have decayed – some showing signs of repair.

The sashes seem to be in better condition – although fixed shut, thereby restricting full access.

Given the positions of the principal vertical posts – which run either side of the openings and also possibly through the windows at first floor level – the decay to the window sills and feet of some vertical elements of window frame is probably not structurally significant when considering the support for the rafter plate/roof.

The damage to the windows and the sills can be repaired in situ.

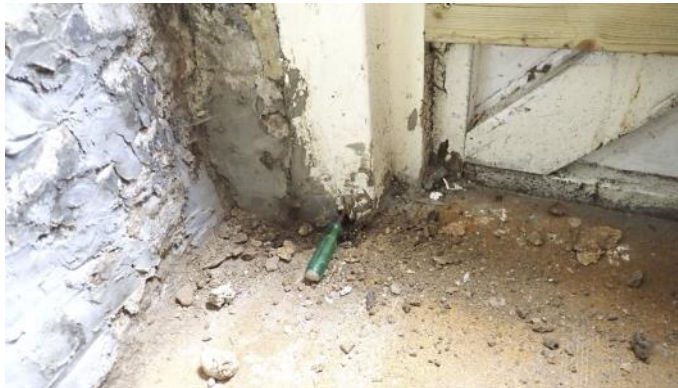
11

The extreme end of the post is decayed where in contact with the floor. It is probable some sort of filler has been used as a (substandard) repair.

The post is strapped to the N wall which seems to have stopped it dropping (again).

The first floor plate or beam is in good condition. Much of the rest of the first floor structure was inaccessible. The base of the principal vertical support post at the N end of the building is historically decayed and requires a more robust sectional repair. It seems probable that the bases of the inaccessible posts will be sound.

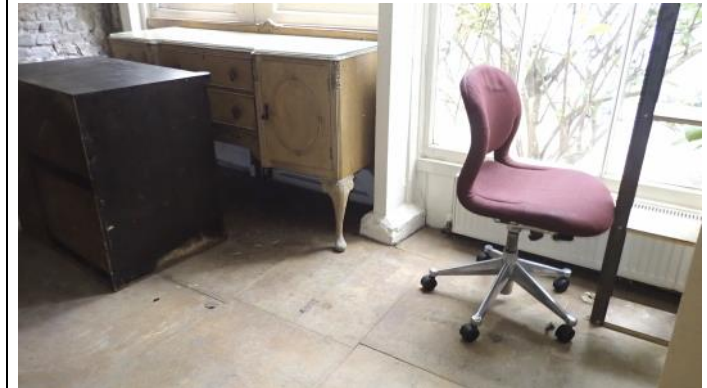
12

The base of the post bears onto a plinth and is sound for its full height.

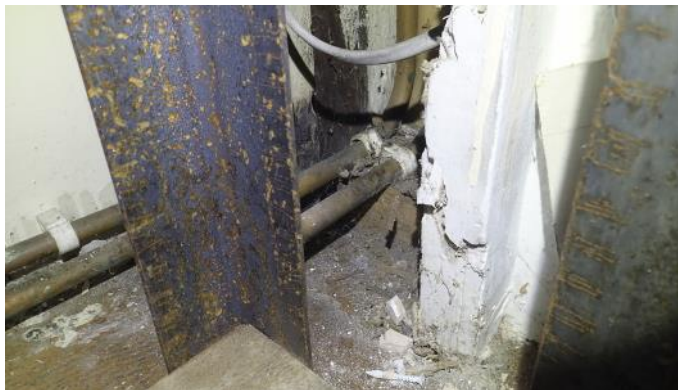
13

The base of the post was mostly concealed and inaccessible.

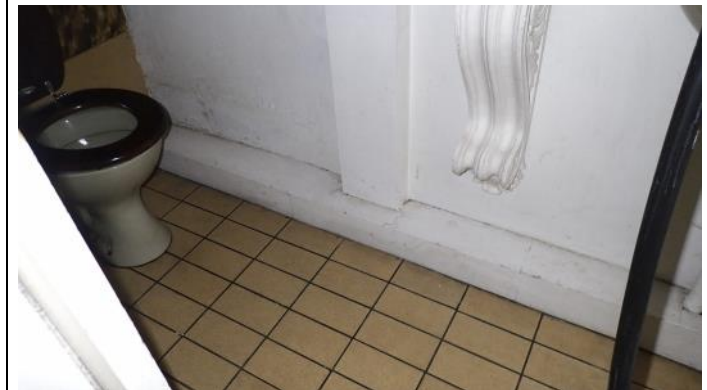
14

Base of post boxed out and partially concealed.
