33 Fitzroy Square
London, W1T 6EU

Design Statement -
Proposed Replacement of the
Front Elevation Medallions

London
10 July 2020

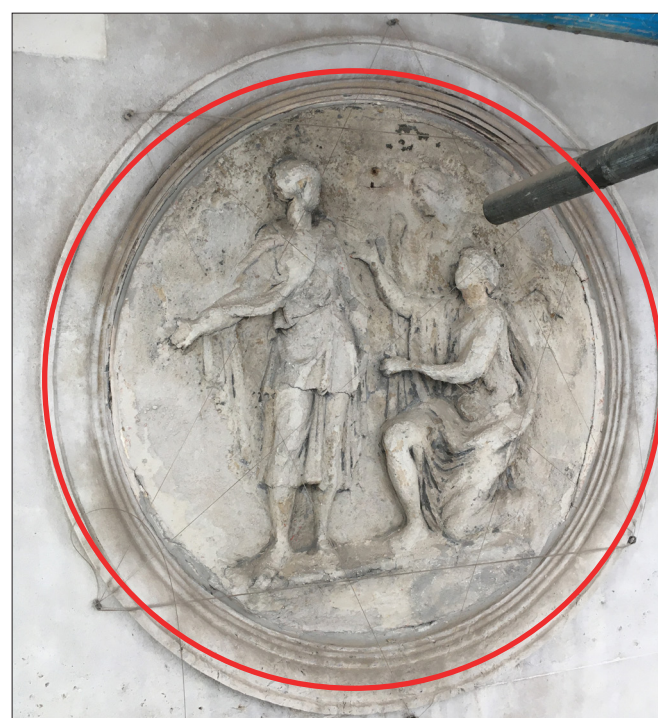
Existing Medallion - Left-hand Side

- Current condition of the medallion scenes in poor & an unsafe condition,
- The analysis into the material has proved inconclusive to the presence of linseed, a prominent material in Liardet,

We believe that the existing medallions are distracting from the significance of the front facade on No.33 Fitzroy Square & the Southern elevation of Fitzroy Square, & on that basis would propose the medallions are replaced with new to match the existing. A full methodology statement on how this can be achieved can be found on the proceeding page & the accompanying Heritage Assessment by Montagu Evans.

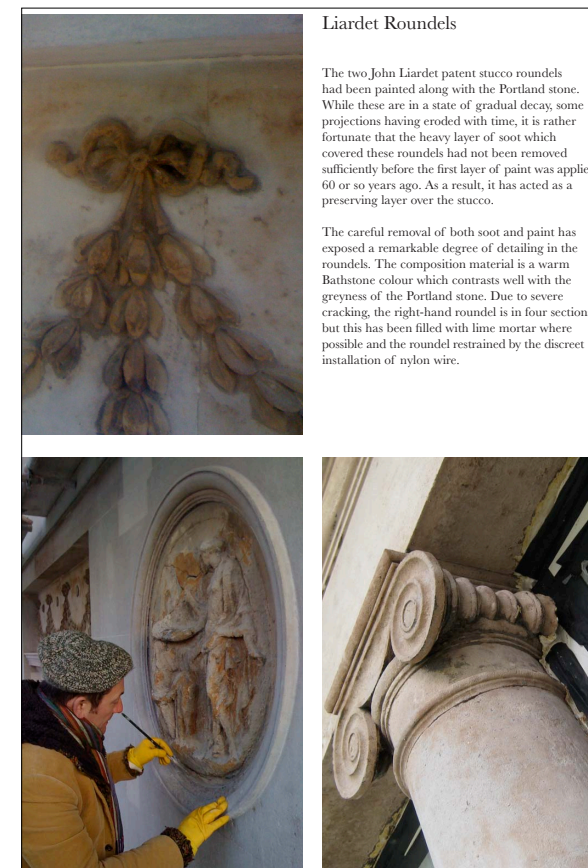
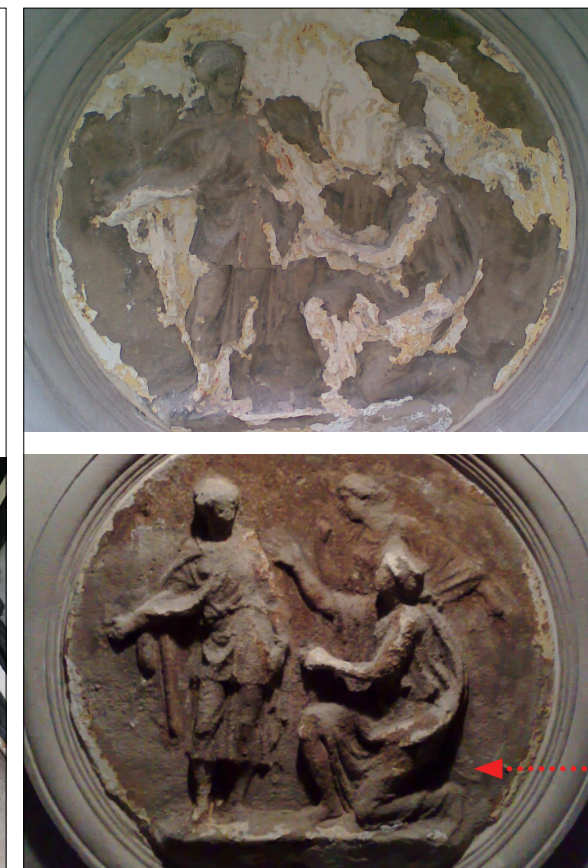
Images (2010/6848/L) - Left-hand side during & post paint removal

- Detailed in Application 2010/6848/L is evidence of the previous restoration works carried.
- Paint removed from the entire facade, to expose the early portland stone & assumed Liardet decorative medallions, depicting individual classical scene.
- Images illustrate more pronounced scenes, suggesting the exposure in the last 8-10years, since this report was produced, has had a detrimental effect on the material.
- Right Hand Medallion, suffered severe cracking & wires installed to prevent material falling.
- Two additional & individual scenes are found in the same location of the facade at No.40 Fitzroy Square (eastern end of the Southern block).

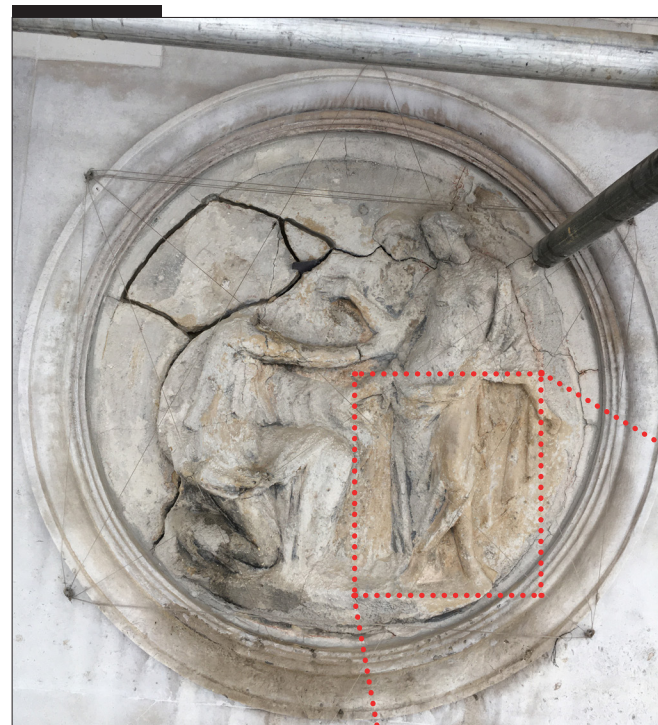
Existing Medallion - Right-hand Side

- 1 The roundels are not made of Coade stone as it was suggested but in either a natural or cement based artificial lime stone .
- 2 Although at our meeting I suggested that the material had the appearance of sandstone our basic testing has shown it to be a lime based material and quite possibly a simple sand and cement mix .

- 3 The material has very little mechanical strength is orange in colour with a textured paint finish ,
- 4 It is difficult to understand why this inferior material with a different colour would have been incorporated into a I façade of this magnitude and so we are of the opinion that these quite possibly are not the original works but poor quality replacements,

- 6 Clearly further investigation will need to be carried out in order to move matters on but It could be that this material is so friable that we may need to consider making replacements , I am always determined to maintain and conserve original work where at all possible but I should make you aware that replacement of the roundels may be our only option

- Scene are not made of Coade Stone, either made of a natural or cement based lime stone.
- Basic testing of material suggested it's a lime based material.
- Material has very little mechanical strength, orange in colour.
- Opinion that these are not early works but poor quality replacements.

- 5 Because of their unstable nature we would suggest that the roundels will need to be removed from the façade to our studios to be either restored or replaced.

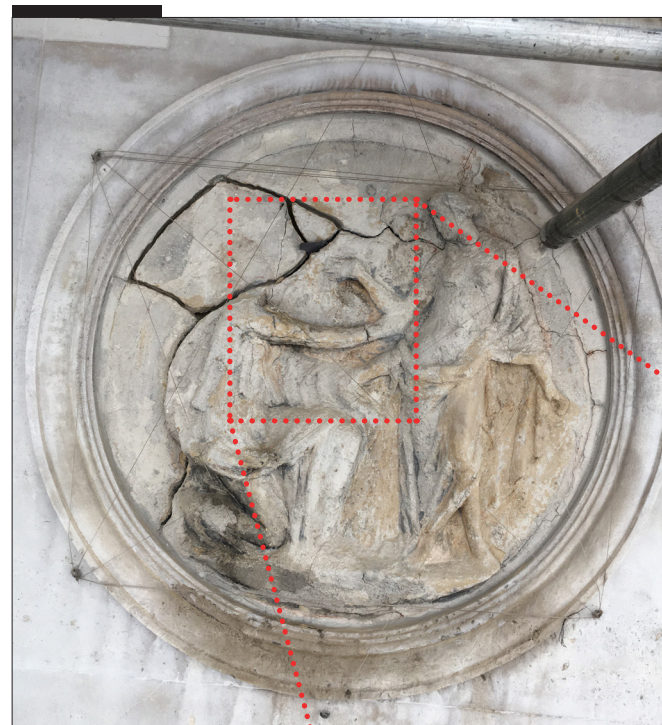
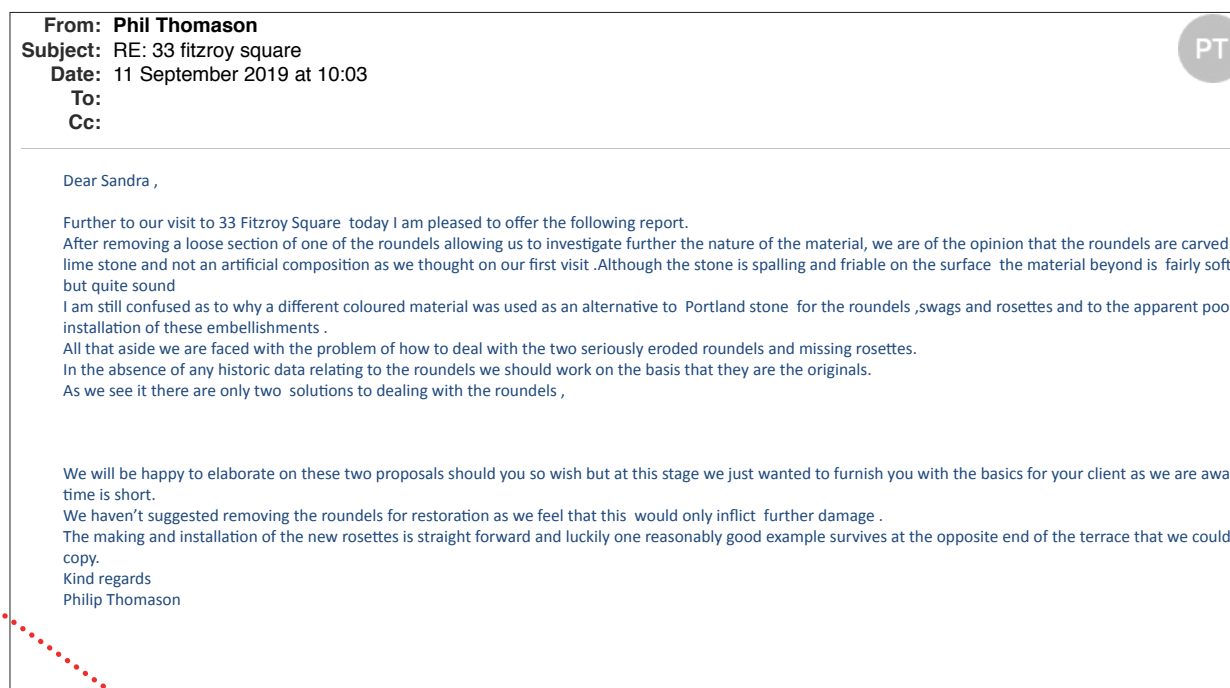
Specialist Investigation - Sympathetic removal of a loose area

- Area of stone removed was blown from surface & loose.
- Surface extremely degraded, friable & appeared to have suffered damage from paint removal - either by chemicals or sandblasting.

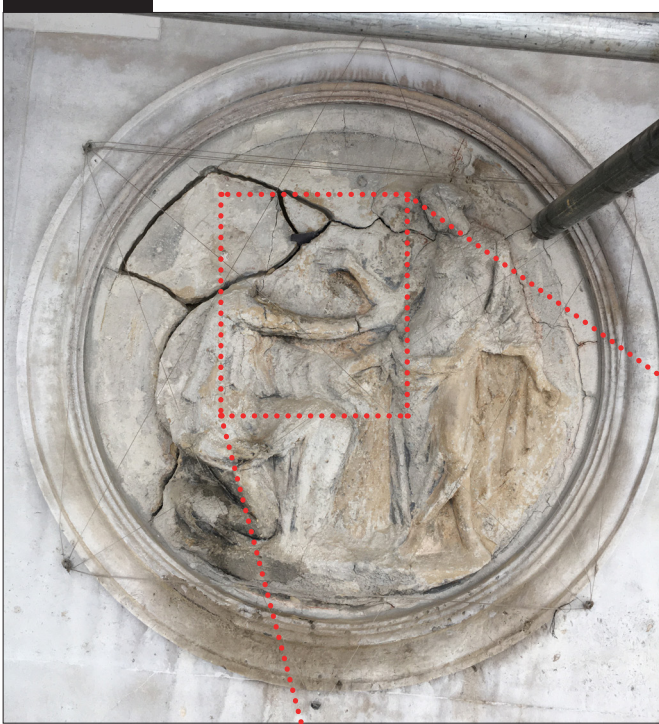
Existing Medallion - Right-hand Side

- Sandberg carried out an analysis of the mortar sample taken from the back of the removed loose section of the medallion.
- Sandberg were specifically asked to concluded if linseed was present in the sample - the blinding material used in Liardet - the anaylsis was inconclusive.
- Sandberg - "We did run FTIR to try an identify the organic material but the analysis was inconclusive and didn't point towards linseed oil nor any other sensible answer."

Sandberg Material Anaylsis - Inconclusive as being Liardet
