CONTRACT: Tottenham Street

CONTRACT NO. 6606

STRUCTURAL INSPECTION  
REPORT

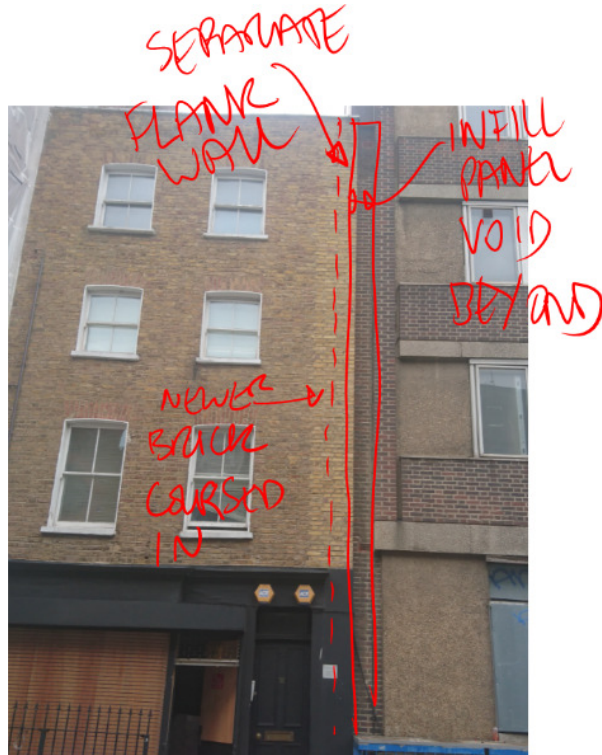
**Figure 2 Existing street elevation east boundary**

The façade is formed of London Stock bricks and appears to have been modified with differing colour bricks coursed in along one edge. To the east the property is bounded by ASH, a concrete frame office block circa 1960. There is an infill panel of masonry on the front elevation between 52 TS and ASH which forms a void between the two buildings.

2. The east flank wall parallel to Arthur Stanley House (ASH) is separate from the adjoining property, with a void between. The panel of brick separating the two properties on the front and rear elevation may require temporary support or demolition if this can be agreed with the adjoining owner. The 'Party Structure' status of the wall should be confirmed by a Party Wall surveyor.

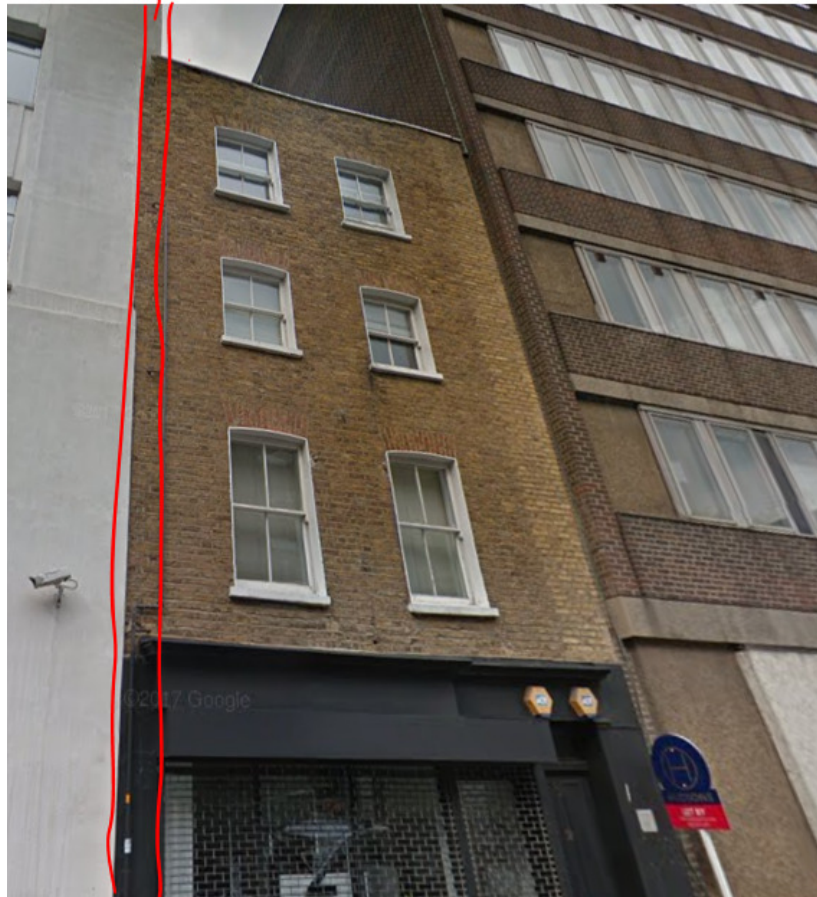
Figure 3 Existing street elevation west boundary

To the west, the property is bounded by 30 CS, an existing 7/8 storey (including basement) loadbearing masonry property circa 1930. The wall between 52 TS and this property appears to be a single 330 thick masonry wall. From roof level of 52 TS to roof level of the adjoining property 30 CS the wall and flues have been raised in later brickwork constructed at the time of the adjoining property. There is evidence of differential movement between the two properties as the junction of 52 TS' parapet with the flank wall has cracked. The adjoining property will require temporary lateral propping to the wall during demolition and construction of the proposed development.

WALL RAISED

1. The flank wall and flues to the west boundary of 52 Tottenham Street (52 TS) forming a party wall with 30 Cleveland Street (30 CS) have been raised when the adjoining property was constructed. The 'Party Structure' status of the wall should be confirmed by a Party Wall surveyor. Temporary lateral support will need to be provided to this wall when the existing building is demolished.

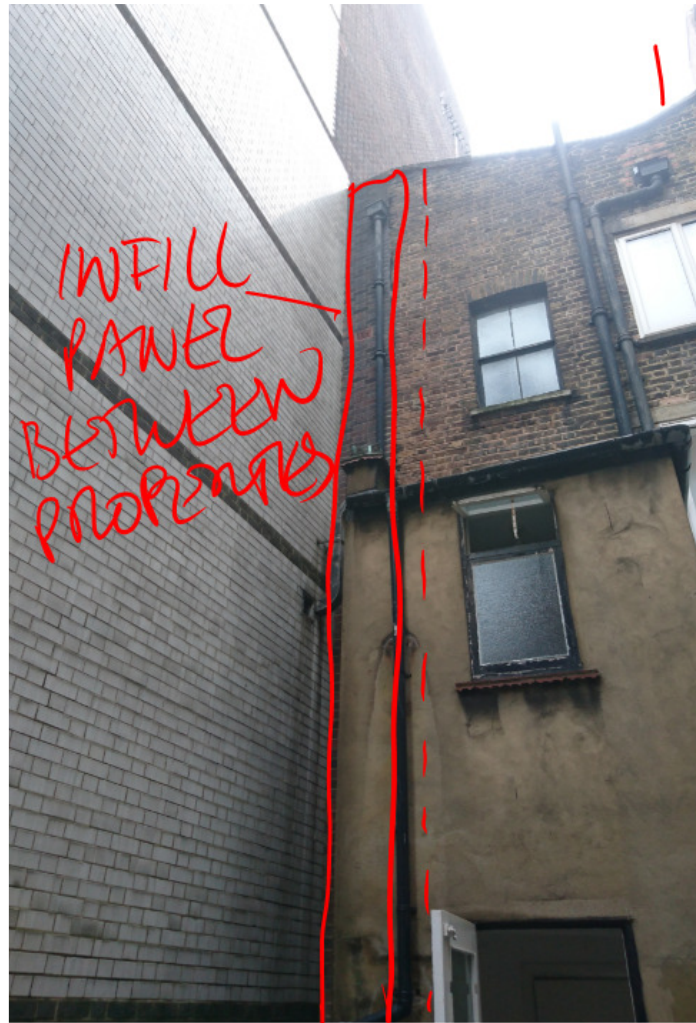
**Figure 4 Existing rear elevation east boundary**

A similar observation to the front elevation is made to the rear east boundary with the ASH, a wider infill panel of brick is evident separating the two properties where there is a void between the two properties.

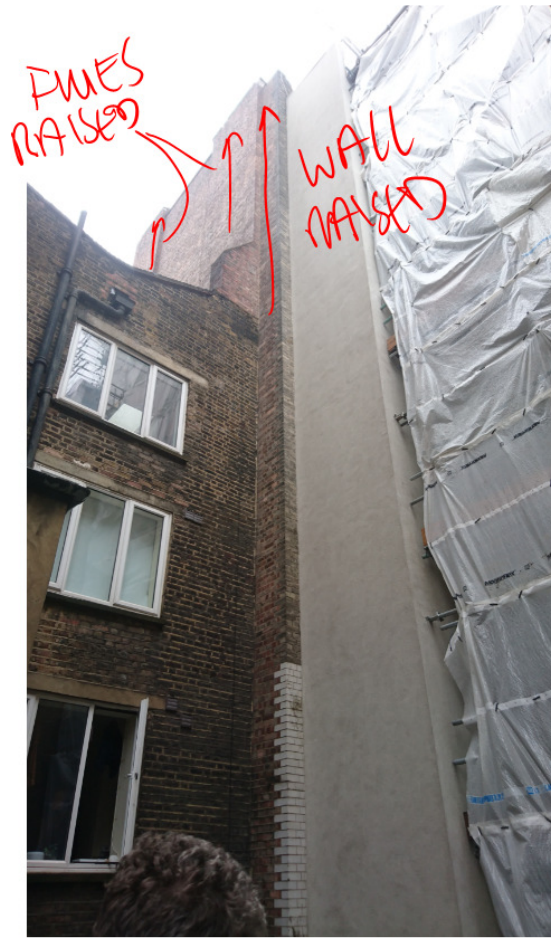
**Figure 5 Existing rear elevation west boundary**

Furthermore it is evident that the flank wall to the west boundary has been raised on the rear elevation along with the flues.

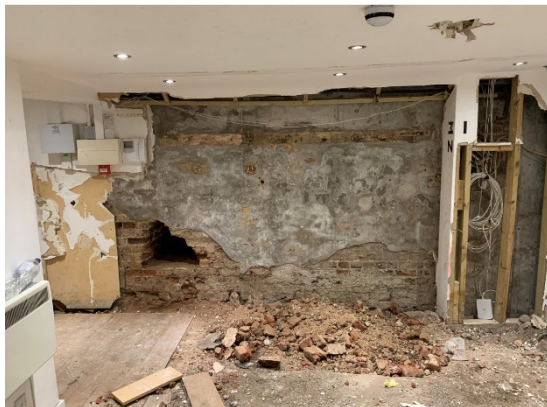
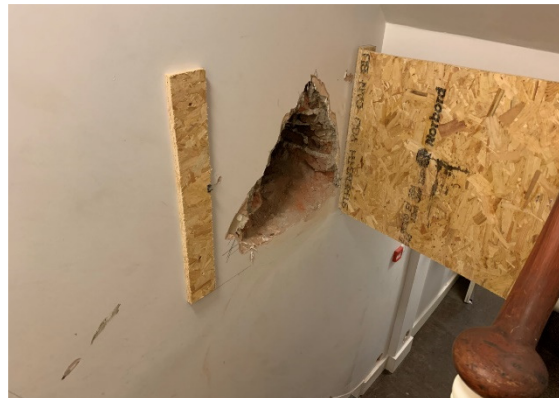
**Figure 6 Holes opened in flank wall into gap**

To the front half of this boundary are two independent walls with a gap between the two buildings. A historic chimney breast was identified on the back of the 52TS flank wall assumed to be the reason the gap is present between the two buildings. Within the gap, the floor slabs of ASH project out and butt against the flank wall of 52TS, assumed to be constructed to provide horizontal lateral restraint to the masonry wall.

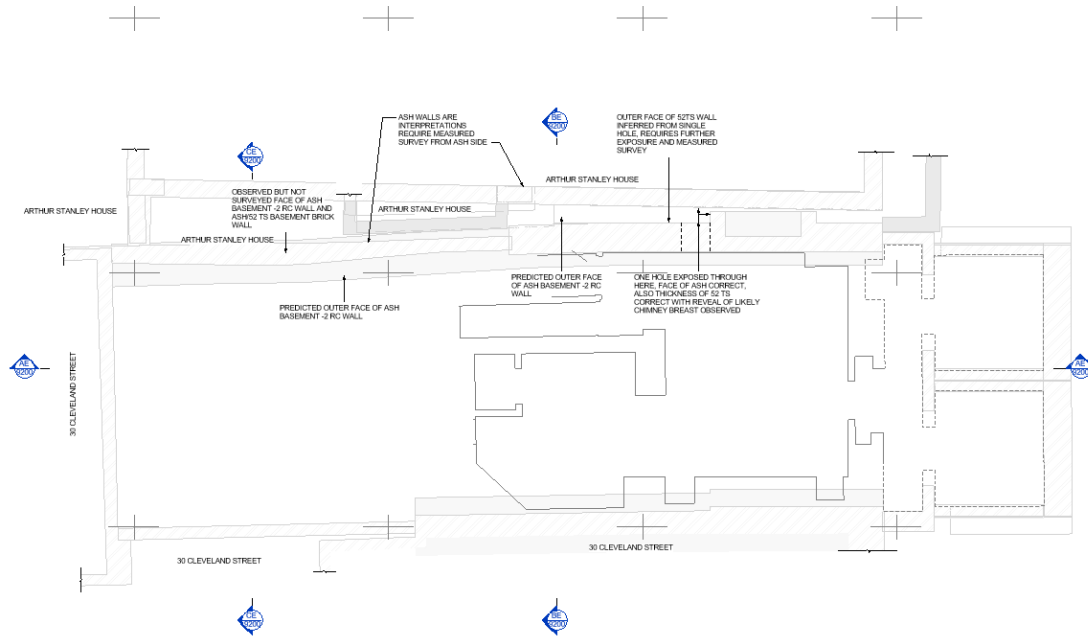
Figure 7 Existing basement plan with ASH boundary investigations

To the rear half of this boundary is a lightwell belonging to ASH. The masonry flank wall of 52TS forms part of this lightwell and has been underpinned to ASH B02 basement level. A hole was drilled through the concrete at the ASH B02 level and has identified the underpins are approximately 850mm thick.

The flank wall of 52TS adjacent to the front gap has been underpinned. A hole drilled through the ASH B02 wall appears to indicate this wall has been underpinned to the lowest level basement. It was not possible to identify the thickness of the underpins as the drill bit was not long enough, however they are at least 600mm thick and would be reasonable to assume they are atleast as thick as the underpins to the rear lightwell wall.
