### Level and Crack Monitoring

| Address: | 57 Aberdare Gardens |

**Level and Crack Monitoring - Site Sketch**

### Crack Monitoring - Movement Against Time

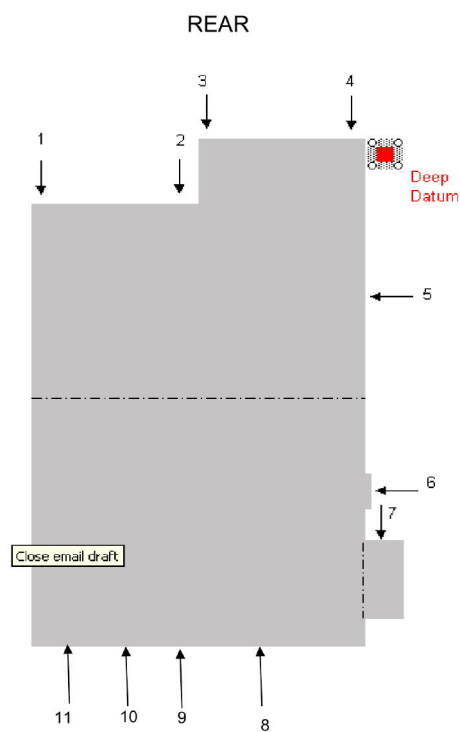
■ TBM 2  
OUTSIDE NO  
57 IN KERB
