CHICHESTER STONEWORKS
STONEWORK, RESTORATION, CONSERVATION

Report in connection with a drinking fountain on Shafetsbury Avenue

Introduction

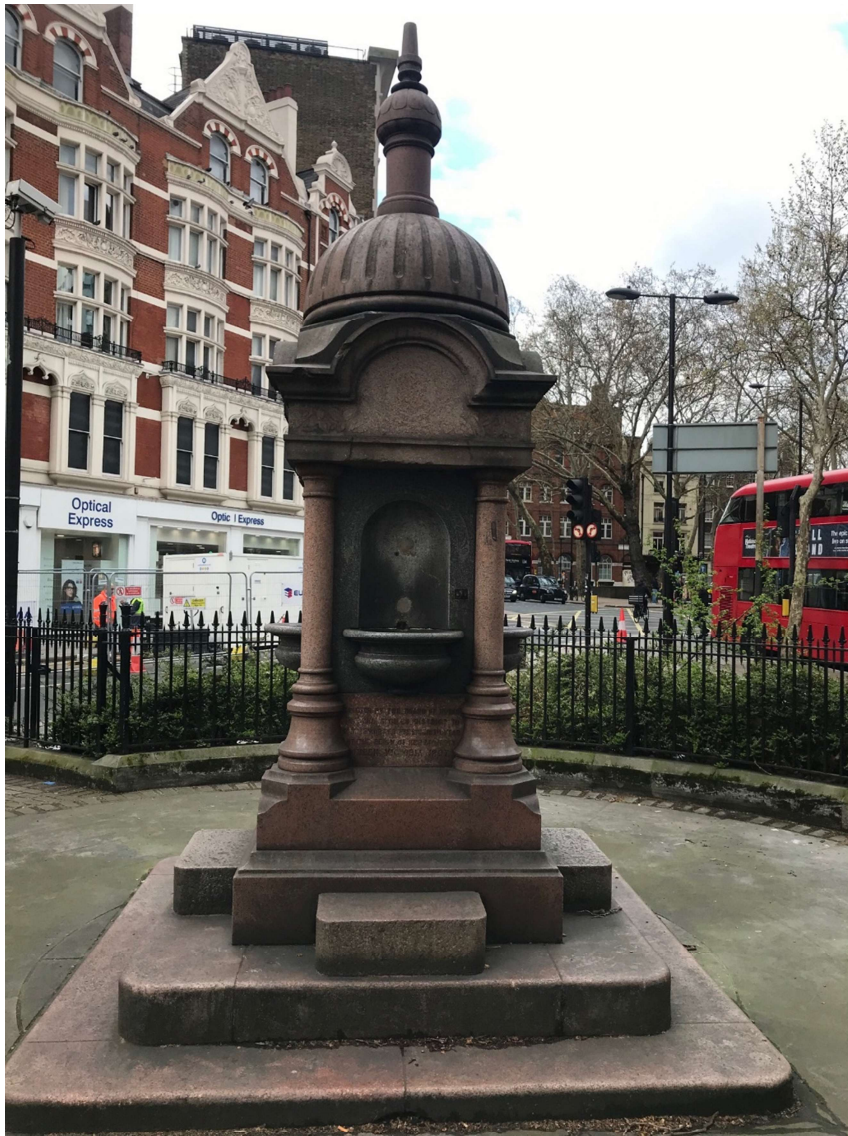
South facing elevation

- Physical damage. There are two sections of chipped stone to the edge of the cornice stone on the south facing elevation approximately 75mm x 50mm. These may result from shrapnel impact during WWII or impact damage by some other means. If required, they could be cut out and indented with new stone. However, they are relatively minor and part of the history of the structure, so it may be preferred to leave them as they are.

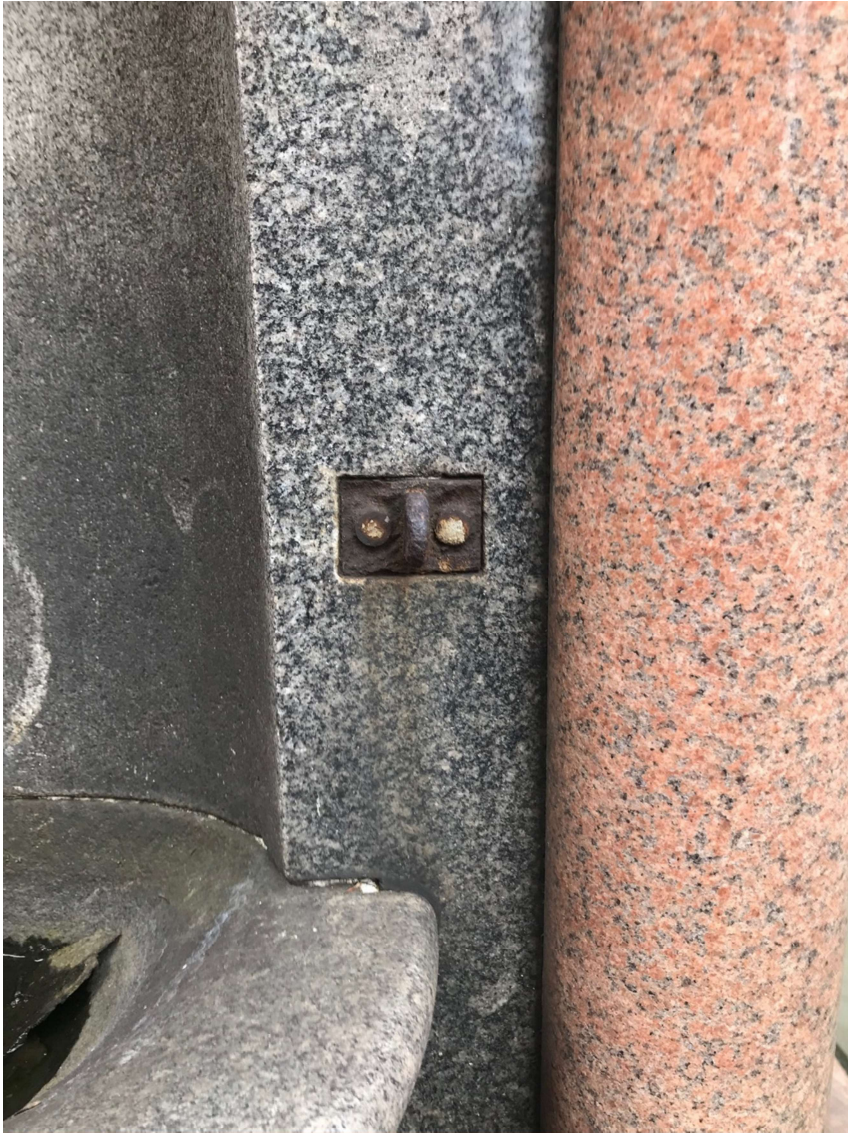
- Missing metalwork. Most of the original metal work associated with its use as a drinking fountain has been removed, and the resulting holes filled with cement mortar. This is likely to have included a drinking cup on a chain, a faucet and a tap. The fixing points to which the chain would have been attached still survive, although they are showing signs of corrosion. It may be possible to manufacture replacement items for these following research on their form which may include consulting the Drinking Fountain Association and viewing other drinking fountains where these items remain in place.

Detail showing the two granite colours and chain fixing point

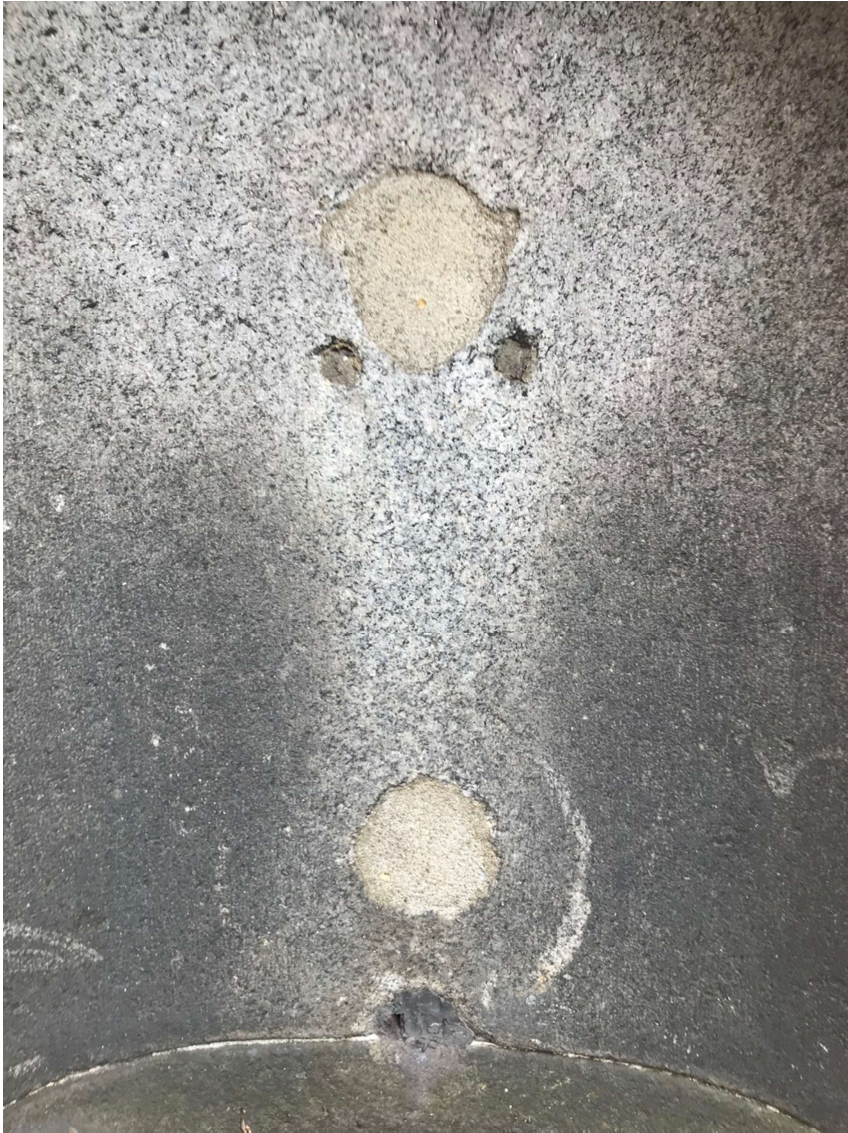
Cement repairs where faucet removed
