4 Flitcroft Street Facade Alterations Discharge of Conditions - render removal rev B

Ian Chalk Architects

Consolidated Group March 2020 1.0 Introduction

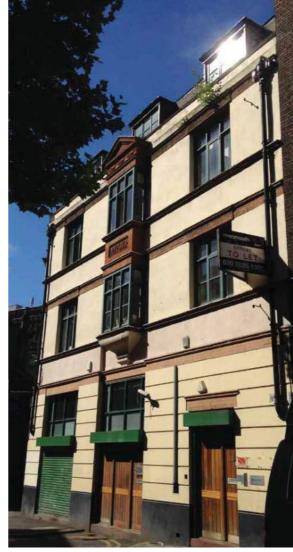
4 FLITCROFT ST. - 2017

The façade at upper level is finished in render applied over original brickwork. Horizontal bands of feature brickwork between windows, with a projecting central barlos of feature bickwork between windows, with a projecting central bay window with terracotta panelling. The ground floor façade has been significantly remodelled with two of the openings having been enlarged with painted metal glazing and prominent steel roller shutters. The lower facade is in stucco render with deep horizontal banding.

Symmetry of facade disrupted by ground floor alterations.

Facade has been rendered over the original brickwork with expressed brick banding retained.

Lintols to ground floor have mostly been lost.

Deep banded render to base of building.

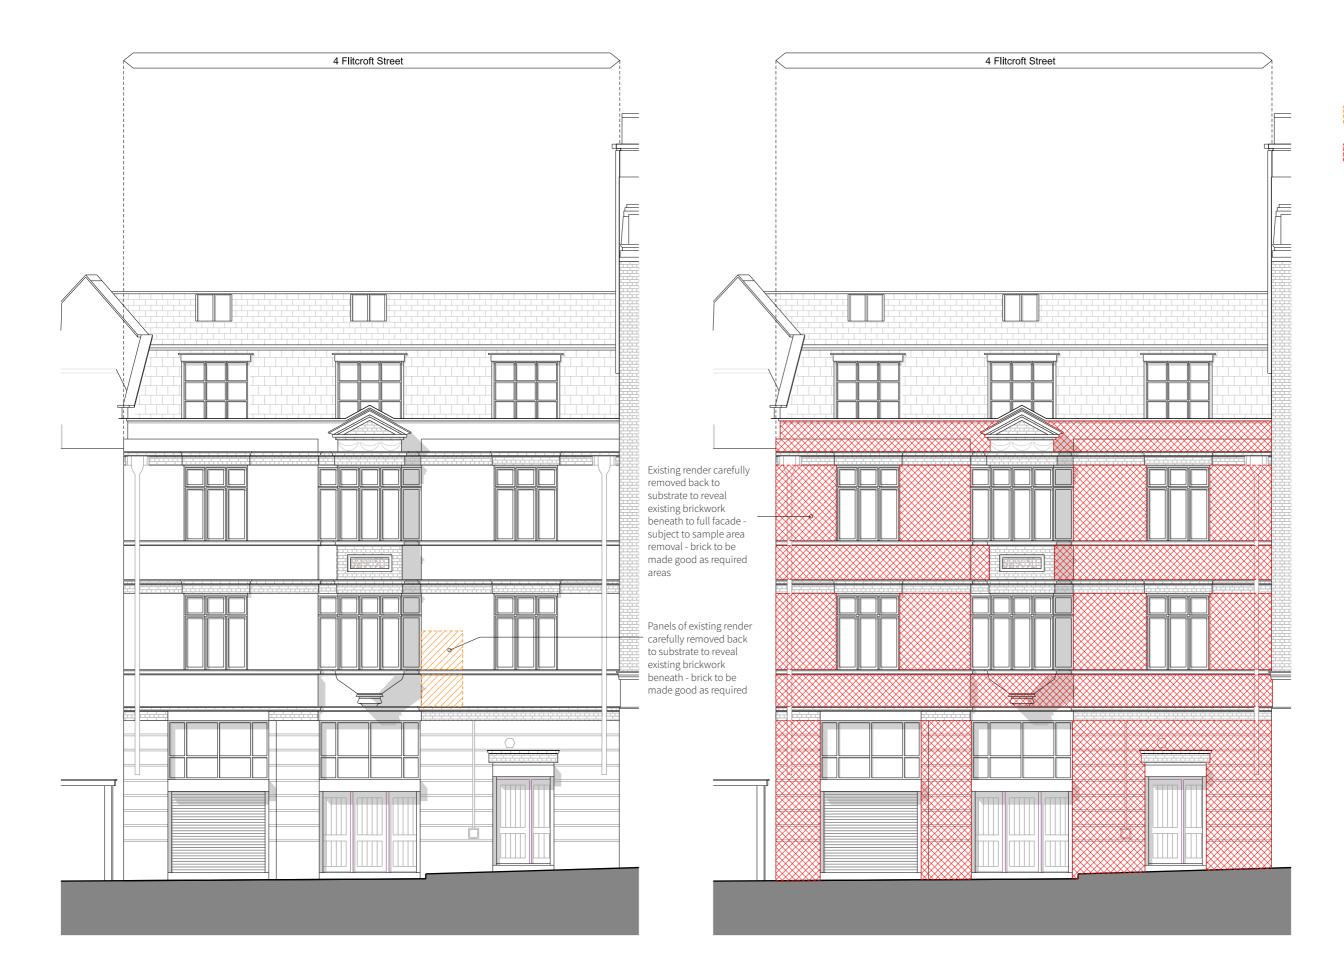
Sample areas of render removal

Proposed extent of render to be removed - subject to successful removal and repair of brickwork to sample areas

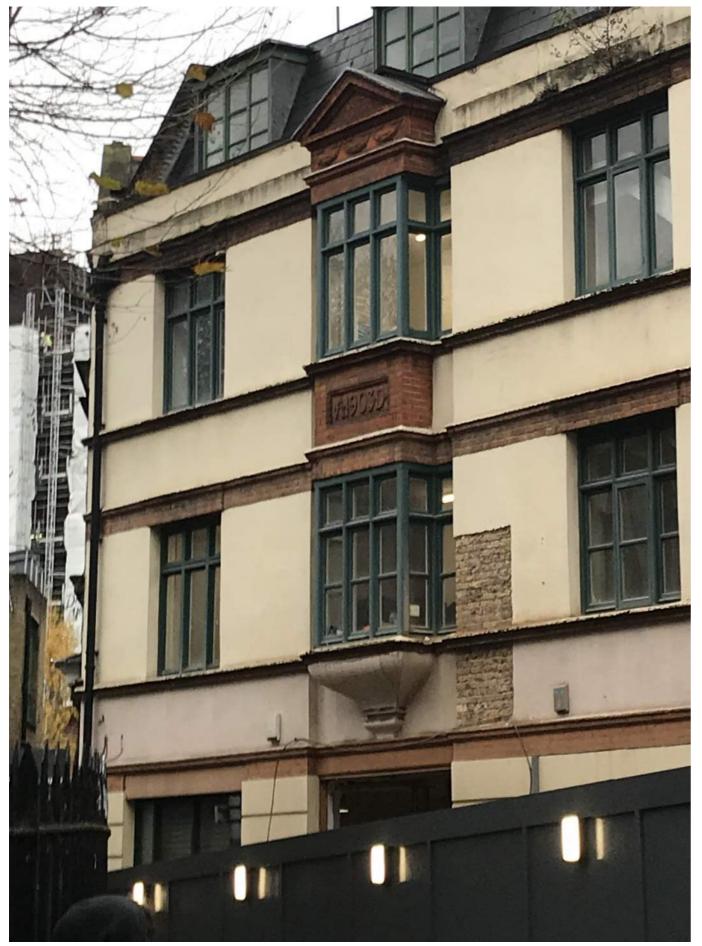
4 Flitcroft Street - front facade showing render removed to First Floor sample area -existing stock brick revealed beneath - generally in good condition with light surface damage due to later applied render but brick integrity largely intact.

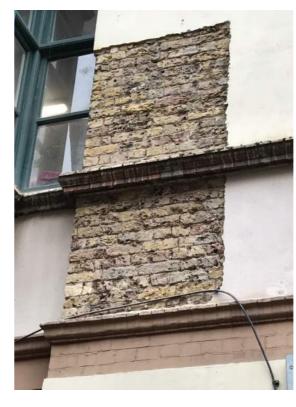
Close-up detail showing render removed -existing stock brick revealed beneath - generally in good condition with light surface damage due to later applied render but brick integrity largely intact. Areas/Bricks with significant damage to be made good in matching brick where the removal has resulted in the loss of the brick surface and would compromise weatherproofing/façade integrity. Mortar joints to be repointed where required

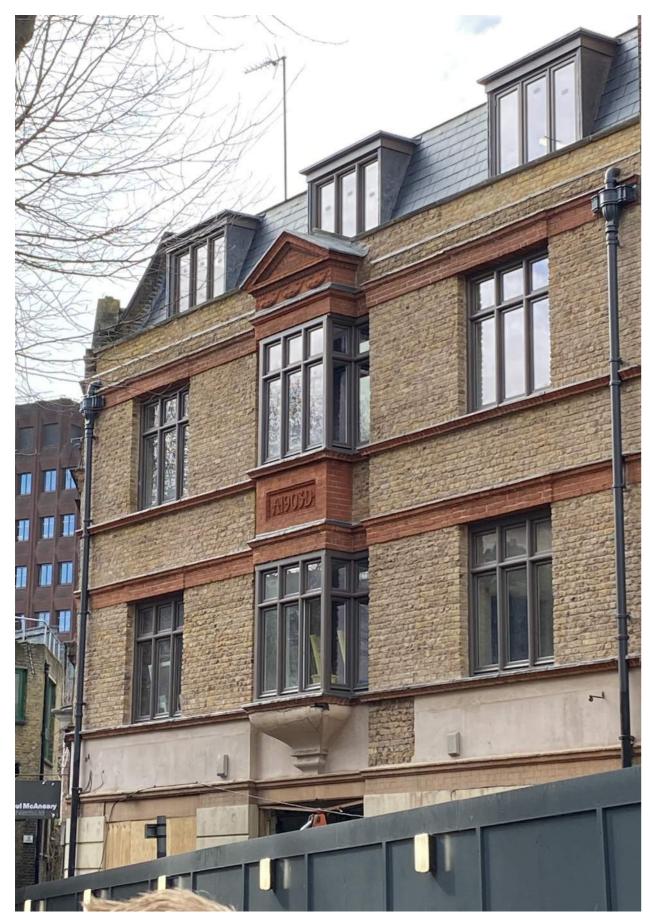
4 Flitcroft Street - front facade showing render removed to First and Second Floors existing stock brick revealed beneath - bricks have been carefully cleaned and repaired by hand creating a soft consistent appearance.

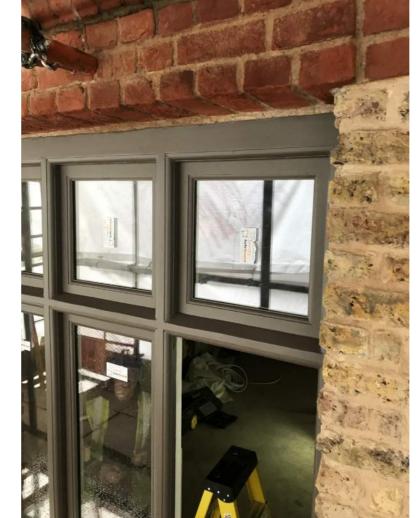
Close-up detail showing render removed -Existing bricks have been revealed showing historic surface damage to the fired-face - this is the result of scratching to create a key for the render when originally applied. The bricks are generally in a good condition and any that have had deeper breakage/damage have been replaced with matching stocks. Pointing has been repaired in lime mortar - the pointing has been slightly recessed to allow the reading of the brick edges to be maintained and keep the mortar joints. A delta membrane is provided internally to mitigate any dampness

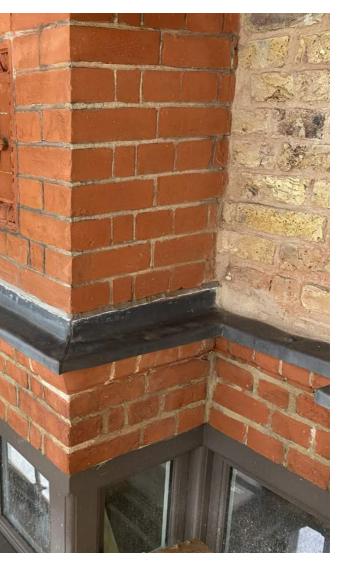
Close-up detail showing repaired brickwork and lead flashings Red rubber brickwork has been carefully repaired and cleaned - lead flashings installed to projecting bricwork to protect leading edges which are soft and liable to erosion
