TECHNICAL REPORT ON A SUBSIDENCE CLAIM

180 Camden Road Limited
180 Camden Road
London
NW1 9HG

SUBSIDENCE CLAIM

27th November 2019

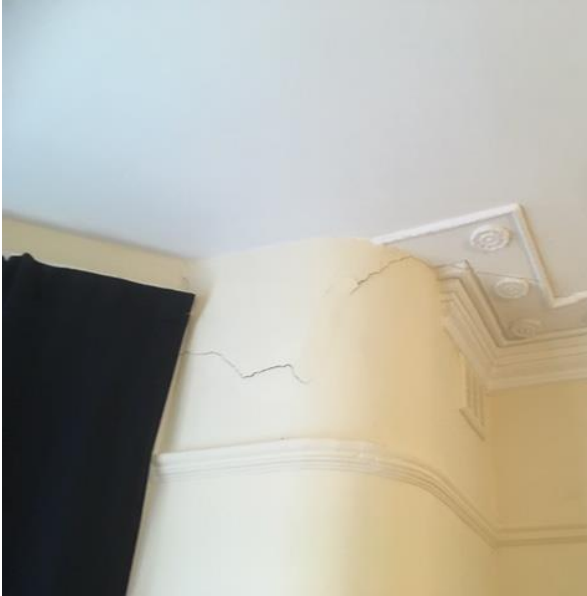
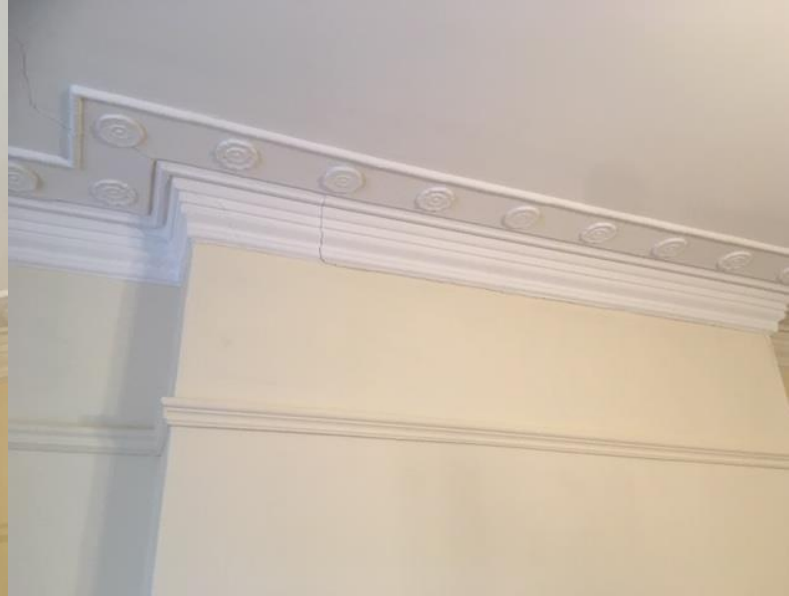
Cracking to first floor flat

- Slight cracking was noted to the left hand side of the bay at its junction with the main house.
- To the right hand dividing wall, a slight diagonal crack was noted to the front corner which extends up to the rear.

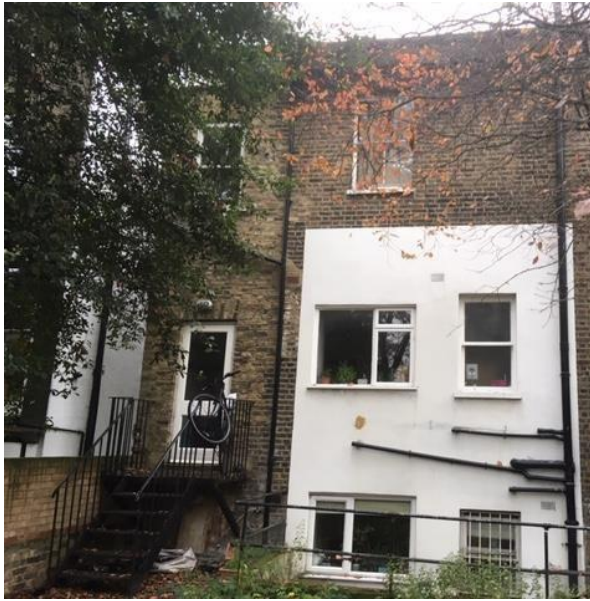
Rear elevation

- Diagonal / stepped cracking was noted to above and below door and window openings.

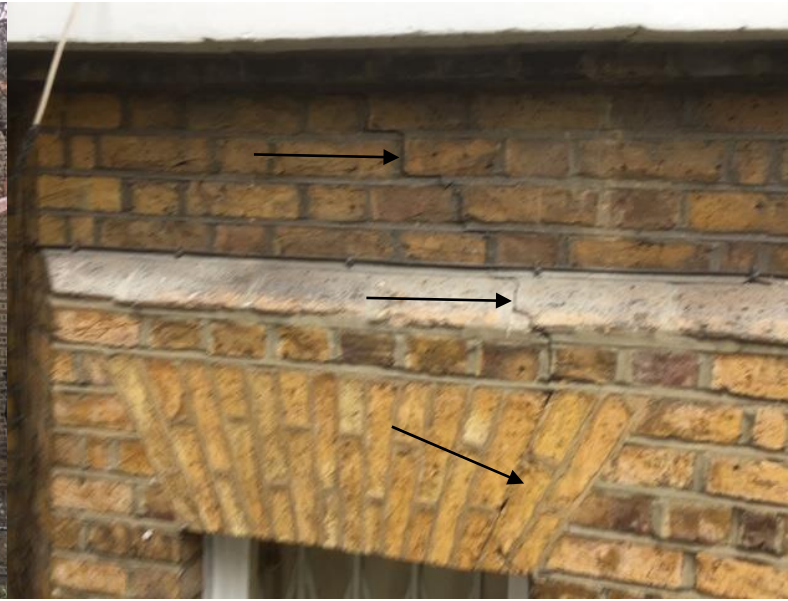
Cracking to bay

- Stepped cracking / displacement of flat brick lintels were noted to the left hand return wall of the bay.

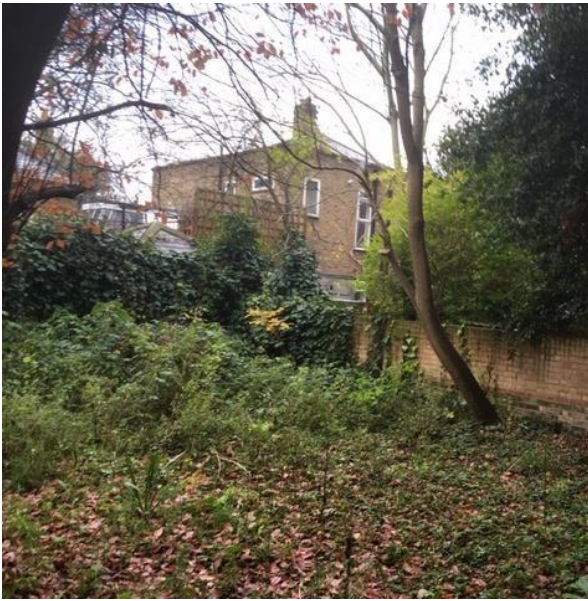
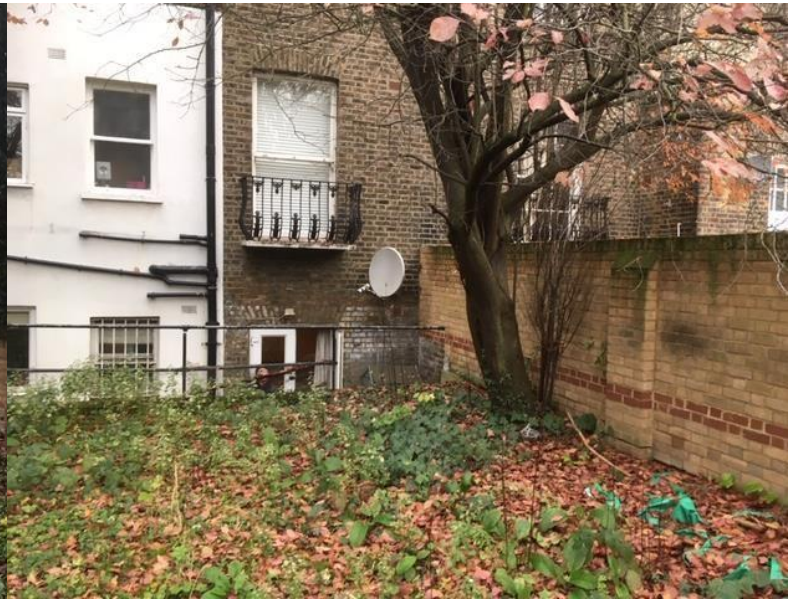
Type	Height	Distance	Ownership
T1 - Deciduous	20 m	4 m	Owners
T2 - Deciduous	20 m	8 m	Owners
T3 - Deciduous	20 m	5 m	Neighbour 1
T4 - Deciduous	20 m	8 m	Neighbour 1
T5 - Deciduous	25 m	11 m	Council

Trees at rear

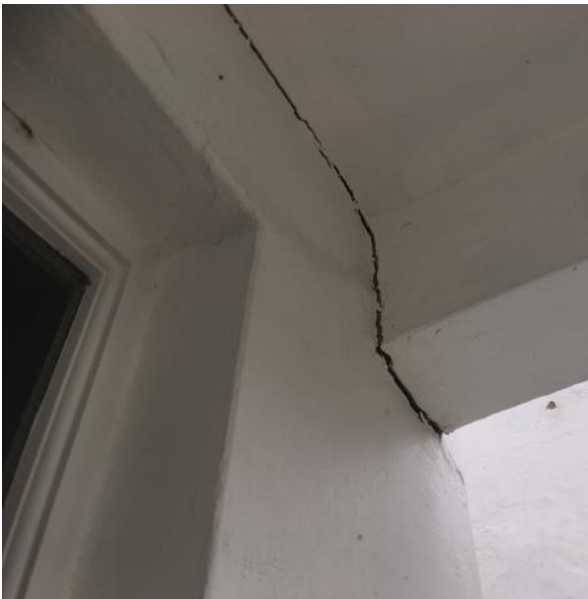
- Cracking, up to 10-15mm in width, was noted at the junction between the porch and main house/extension.
- Stepped cracking, up to 6mm in width was noted the right hand wall of the porch.

Cracking to porch

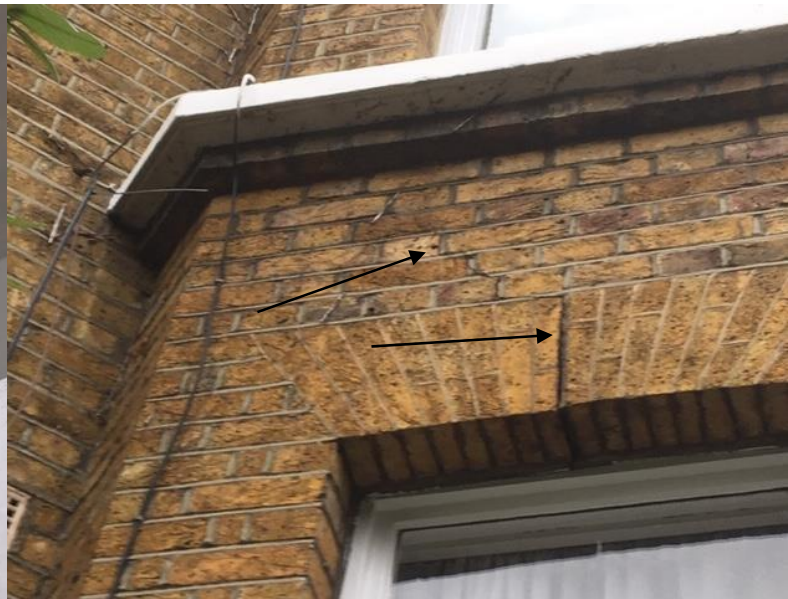
Cracking to bay

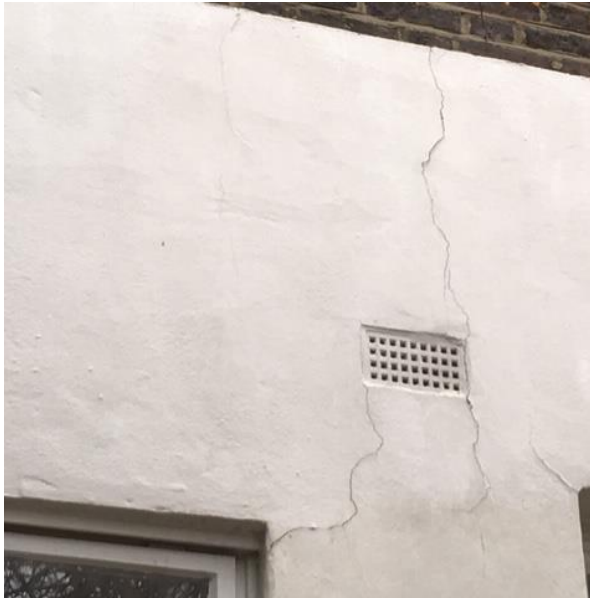
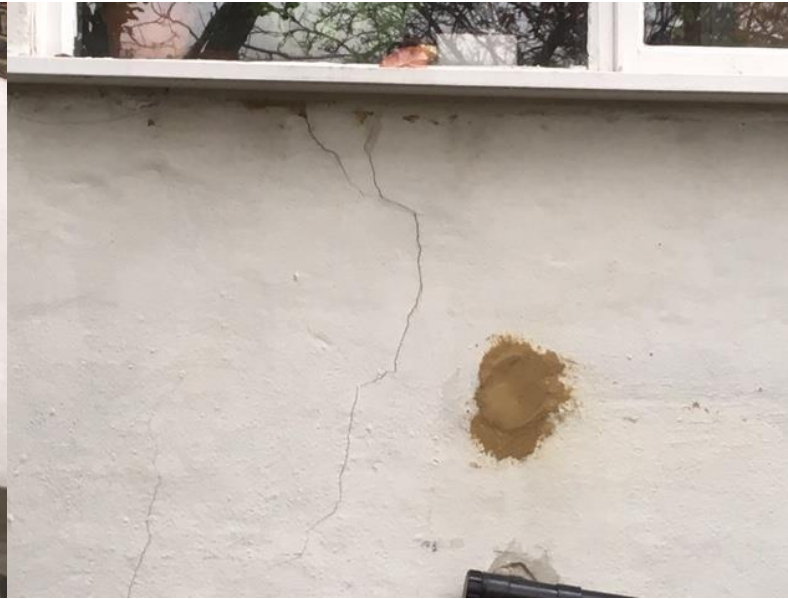
Cracking to rear elevation

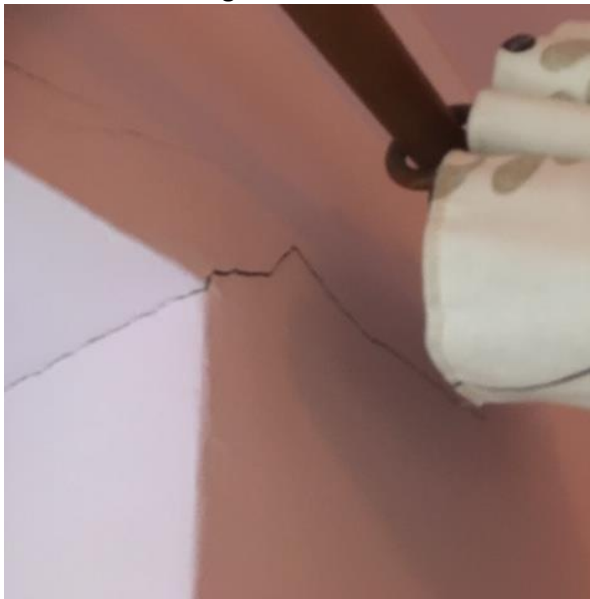
- To the right hand wall slight cracking was noted above the corridor door (seen both sides).
- To the rear wall, 3mm wide cracking was noted to the top right of the window.

Rear Bedroom - Garden floor flat - rear wall

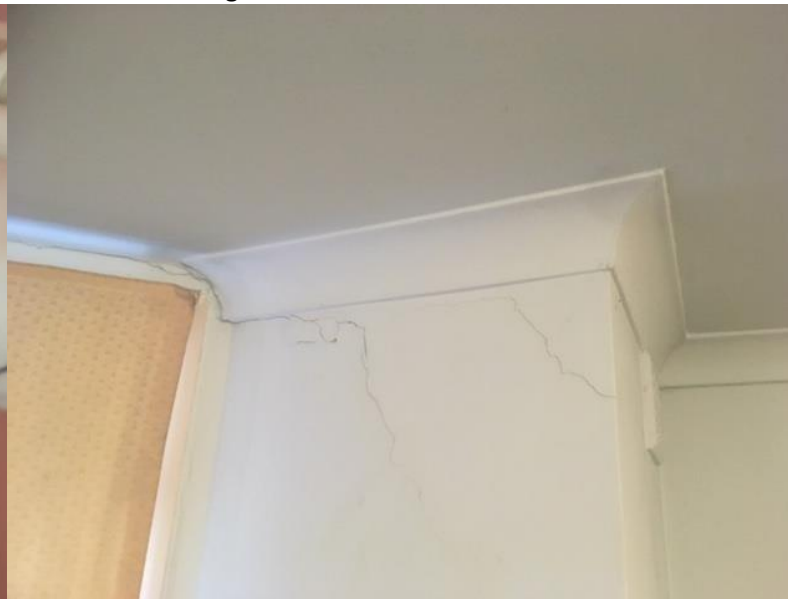
- Slight cracking was noted to the left hand side of the bay at its junction with the main house.
- To the right hand wall cracking was noted either side of the hall door head.

Garden flat - Lounge
