**ATWORTH ARBORICULTURE LTD**

**DECAY DETECTION ON 6 TREES AT BEECHWOOD HOUSE,  
HAMPSTEAD LANE, N6 4RU.**

**Prepared for: David Williams, Beechwood House Estate Management.**

**Site Address:** Grounds of Beechwood House, Hampstead Lane N6 4RU.

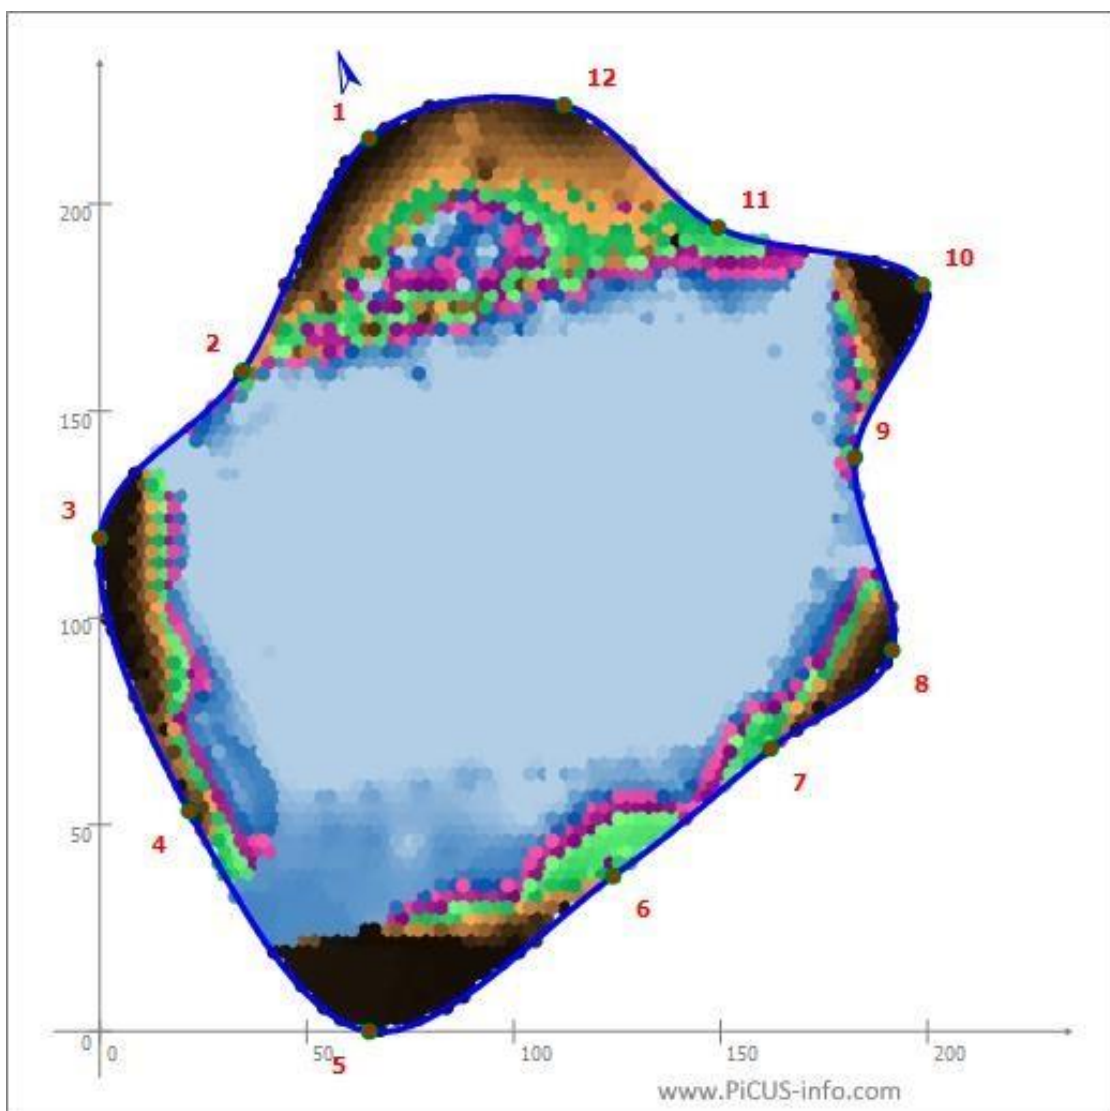
A Ganoderma bracket was observed at ground level east on the stem. Also some black staining and exudates south east, north east and North West at 20cm above ground level. The trunk has developed cankers and burrs up the stem, at 8m above ground level, which is quite normal given its mature age.

**Conclusion:** This is a very old tree which is reaching the end of its natural life span. The Ganoderma brackets are indicative of the fact that it has probably developed white rot within its stem, as the Tomograph indicates a significant cavity coloured blue and there is very little good wood left within the stem structure to guarantee the trees integrity. The Resistograph tests back up that the tree stem is significantly decayed.

The tree itself occupies a large area at this site, and because it is sheltered, the target area is relatively low. Should the tree fail, it would not reach the main house, but could cause damage to the surrounding trees, none of which are as historically significant as this tree.

**Recommendations:** This tree is at risk from failing. Due to the trees location the target area is minimal. The tree management would depend on the owner's attitude to risk. To leave the tree is to accept it could fail at any time. It would not be sensible to reduce the tree as beech trees do not generally respond well to reduction, especially as it is under stress. Should it be decided that the tree is too unsafe, the requisite consent from the local authority would not be a problem with this evidence. Any tree work should only be carried with the correct permissions and undertaken by a tree surgeon with the relevant insurance and qualifications, working to BS3998(Tree work) 2010.

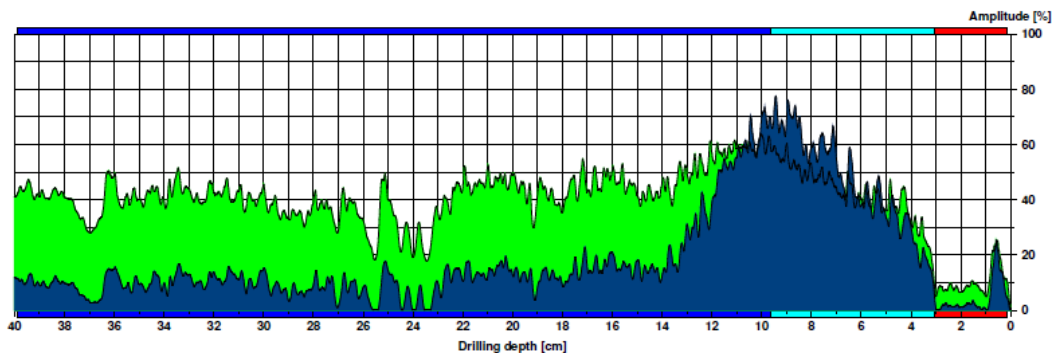
Direction	Height of Test	Result
East	30cm	1-14cm= good wood, 14-39cm= decay
North East	40cm	3-9cm=good wood, 9-39cm= decay.

From 0,13 cm to	3,04 cm :	Bark
From 3,04 cm to	9,66 cm :	Good Wood
From 9,66 cm to	39,87 cm :	Decay

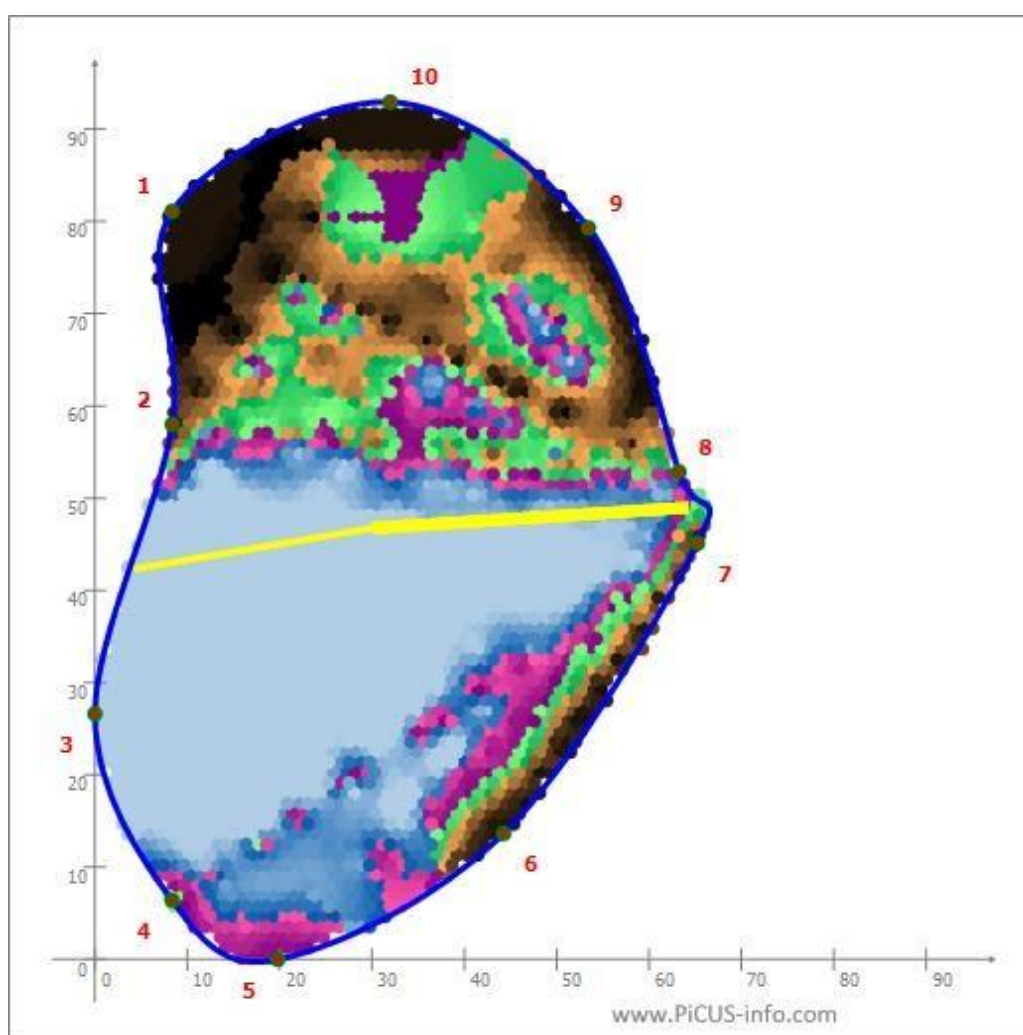
There is a bark wound on the south side of the tree at 0.5m above ground level, and a cavity was observed north at ground level.

The crown is very sparse for the species and shows signs of apical die back.

**Conclusion:** The Tomograph shows a significant cavity and some advanced and early decay. The yellow line on the Tomograph shows where the software indicates there may be some internal cracking. The thicker the yellow line the larger the crack. The Resistograph indicate significant levels of decay, with also a structural crack running through the stem (indicated by the yellow line on the Tomograph). This will weaken the stem of the tree and also, the tree does appear to be stressed, as indicated by the atypical die back.

**Recommendations:** This tree has a high likelihood of failure and due to its proximity to the main drive, it is advised that this tree should be felled as soon as practically possible. Permission would need to be obtained from the local council as it is subject to tree preservation order, and only then should a suitably insured and qualified tree surgeon carry out the tree work, working to BS3998( Tree work) 2010.

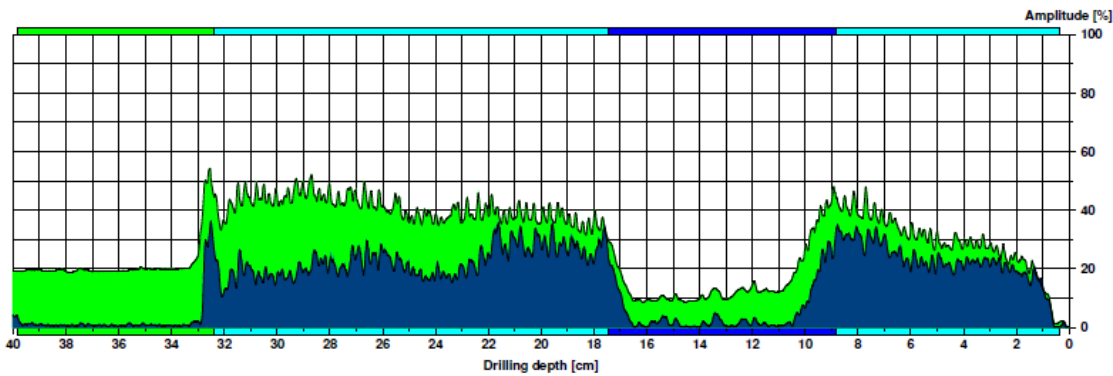
From	0,36 cm to	8,85 cm	: Good Wood
From	8,85 cm to	17,45 cm	: Decay
From	17,45 cm to	32,41 cm	: Good Wood
From	32,41 cm to	39,81 cm	: Cavity

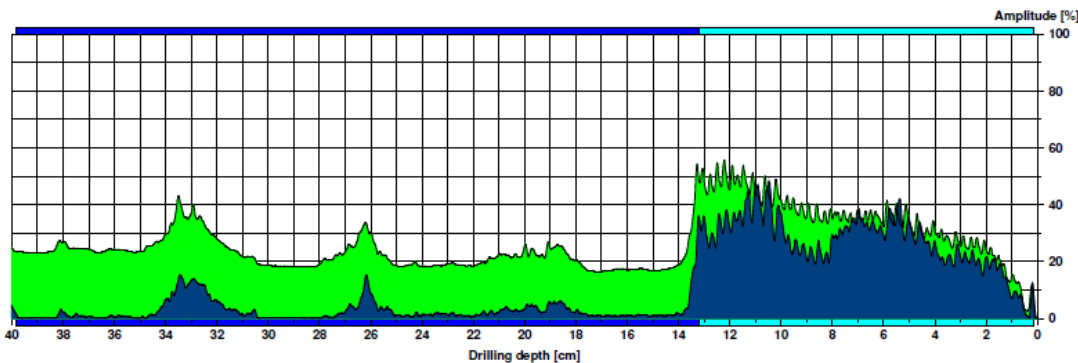
From	0,16 cm to	13,18 cm	: Good Wood
From	13,18 cm to	39,84 cm	: Decay
