PHOTO APPENDIX

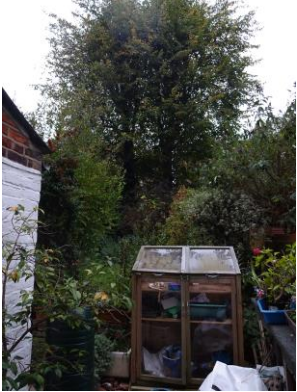
Lime trees in the rear garden
 	Crack damage above the ground floor right hand window.

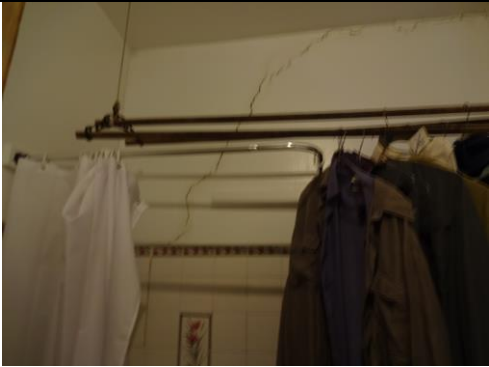
Crack damage on the cross wall between the bathroom and rear right hand bedroom.

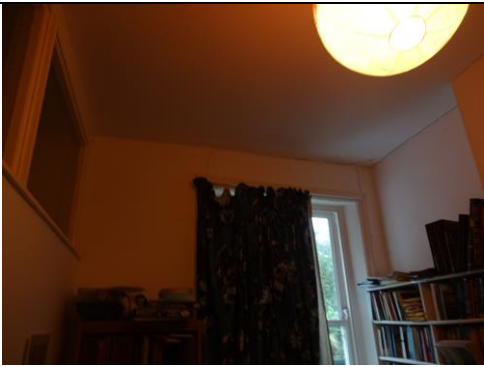
Cracking on the rear wall and ceiling line adjacent to the rear window – rear right hand bedroom
