Site Investigation Report

63 Parliament Hill, London, NW3 2TB

85688.1.USI

Overview

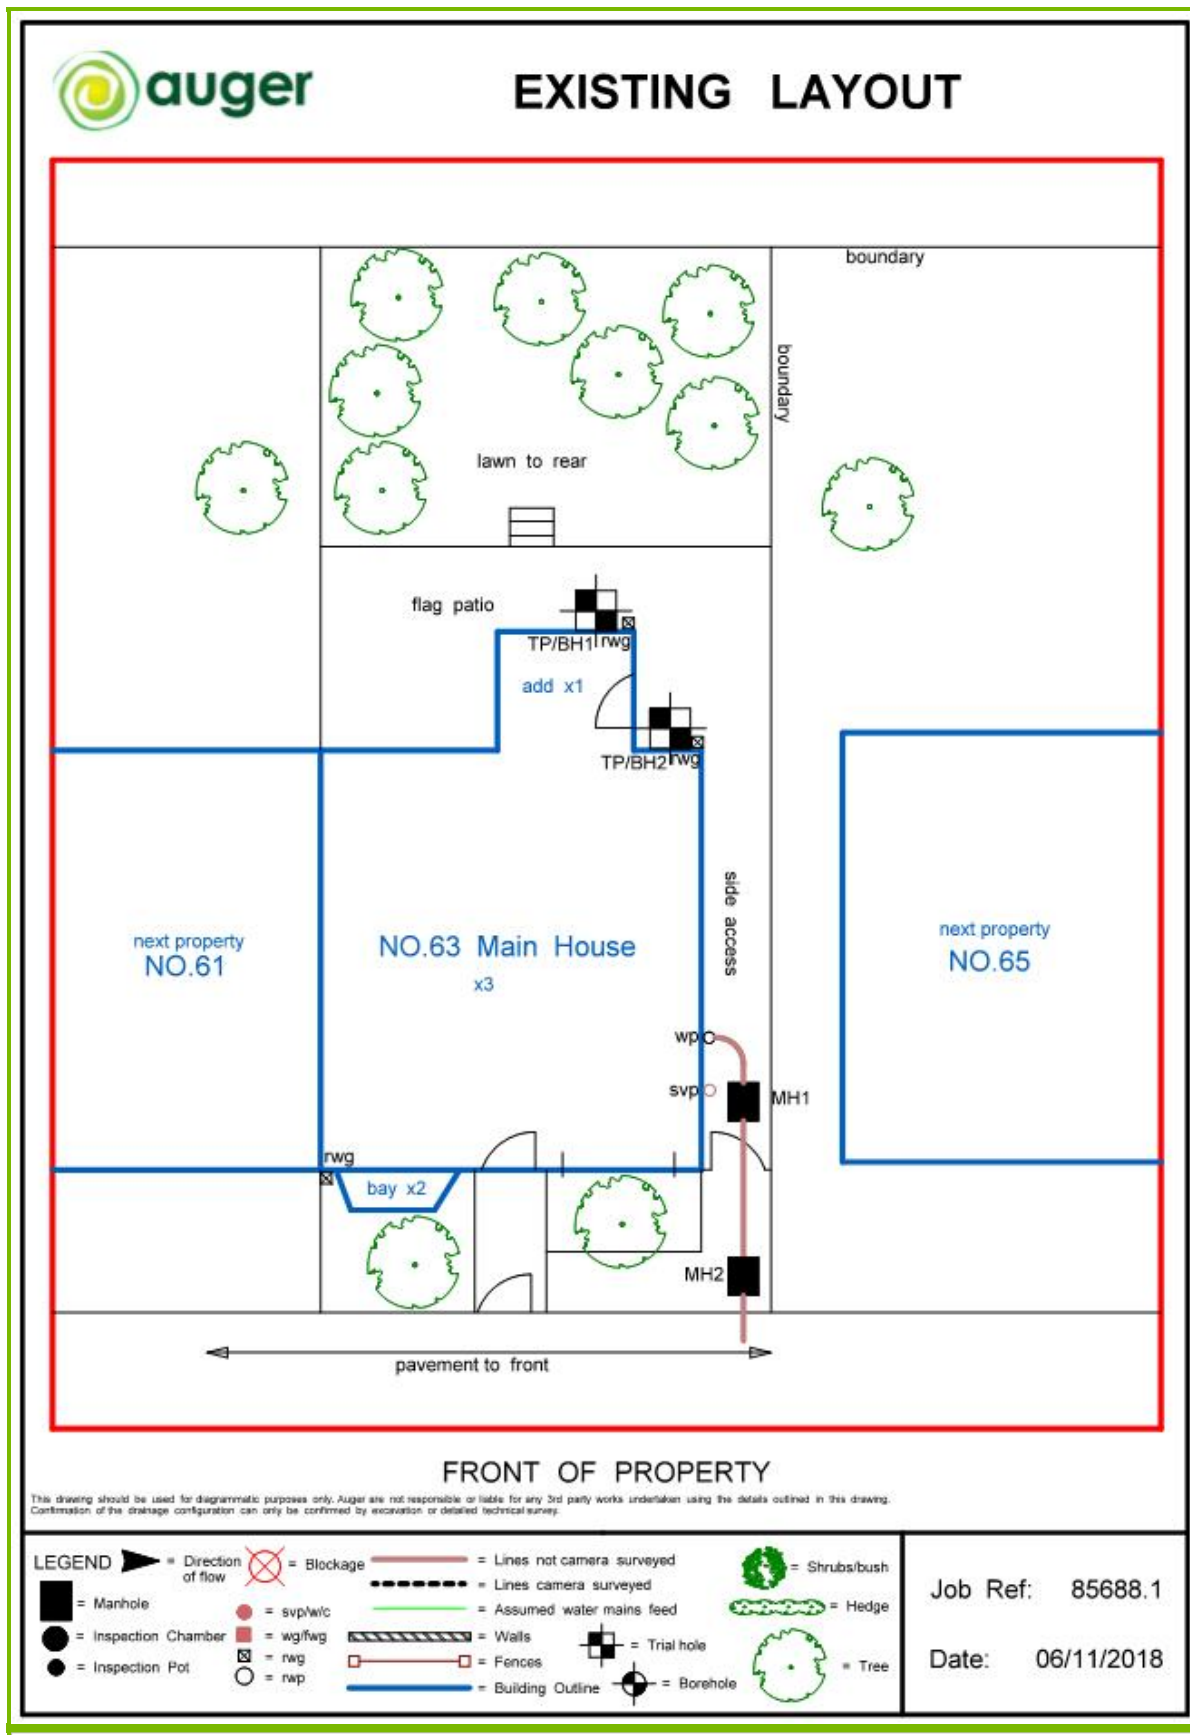
<p>Risk Address : 63 Parliament Hill London NW3 2TB</p> <p>Insured : Anne Elton</p> <p>Date Drawn : 06/11/18</p>	<div style="text-align: right;"> </div> <p style="text-align: right;">Drawn By : D. C.</p> <p style="text-align: right;">Job No : 85688.01</p>						
<p>Trial Hole Log No. 1 Location : REAR OF OUTRIGGER</p> <p style="font-size: small;">Moist = Normal wetting condition of subsoil. MP = Mackintosh Probe (Blows per 100mm). SV() = Shear Vane (19mm or 33mm)</p>							
DEPTH METRES	SYMBOLIC LOG	STRATA DESCRIPTION	INSITU TESTS		Soil Sample	Root Sample	Water / Stability
Type	Result						
<div style="display: flex; align-items: center;"> <div style="flex: 1;"> <p>0.0</p><p>0.5</p><p>1.0</p><p>1.5</p><p>2.0</p><p>2.5</p><p>3.0</p><p>3.5</p> </div> </div>	<p>Ground Level</p> <p>Flagstones</p> <p>Brickwork</p> <p>Double Step</p> <p>Brown fine to coarse gravelly silty CLAY</p> <p>Brown silty CLAY</p> <p>Brown fine to medium gravelly silty CLAY</p> <p>TRIAL HOLE TERMINATED</p>	<p>SV(19)</p> <p>SV(19)</p> <p>SV(19)</p> <p>SV(19)</p> <p>SV(19)</p>	<p>110kpa</p> <p>150+kpa</p> <p>150+kpa</p> <p>150+kpa</p> <p>150+kpa</p>	<p>Soil @ 1m</p> <p>Soil @ 1.5m</p> <p>Soil @ 2m</p> <p>Soil @ 2.5m</p> <p>Soil @ 3m</p>	<p>Root @ 1m</p> <p>Root @ 1.5m</p> <p>Root @ 2m</p> <p></p> <p></p>	<p></p> <p></p> <p></p> <p></p> <p></p> <p></p>
