Holm Oak

49 Willow Rd. Hampstead. NW3 1TS. July 2020

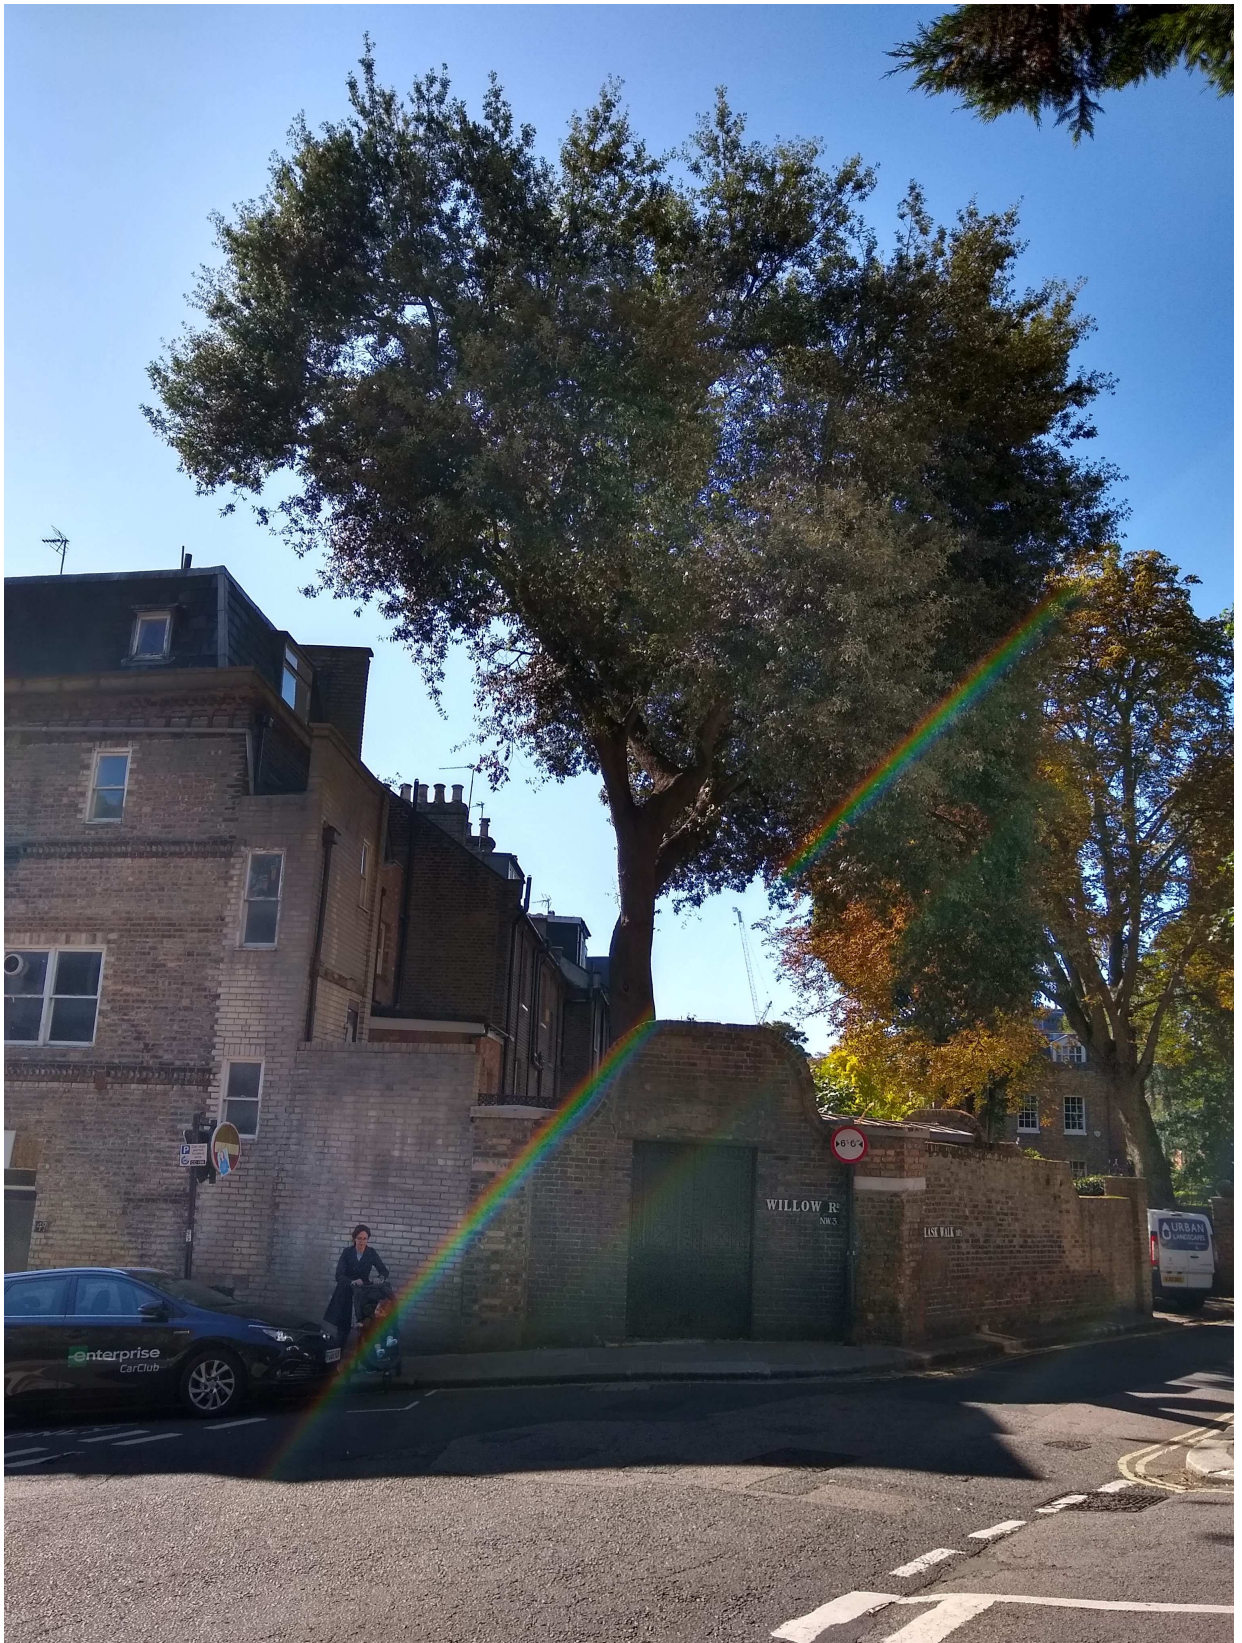
The tree is confined by built structures.
The stem diameter of the tree is circa 900mm.
The vast majority of its normative root protection area (as described in the BS) is paved or built over. However there is an area of permeable ground at the base of the tree.

The most recent substantial new building adjacent to the tree is the Gardnor House garage (planning reference P9601034).

The LPA would have taken consideration to table 1 of the then current 1991 BS5837. The application plans indicate that the Holm Oak was a substantial tree at the time of building the garage.

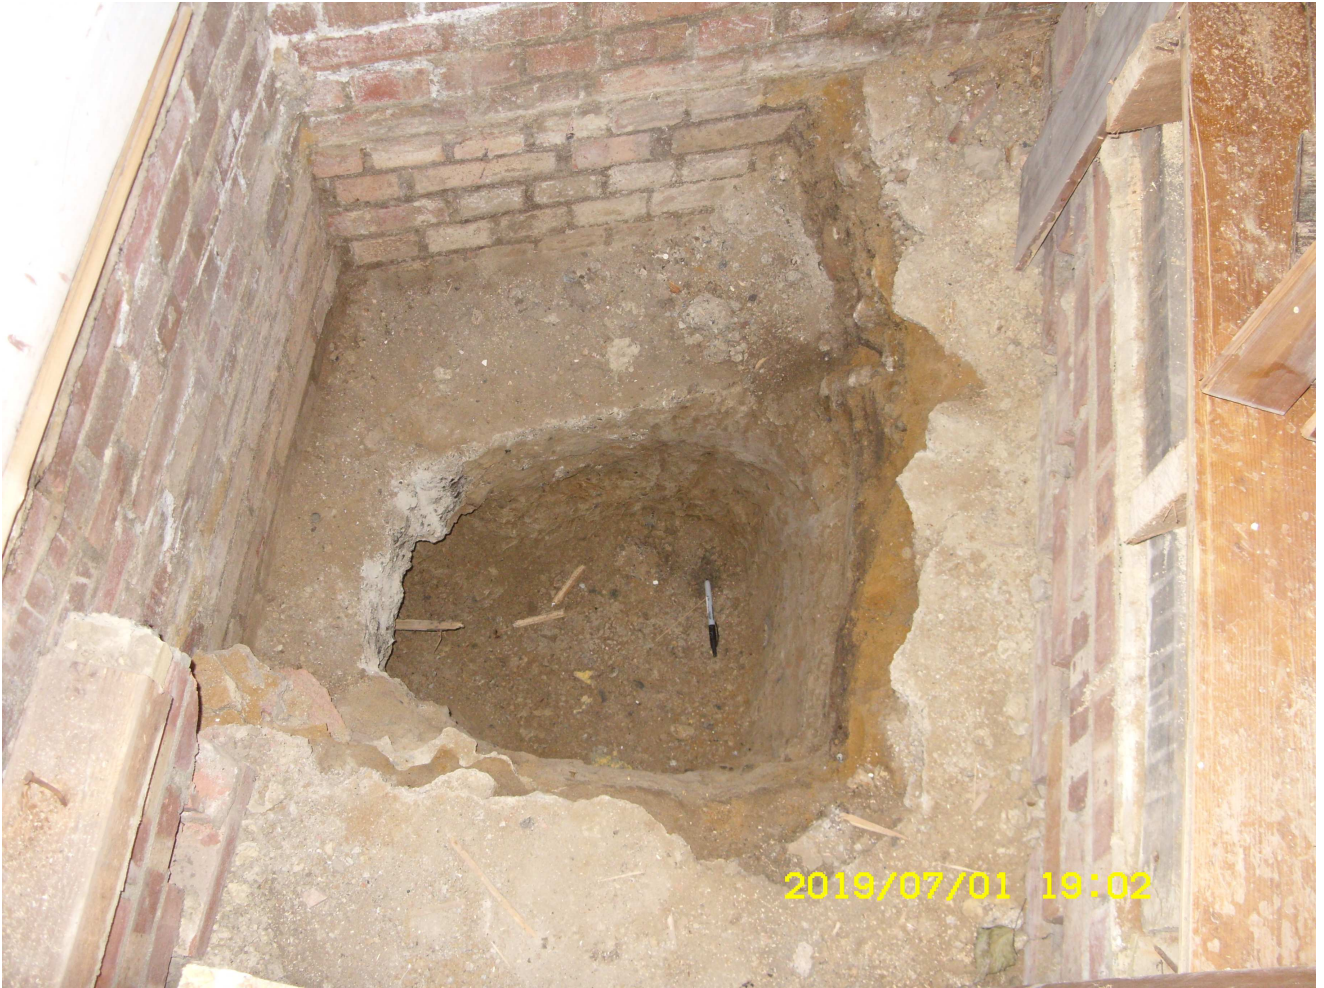
The above photograph shows more recent building at number 49 adjacent to the party wall (on the left).
The sub base adjacent to the foundations has all of the characteristics of a heavy clay.
The sub base is amorphous and is not a good material for Holm Oak roots.
The sub base is not waterlogged.
The sub base is not showing signs of shrinkage.

There is no evidence of the sub base being disturbed by human activity with the exception of the original foundation trench which must have been dug by hand all of those years ago.

Inspection pits have revealed that there are no Holm Oak roots within the sub base.

The conclusion is that the party wall is a continuous barrier to roots.

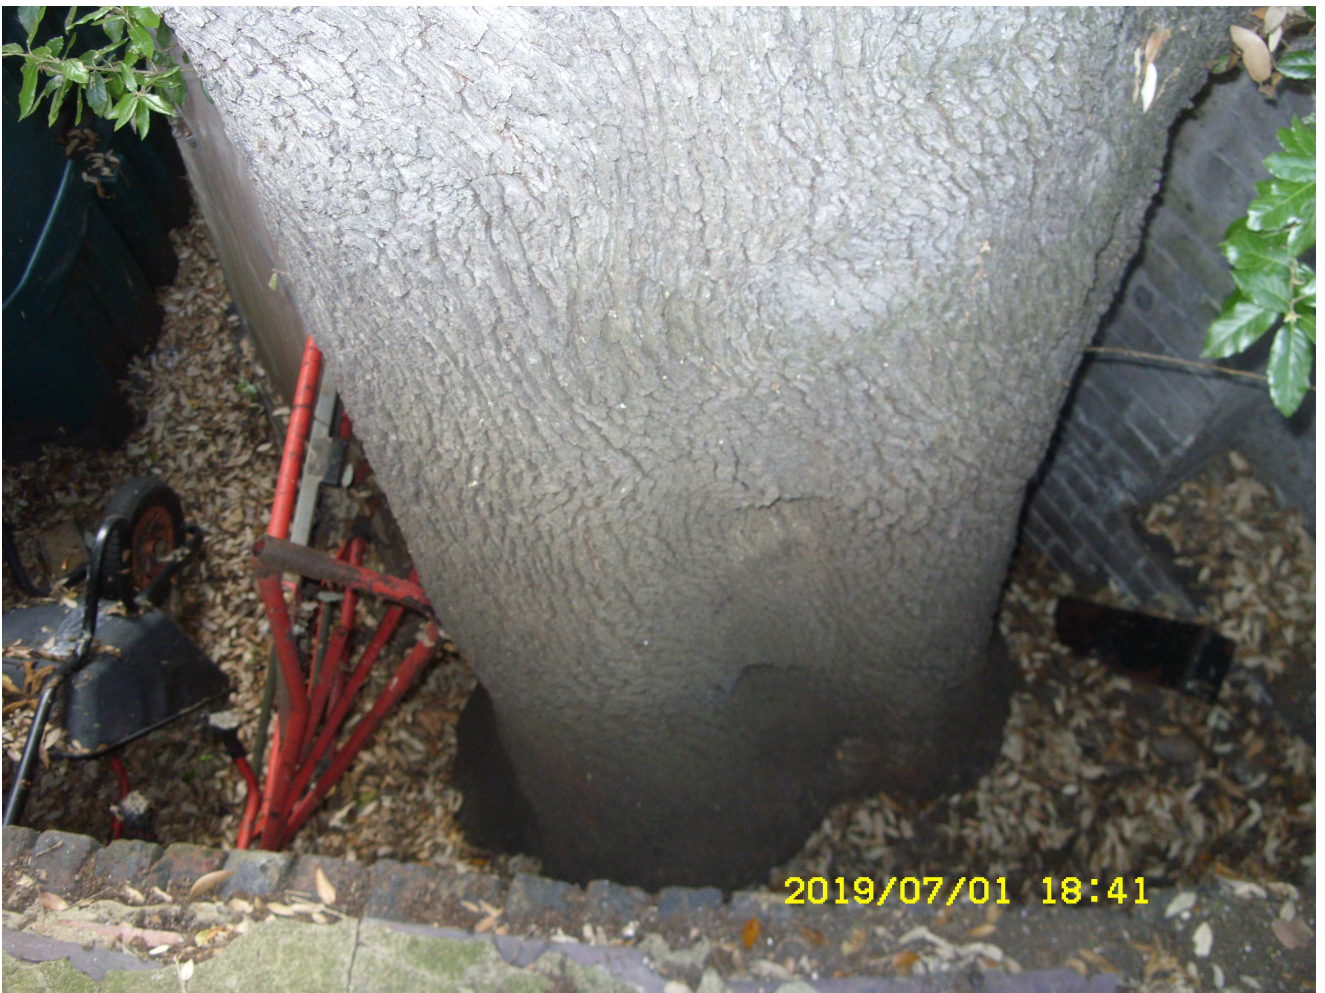
The Holm Oak is confined by built structures.
