**64 Lincolns Inn Fields, London**

## Structural Assessment Report

**Ref:** 190861/K Clark

**Date:** 10 Jul 2020

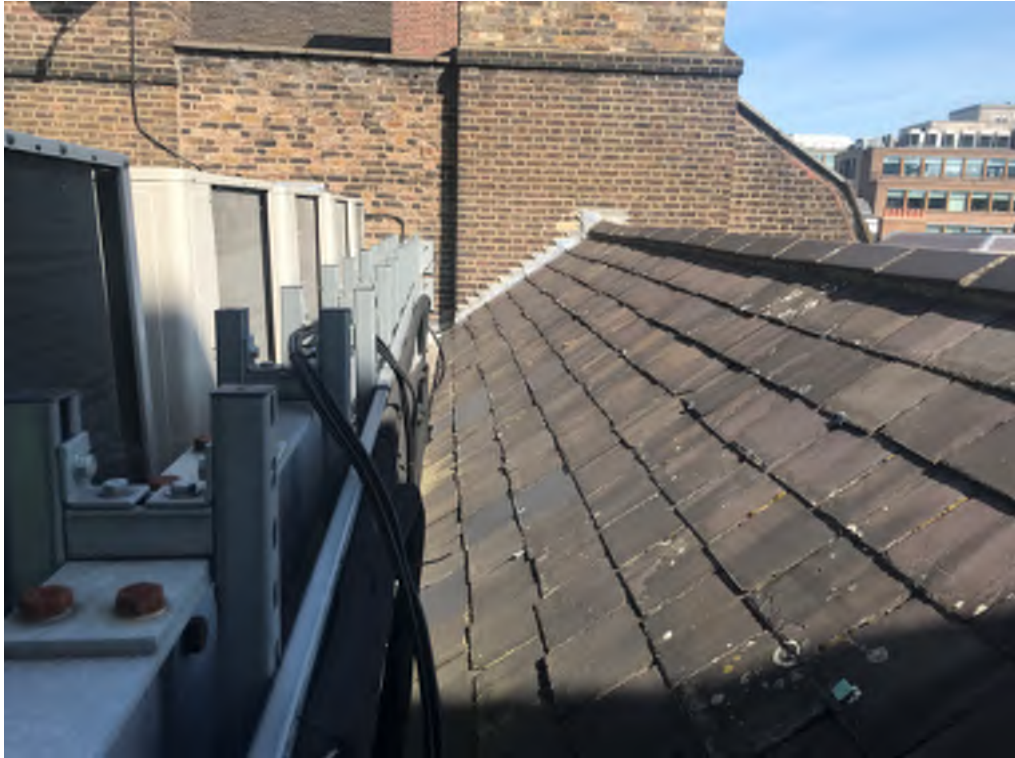
- 5.2.8 Each of the pitched roofs (Roofs 1, 3, 4 & 5) are traditionally finished with natural slates and lead flashings supported on timber battens on timber sarking boards. There are some cracked, slipped and otherwise defective slates and leadwork but these are relatively minor, so the existing slates, battens and sarking boards can and should be reused where possible. The flat roof above the lift overrun (Roof 2) is finished with asphalt laid on woodwool slabs spanning between the supporting blockwork walls of the lift shaft, while the flat roof by the south party wall (Roof 6) is finished with a continuous waterproof membrane (see photographs 3 to 6).

**Photograph 3:** Roof 1 view north

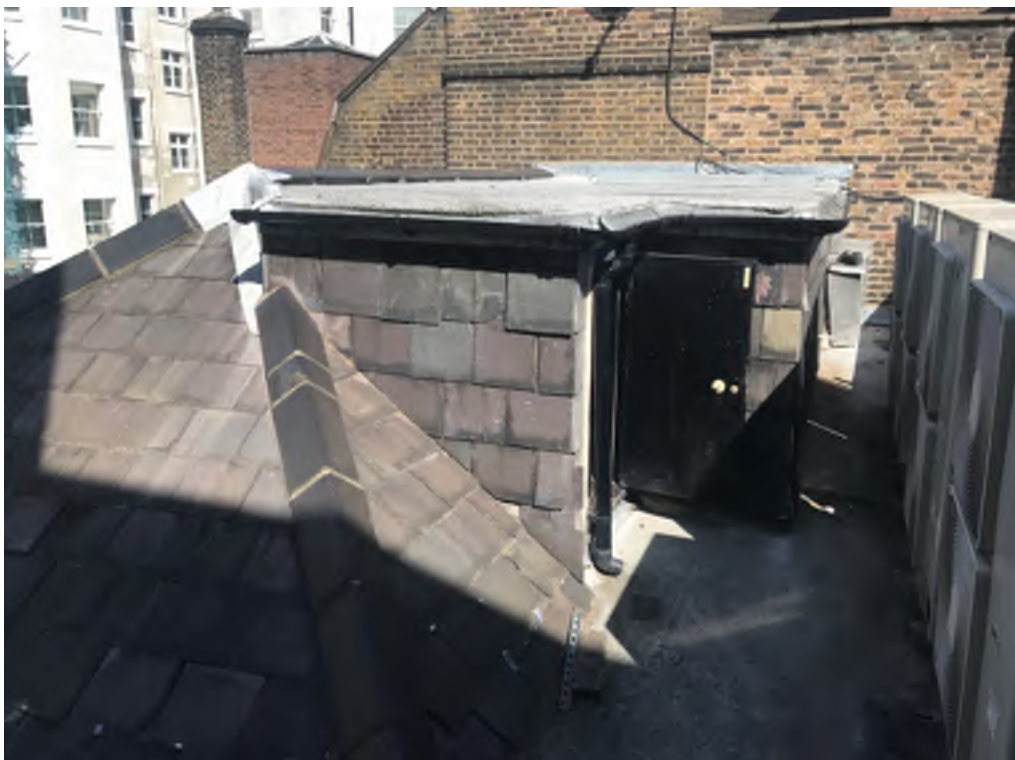
**Photograph 4:** Roofs 2 & 3 view north

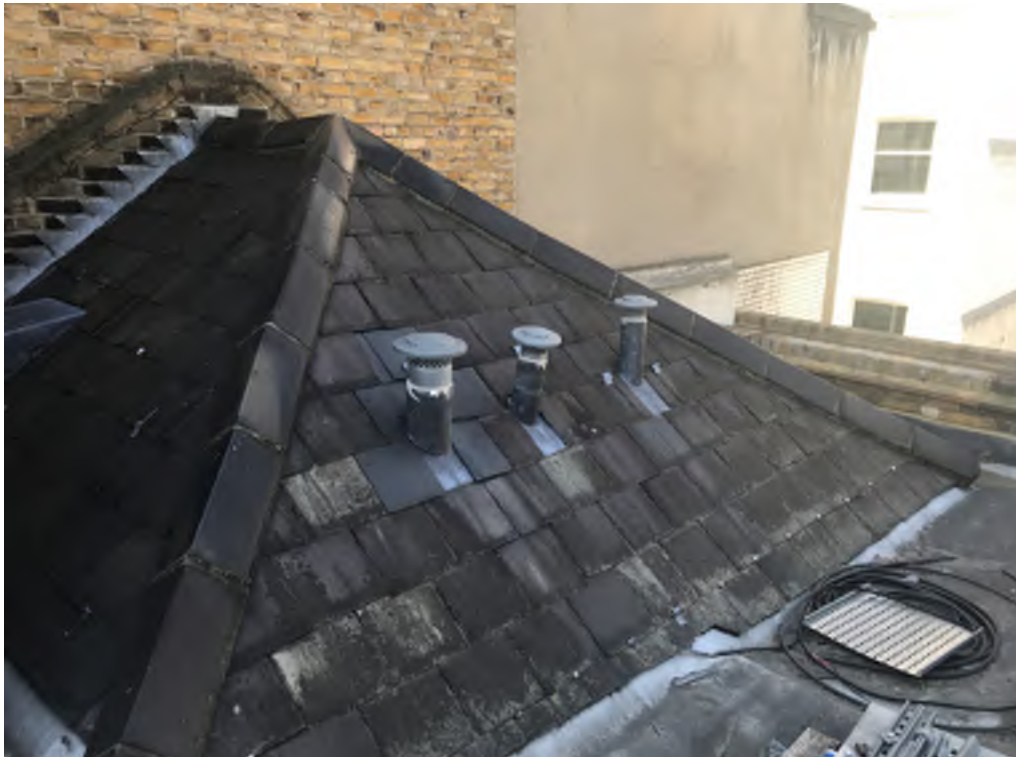
**Photograph 5:** Roof 4 view south west

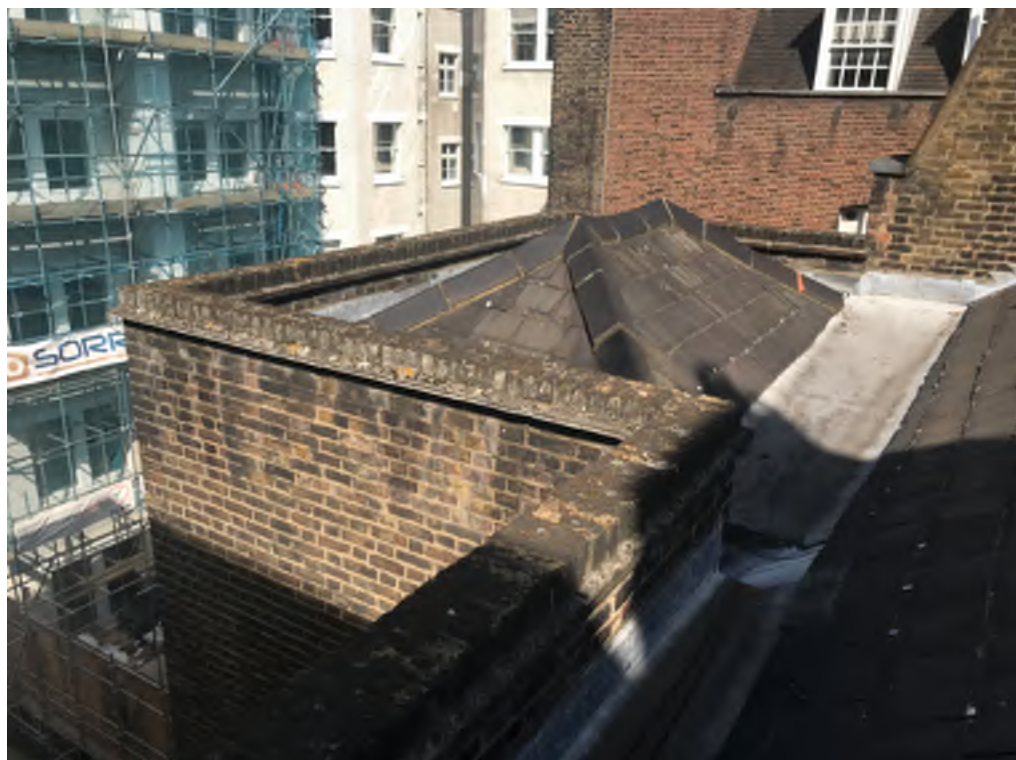
**Photograph 6:** Roof 5 view north west

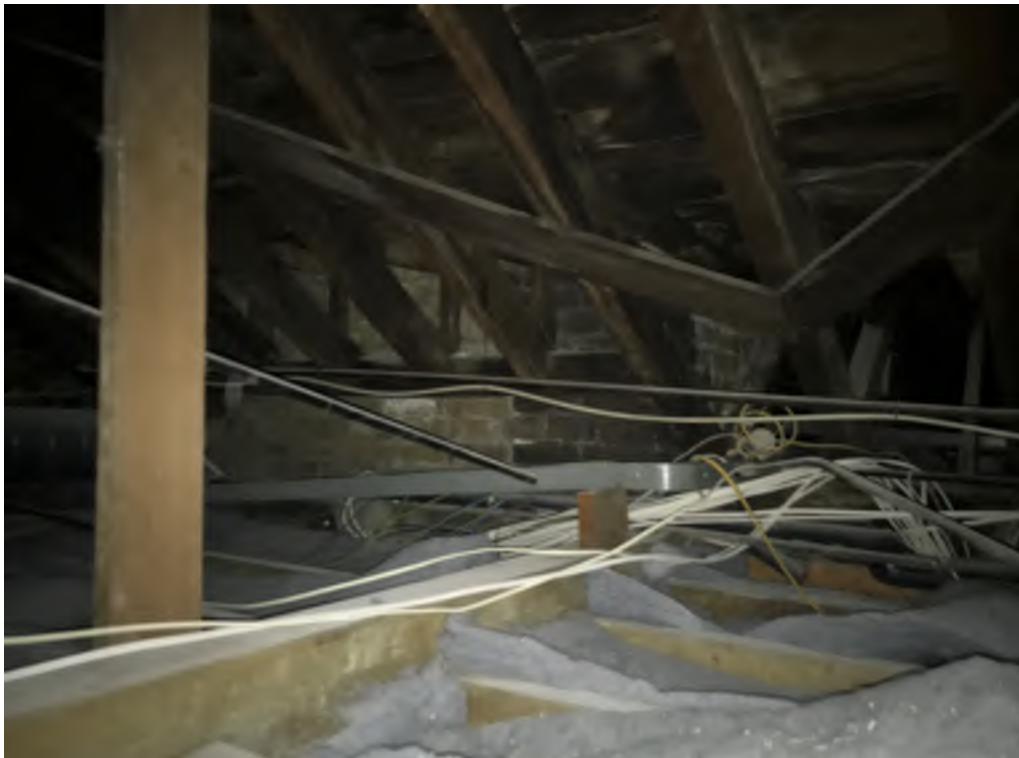
- 5.2.12 A large C19<sup>th</sup> chimney stack is located halfway along the south party wall which intervenes into Roof 1 (photograph 10). The roof structure is built around the stack where it passes through the roof void suggesting that the roof structure in this area post-dates the stack.

**Photograph 10:** Roof 1 view south west

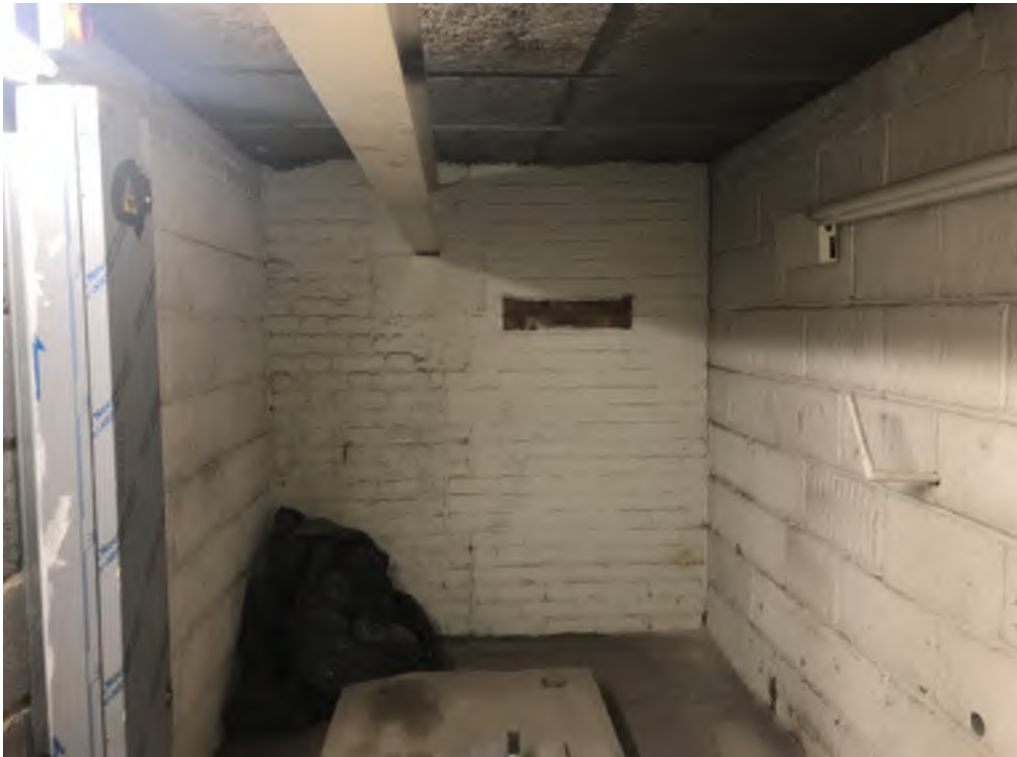
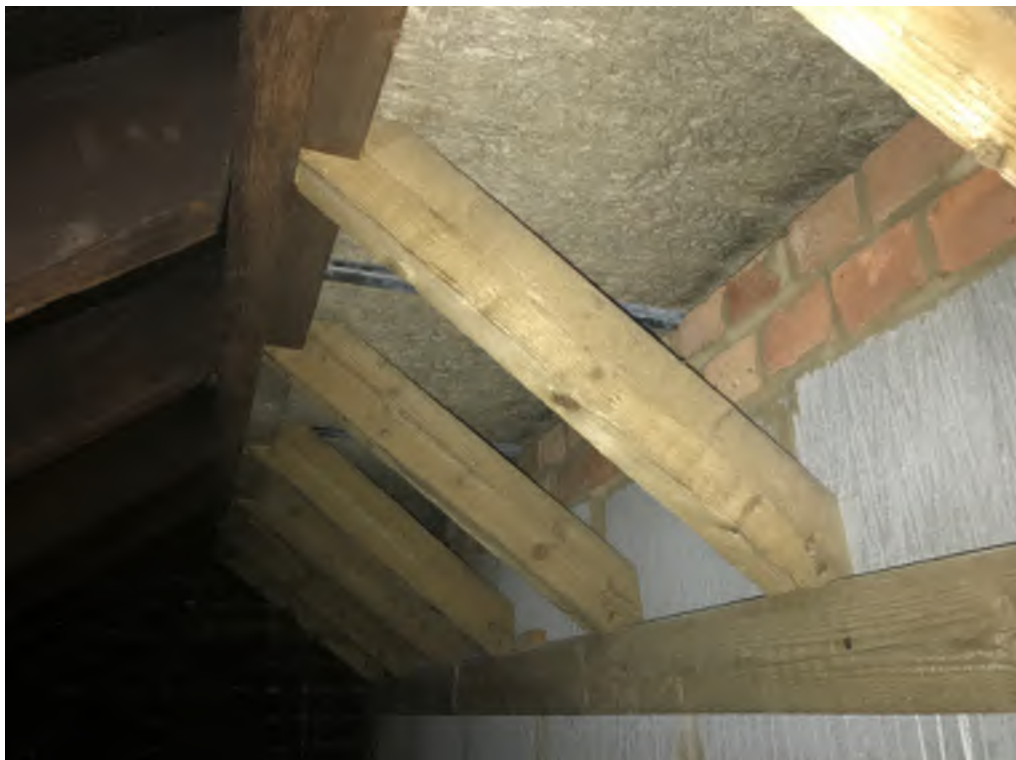
- 5.2.13 Roof 2 was built in the 1970s to accommodate the lift overrun (photographs 11 & 12) and would have originally comprised common rafters in a corresponding arrangement to that remaining at the rear pitch of Roof 3. There is some evidence to suggest that prior to these alterations collar ties or straining beams were present in a similar arrangement to that seen in Roof 1.

**Photograph 11:** Roof 2 view north

**Photograph 12:** Roof 2 view north

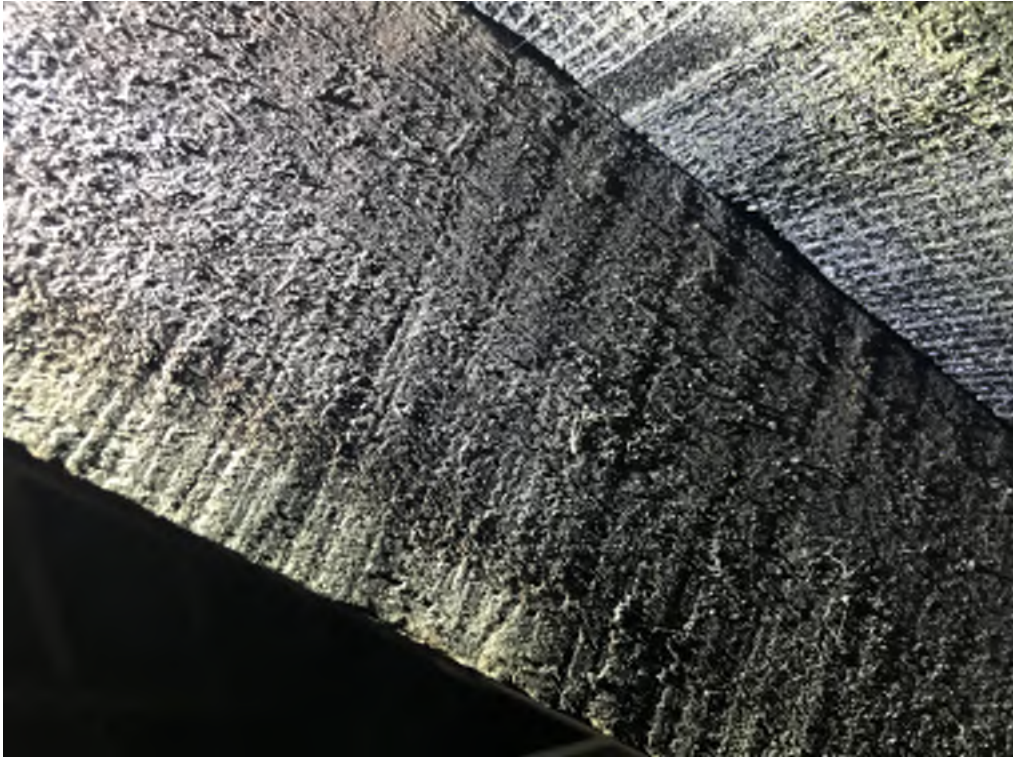
- 5.2.16 This inspection revealed that the common rafters are a mixture of machine sawn early- to mid-C19<sup>th</sup> timbers (displaying distinctive regularly spaced straight or curved lines characteristic of bandsawn or circular sawn timber) and hand worked timbers from the late C18<sup>th</sup> or possibly earlier (displaying randomly distributed axe or adze marks).

**Photograph 17:** Roof 3 rafter detail showing machine formed cutting marks

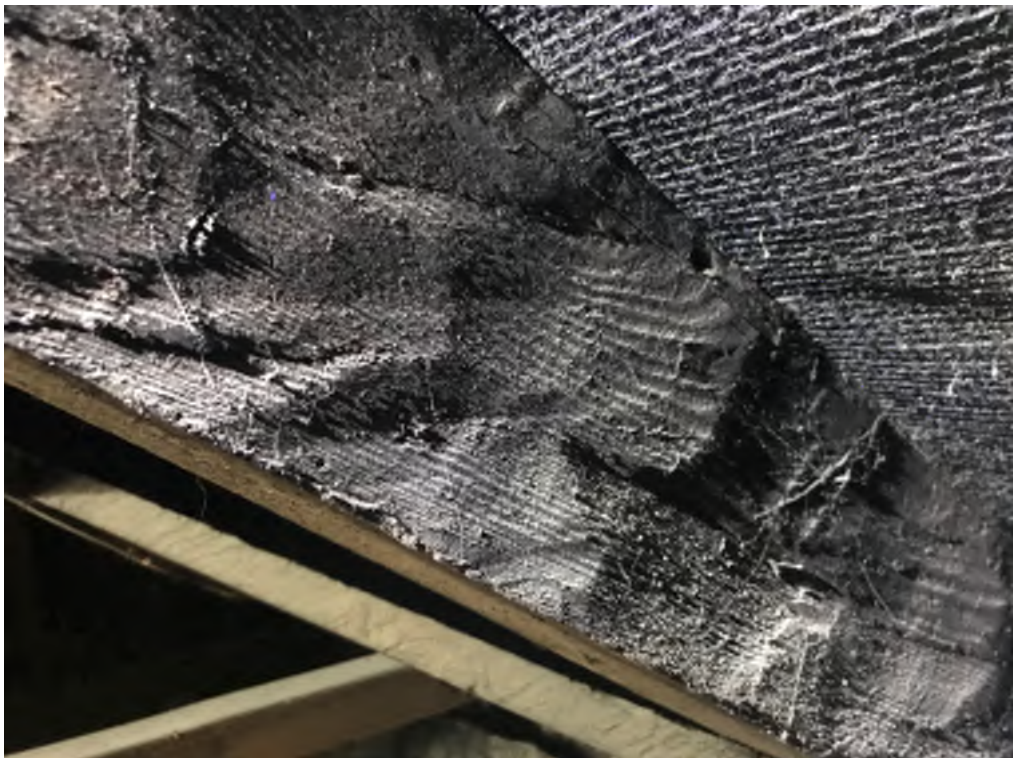
**Photograph 18:** Roof 3 rafter detail showing hand formed cutting marks

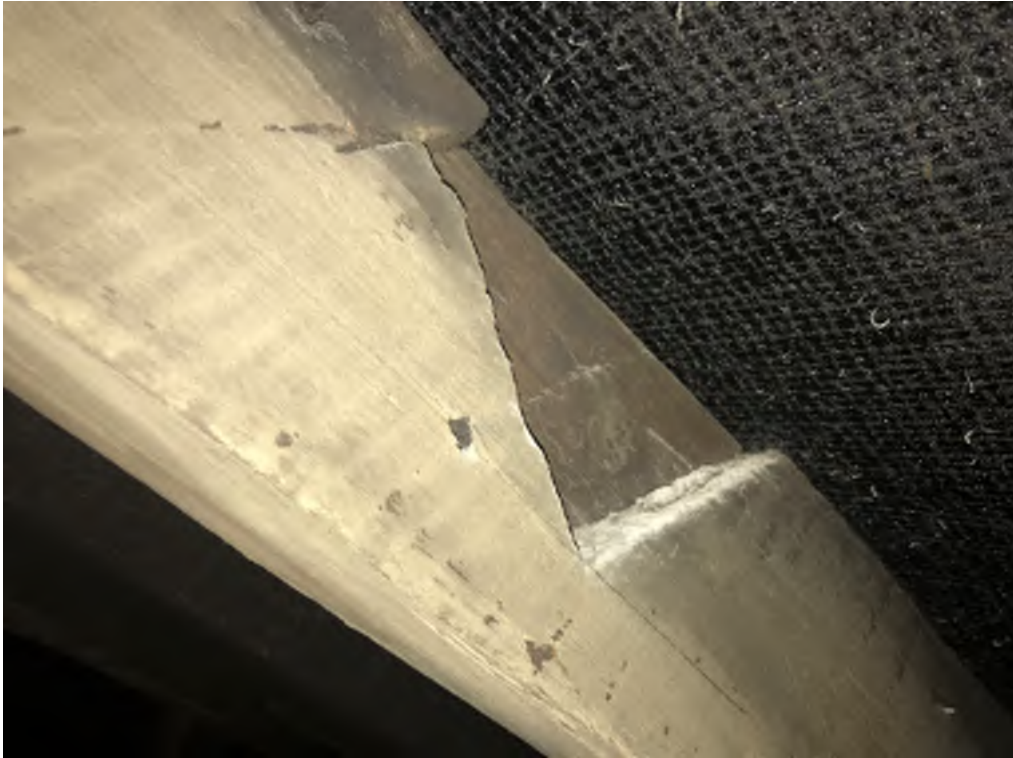
- 5.2.17 The timbers in Roof 3 and in the remaining roofs inspected are predominantly (approximately 90%) machine sawn C19<sup>th</sup> material. The as found position of the late C18<sup>th</sup> rafters reveals little about the previous form of the roof but their inclusion together with many more rafters of a much later date suggests they derive from re-used cut down elements from a previous roof or floor configuration within No. 64, or possibly from another building altogether.

**Photograph 19:** Roof 3 rafter detail showing reused common rafter

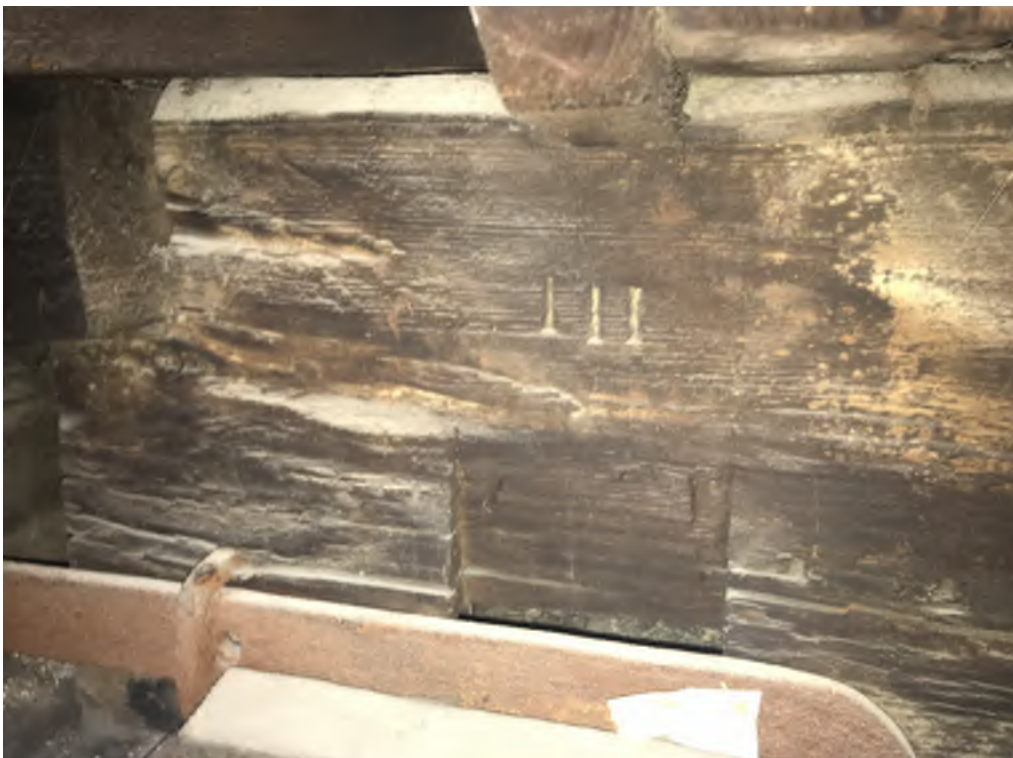
- 5.2.18 The larger timbers also possess carpenters' assembly marks in Roman numeral format (photograph 20) which were most commonly used before the mid-C19<sup>th</sup>. The primary beams also contain several unused mortices in a configuration suggestive of reuse (photograph 19), either from one of the previous roof configurations or possibly from elsewhere off site.

**Photograph 20:** Roof 3 primary beam detail showing carpenters' assembly mark

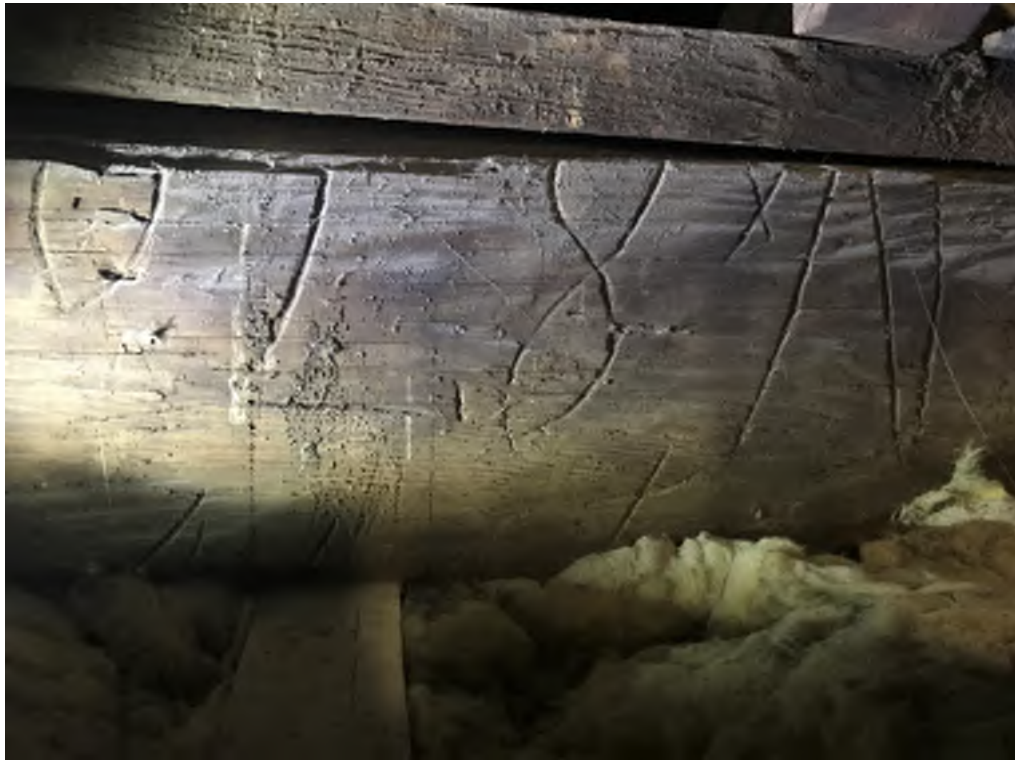
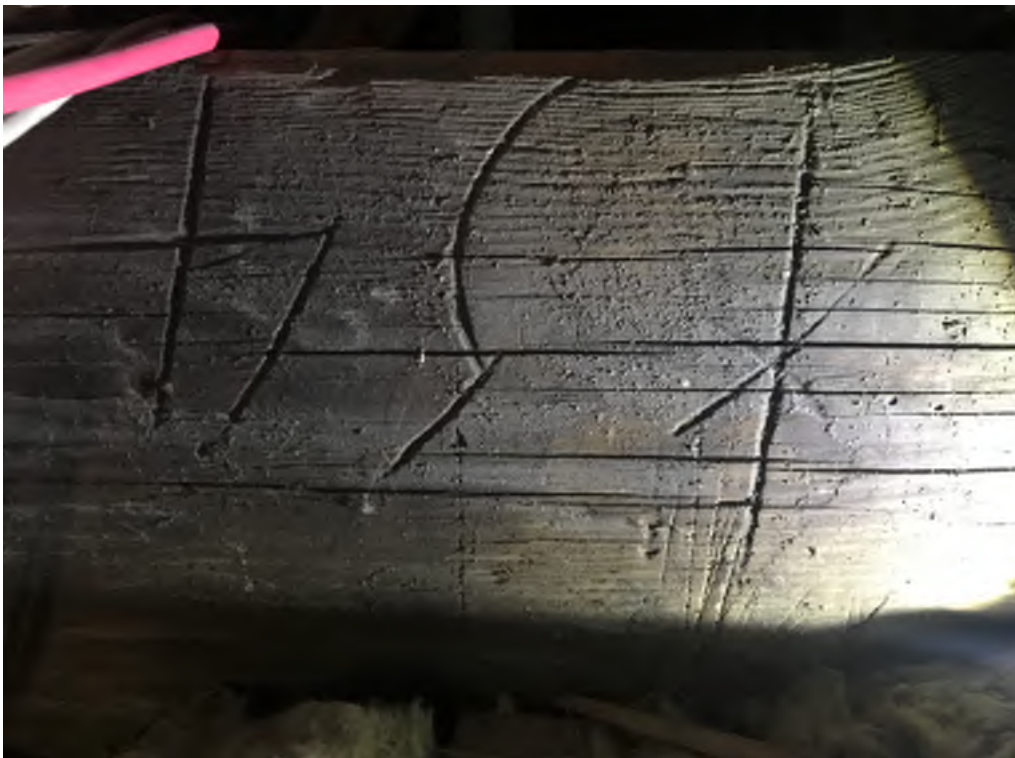
- 5.2.19 Close inspection also revealed that some of the larger timbers are inscribed with shipping marks (photographs 21 & 22), and reference to recent research indicates that these marks confirm that the timbers were sourced from eastern Europe and exported to London via the port of Danzig (now Gdańsk) as part of the Baltic pine trade that began in the 1820s and boomed in the 1850s. The marks are corroborated by confirmation of the species as pine.

**Photograph 21:** Roof 3 primary beam detail showing shipping marks

**Photograph 22:** Roof 3 primary beam detail showing shipping marks

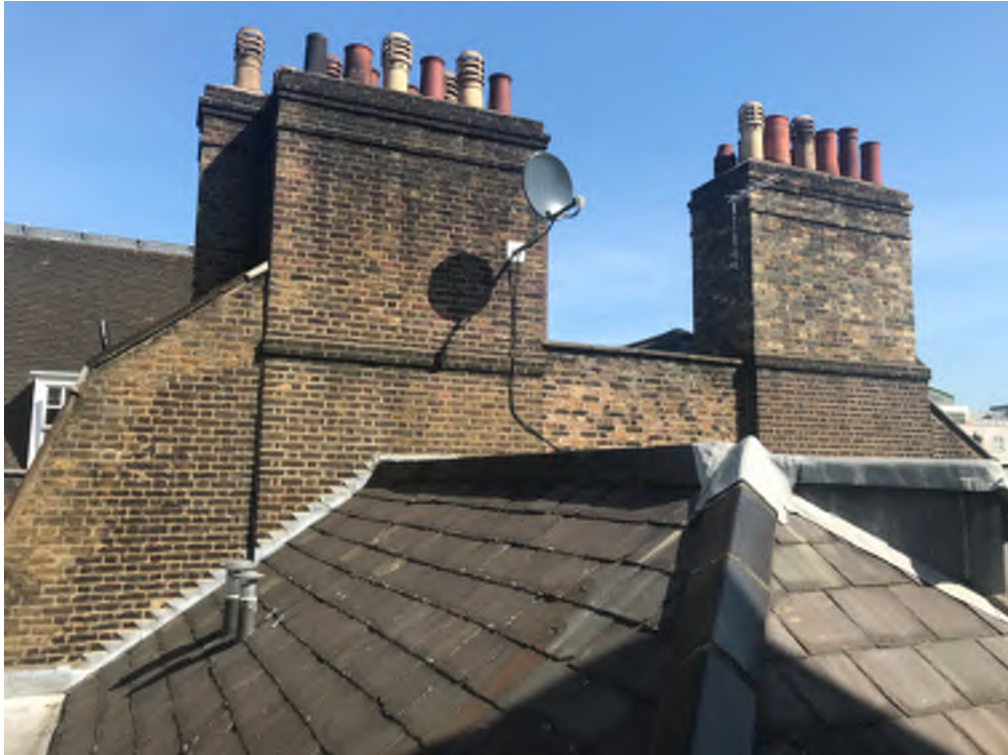
**Photograph 25:** North party wall showing sequential construction

- 5.2.24 The brickwork party walls display evidence of previous alterations and additions (photograph 25). Both of the chimney stacks at the north party wall appear to have been extended vertically at some stage in their life, most likely in the late C19<sup>th</sup> to accommodate major alterations to the previous roof structure. The wall between these two stacks has also been remodelled and is an infill of much later date.

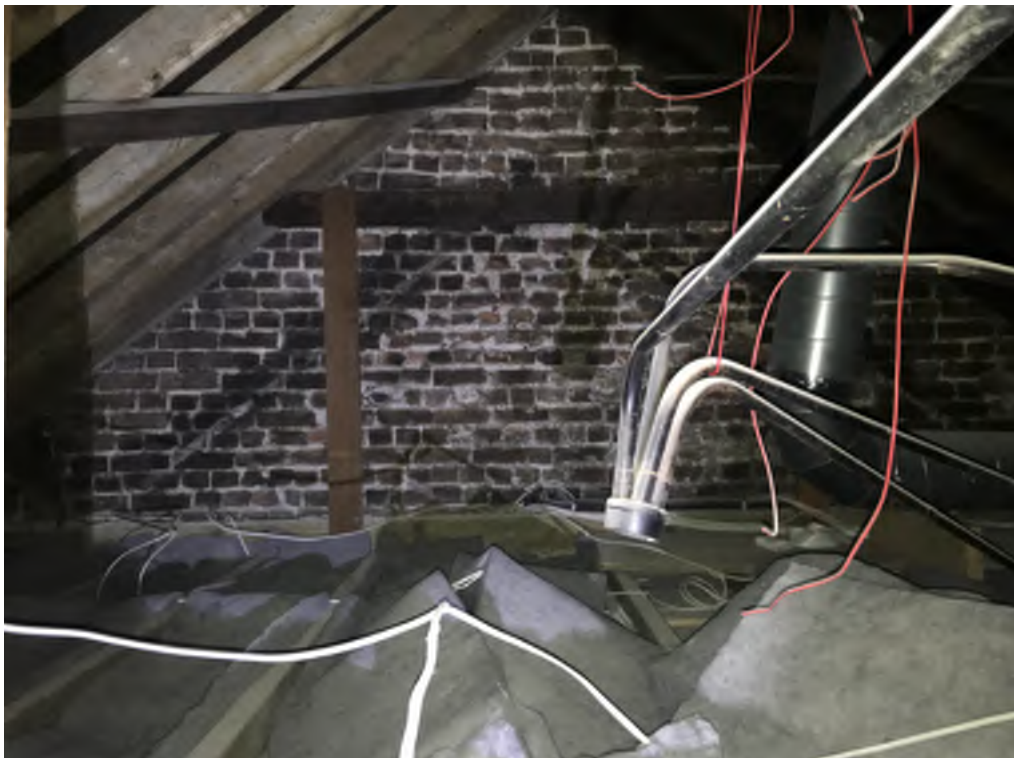
**Photograph 26:** Roof 1 south party wall showing previous duo-pitched roof profile

- 5.2.27 There is a clear visible profile of a previous duo-pitched roof on the south and north party walls in Roofs 1 and 3 respectively (photographs 26 and 28). Curiously there is no corresponding roof profile on the opposing north party wall in Roof 1 (photograph 27) which suggests that this wall has been subsequently reconstructed, thereby removing any evidence of the previous roof profile in this area.

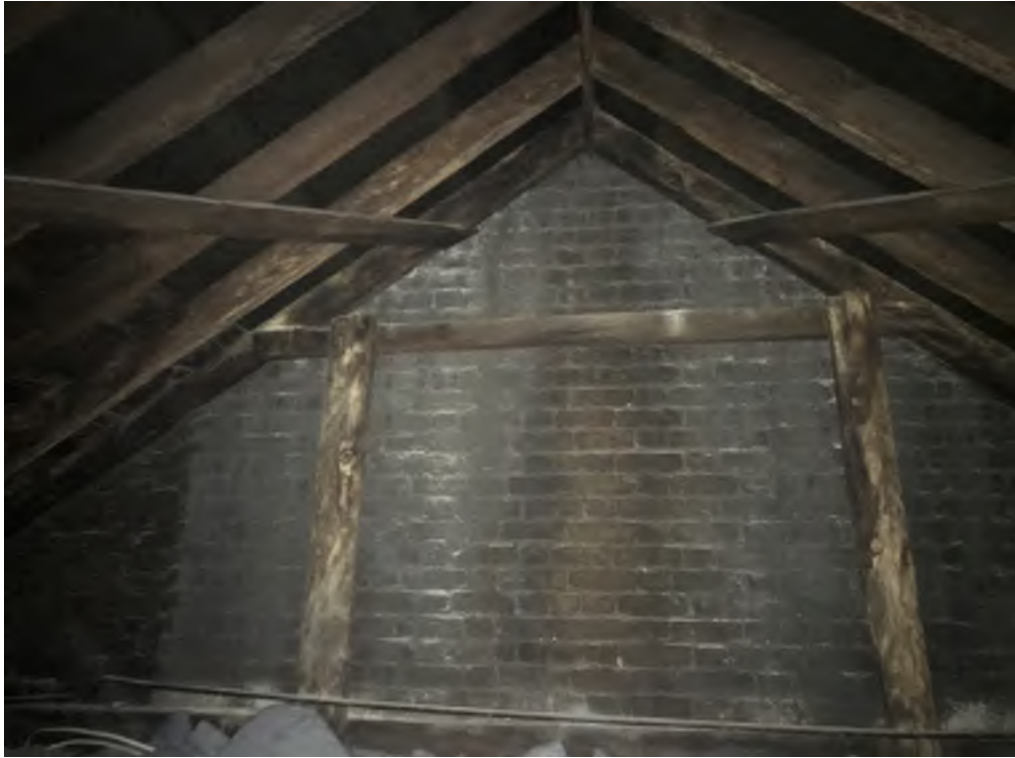
**Photograph 27:** Roof 1 north party wall with no evidence of previous roof profile

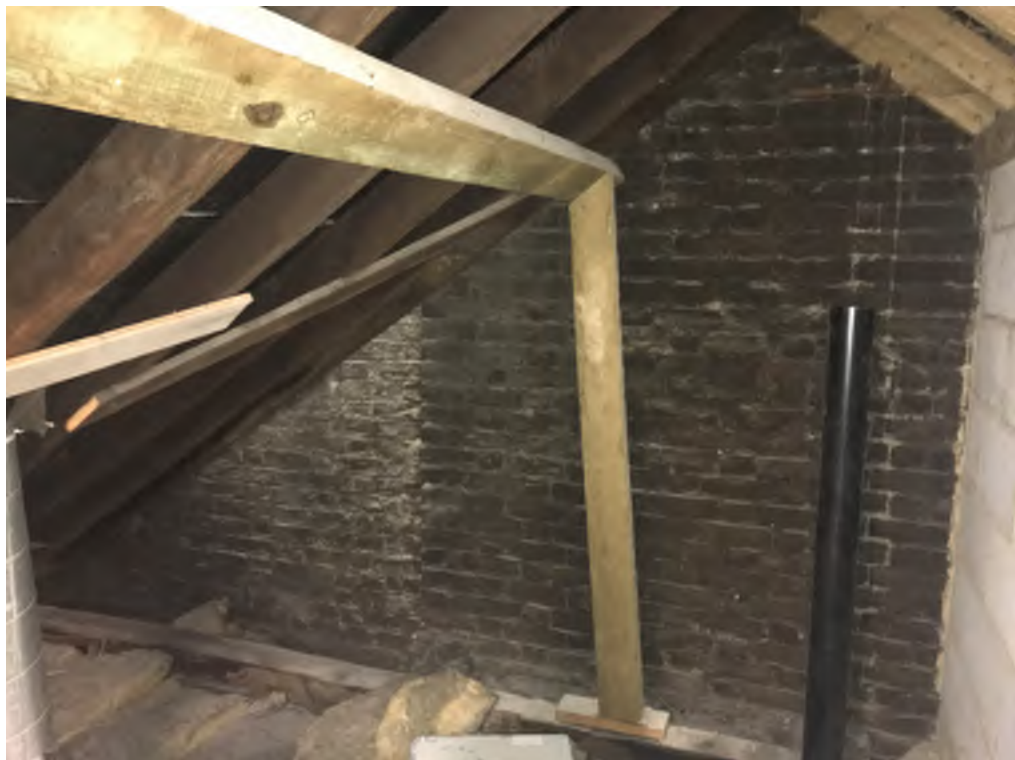
**Photograph 28:** Roof 3 north party wall showing previous duo-pitched roof profile
