Godwin & Crowndale Estate

Arboricultural Survey and Impact Assessment

Report for London Borough of Camden

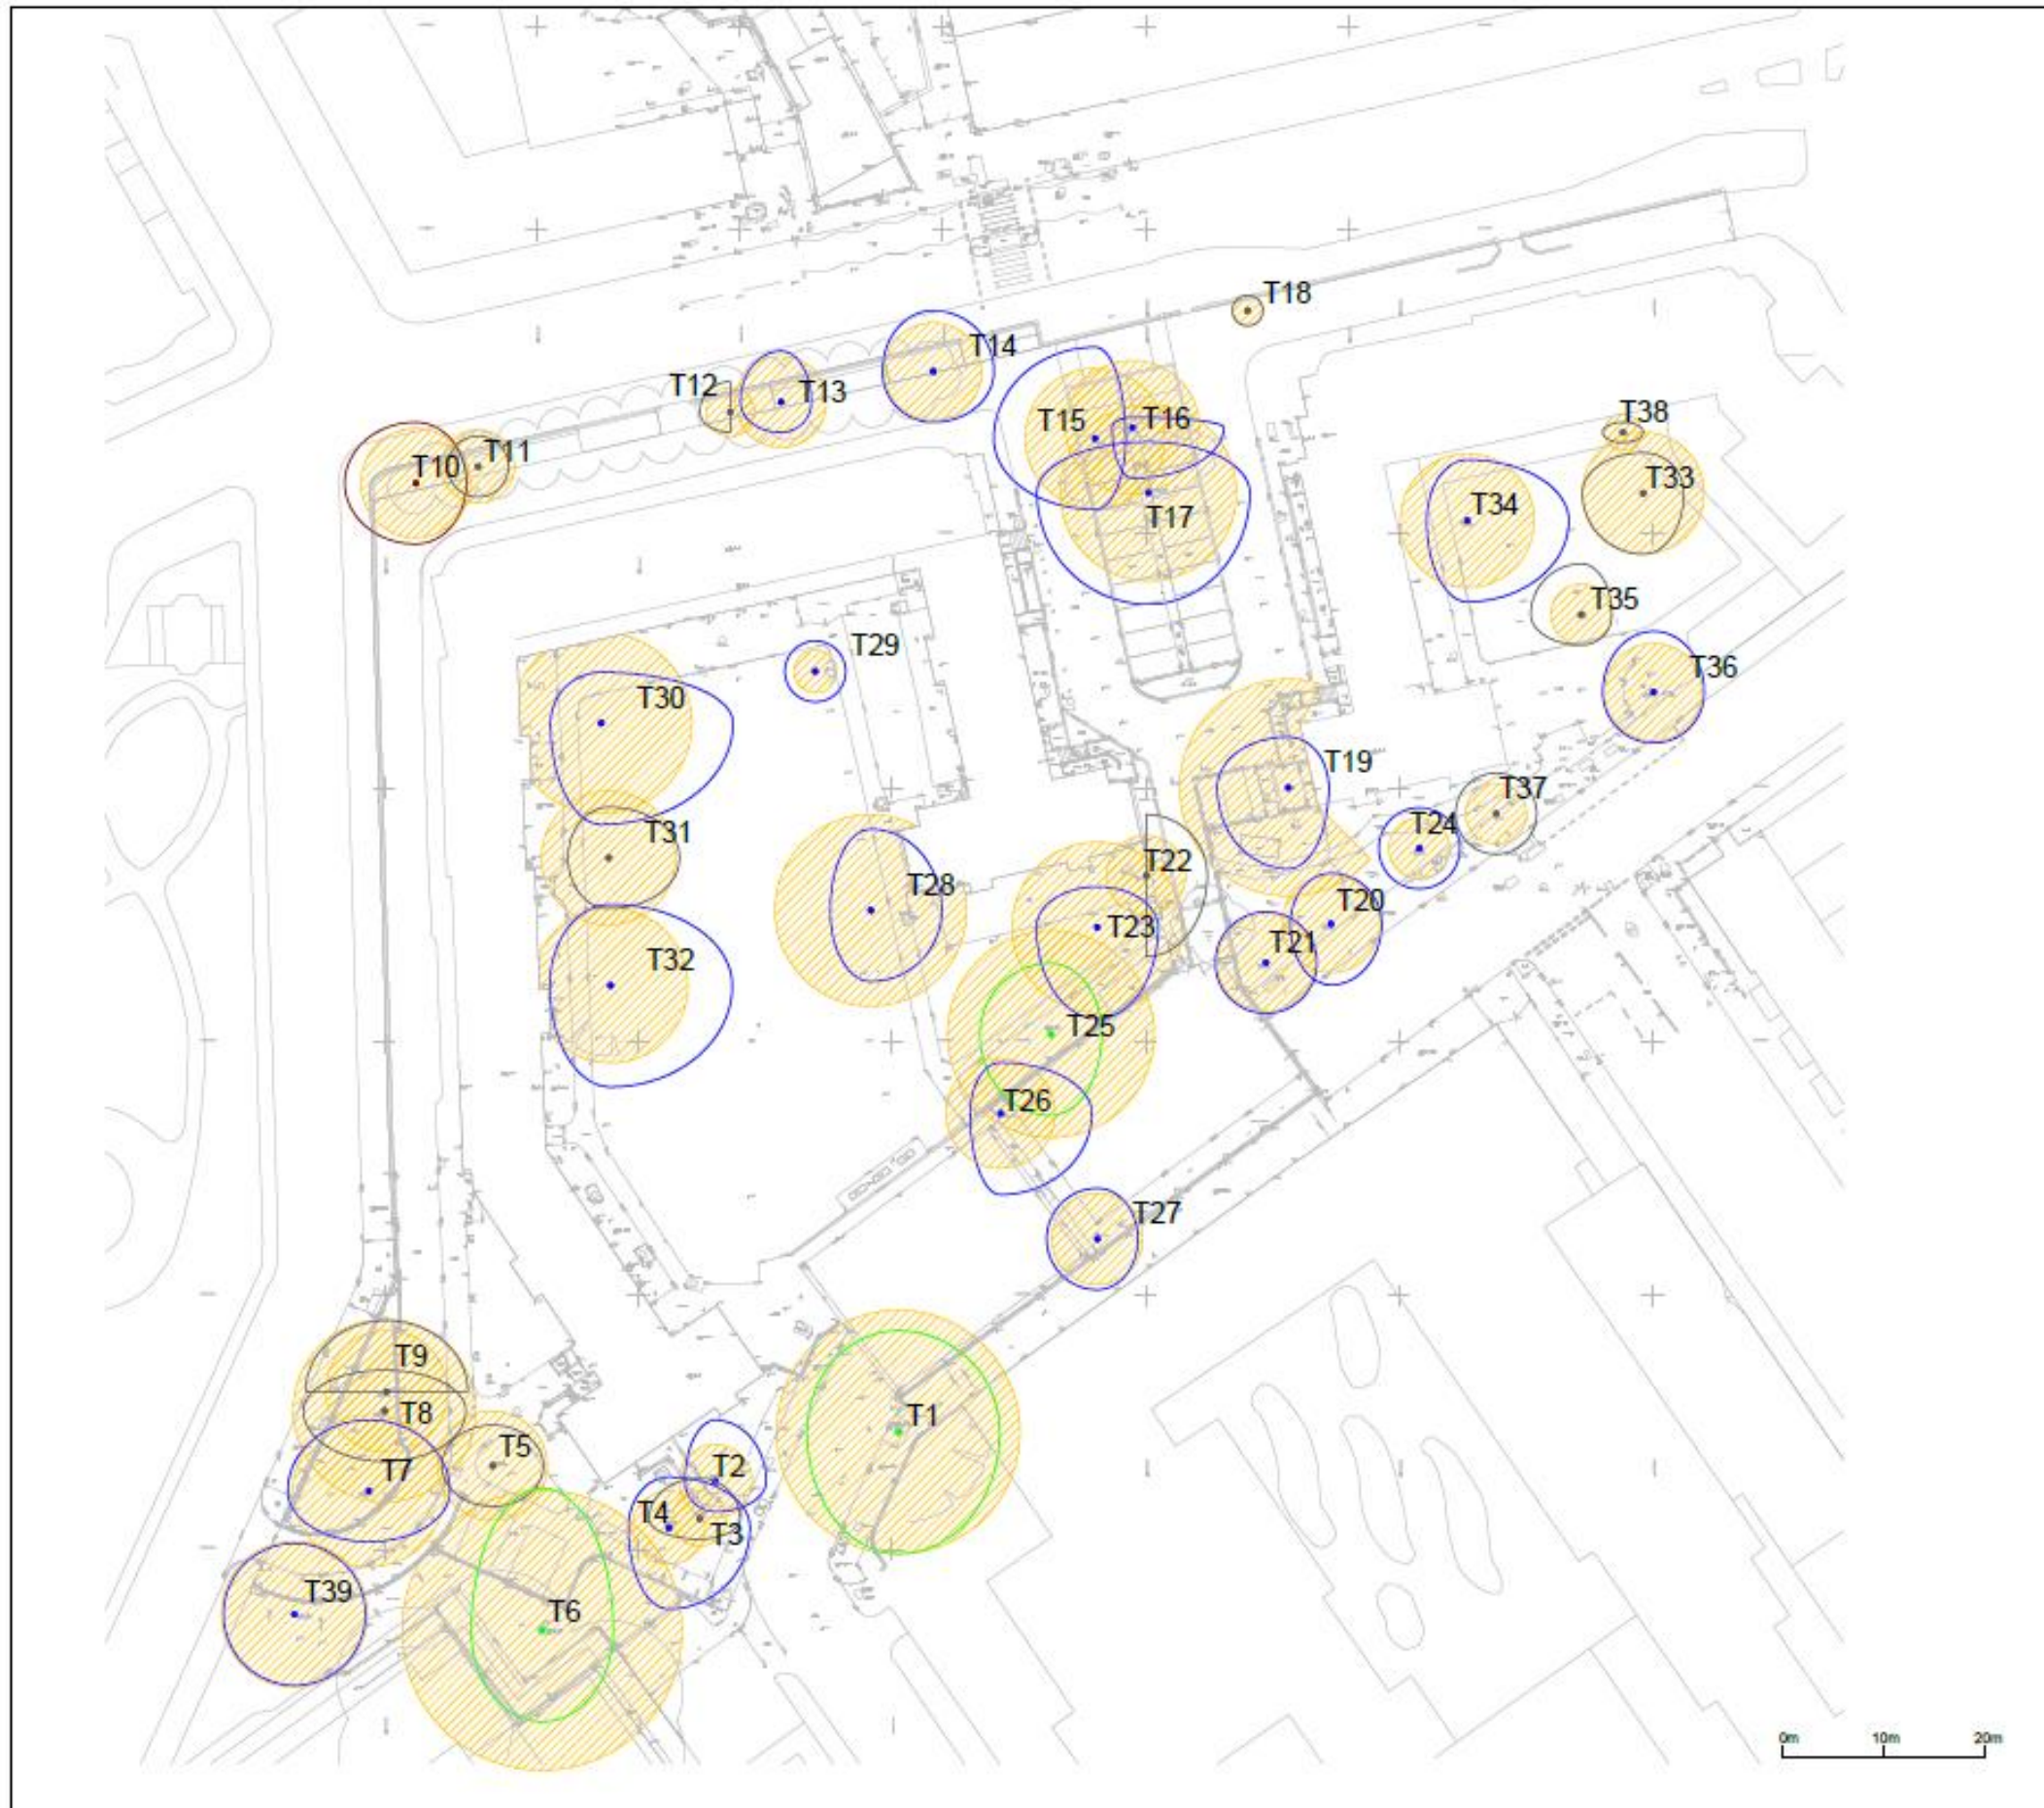
Appendix 2: Tree Constraints Plan

RPA Incursion (Building Foundation)
 -

RPA Incursion (Hardstanding)
