**NOS 2 - 4 CUMBERLAND PLACE
REGENTS PARK, LONDON NW1**

CONTENTS		PAGE
1	INTRODUCTION	1
	a) Location	
	b) Brief Description	
2	HISTORIC REPORT	3
	a) Historic details and listing	
	b) Summary of items of special historic note	
3	BRIEF REPORT UPON PRESENT CONDITION AND PROPOSALS	7
	a) Exterior	
	b) Interior

Project Title: Nos. 2-4 Cumberland Place, Regents Park Report no: —

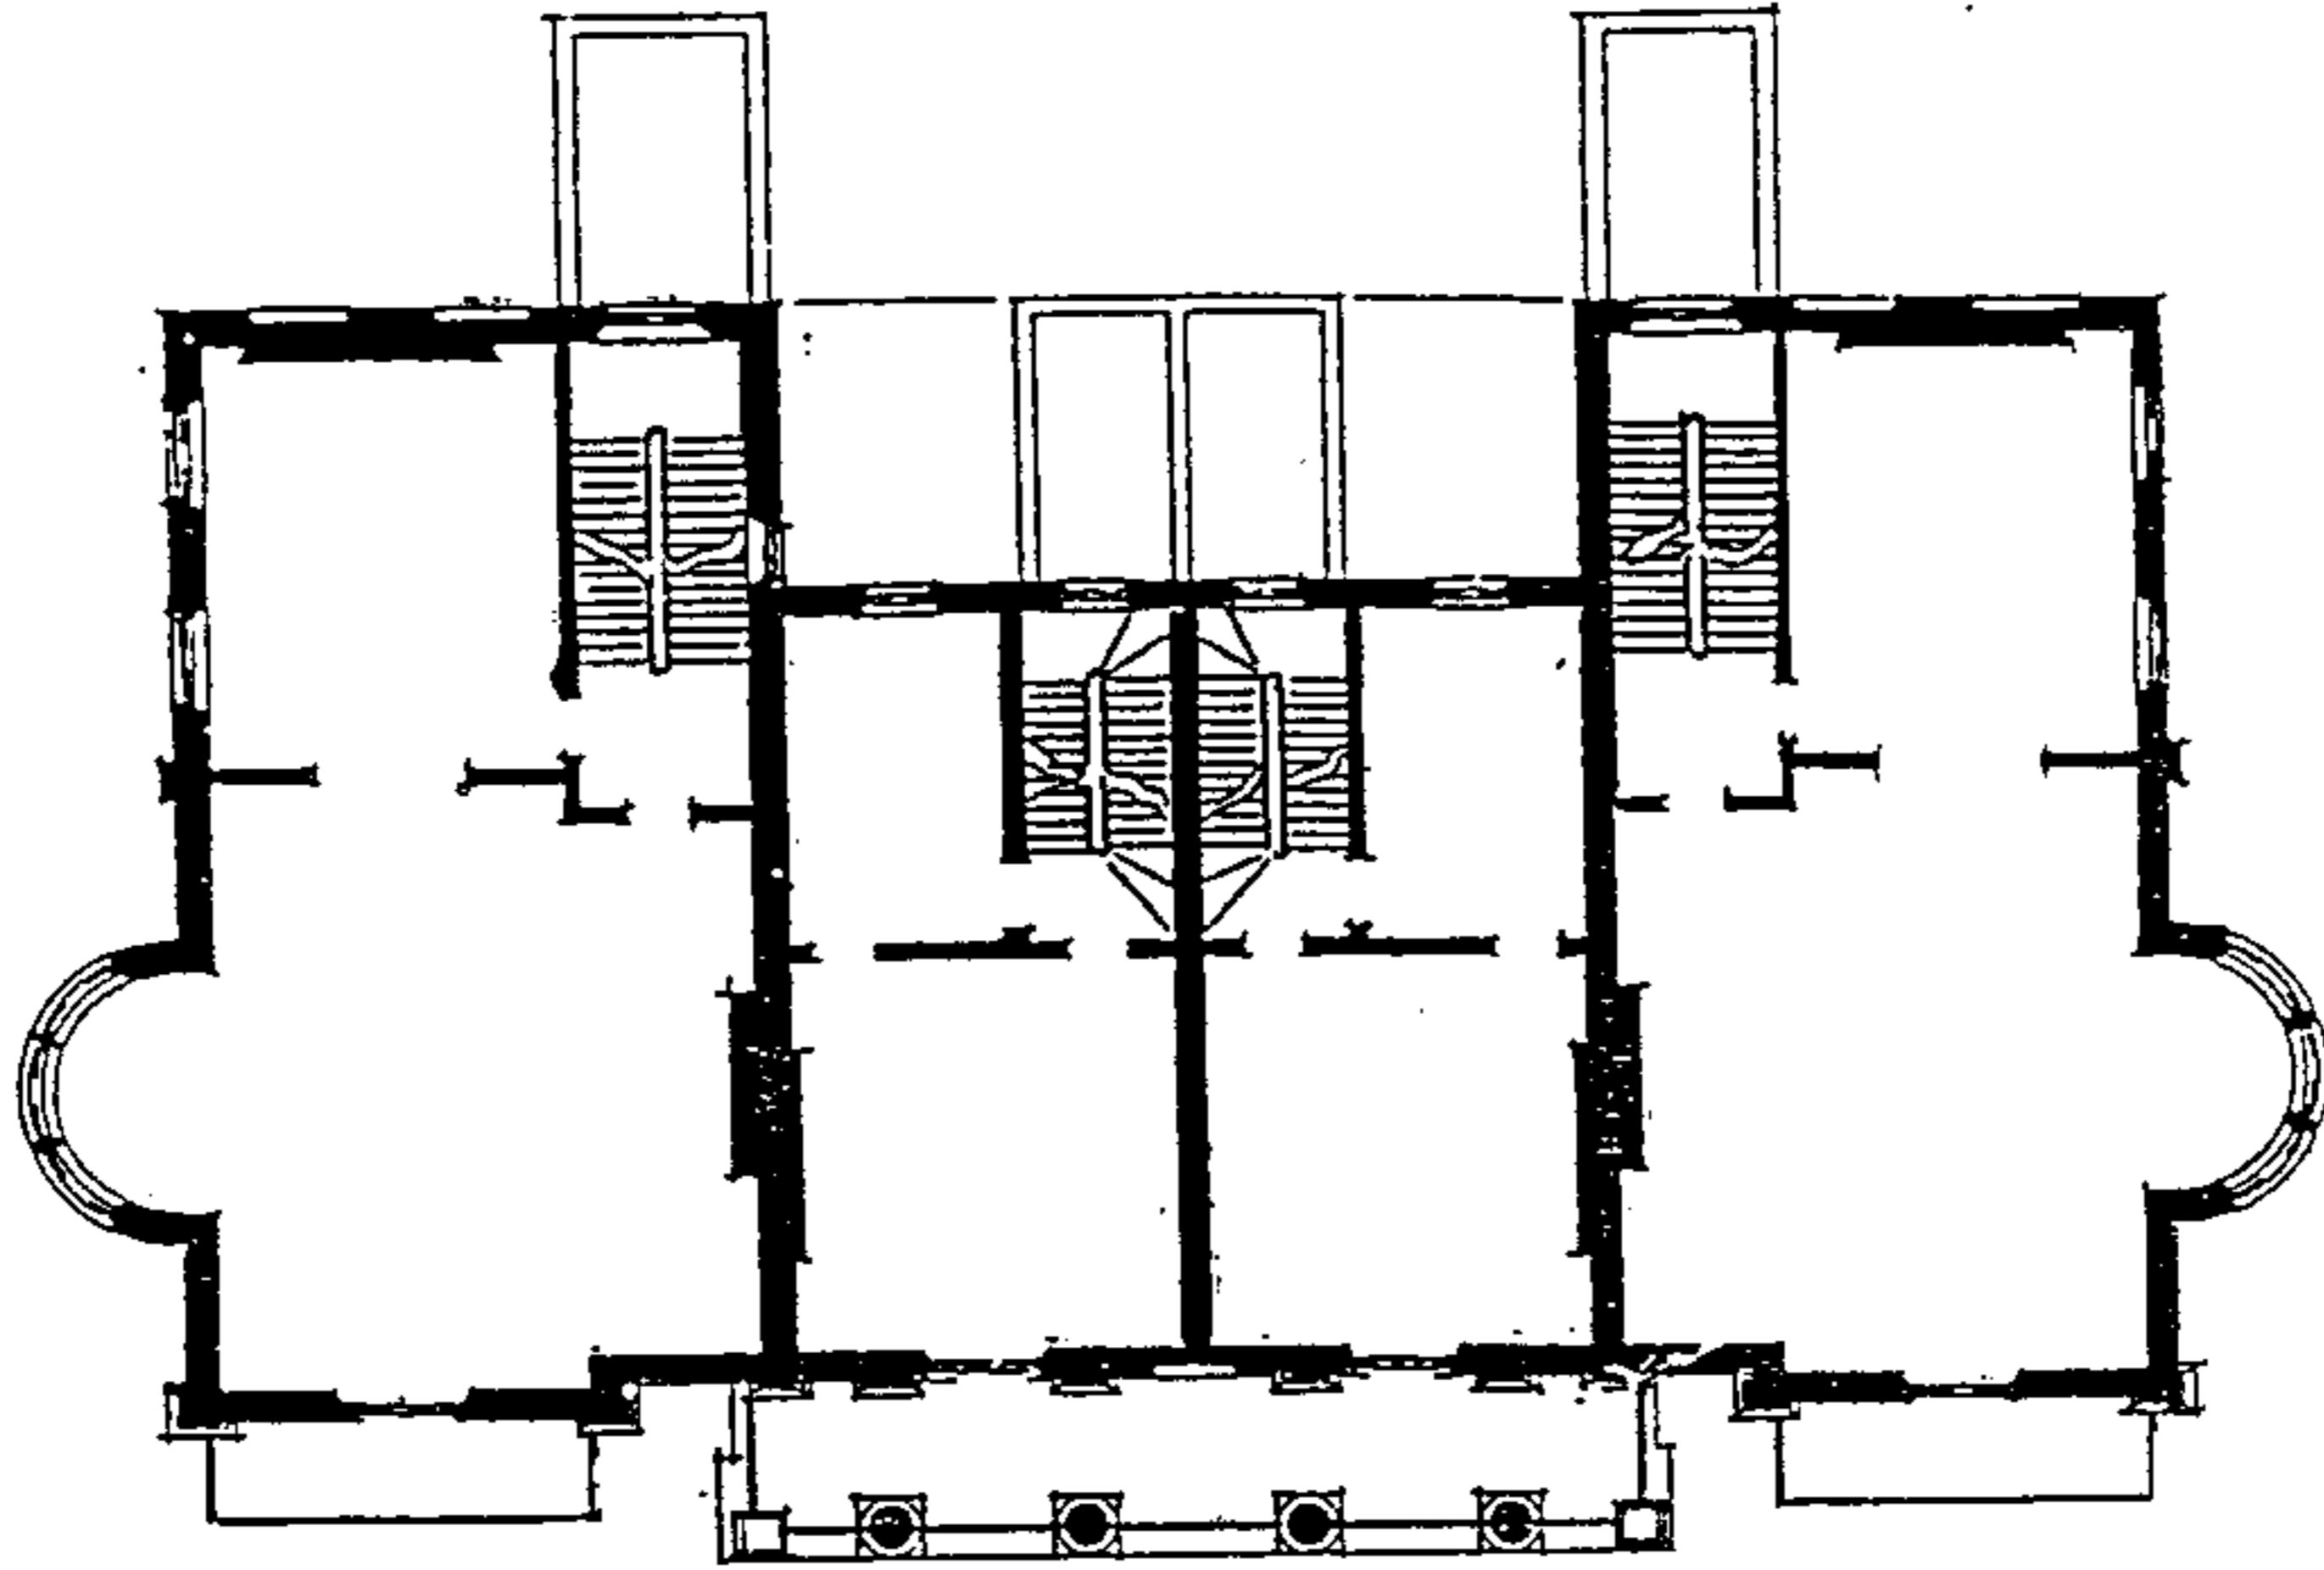
CUMBERLAND PLACE

Between Cumberland and Chester terraces is another group of four houses illustrated in plate 97, and by the plan above. They are numbered 1-4 Cumberland Place. To the Park they show a central projecting portico of four columns of the Corinthian order rather widely spaced extending through two storeys above the ground floor. Flanking this at either end are slight projections treated with pairs of double pilasters of the same order. To the north and south are well-designed semi-circular bays rising to the main cornice, while above the main block is an attic storey.

Survey of London, 1938.

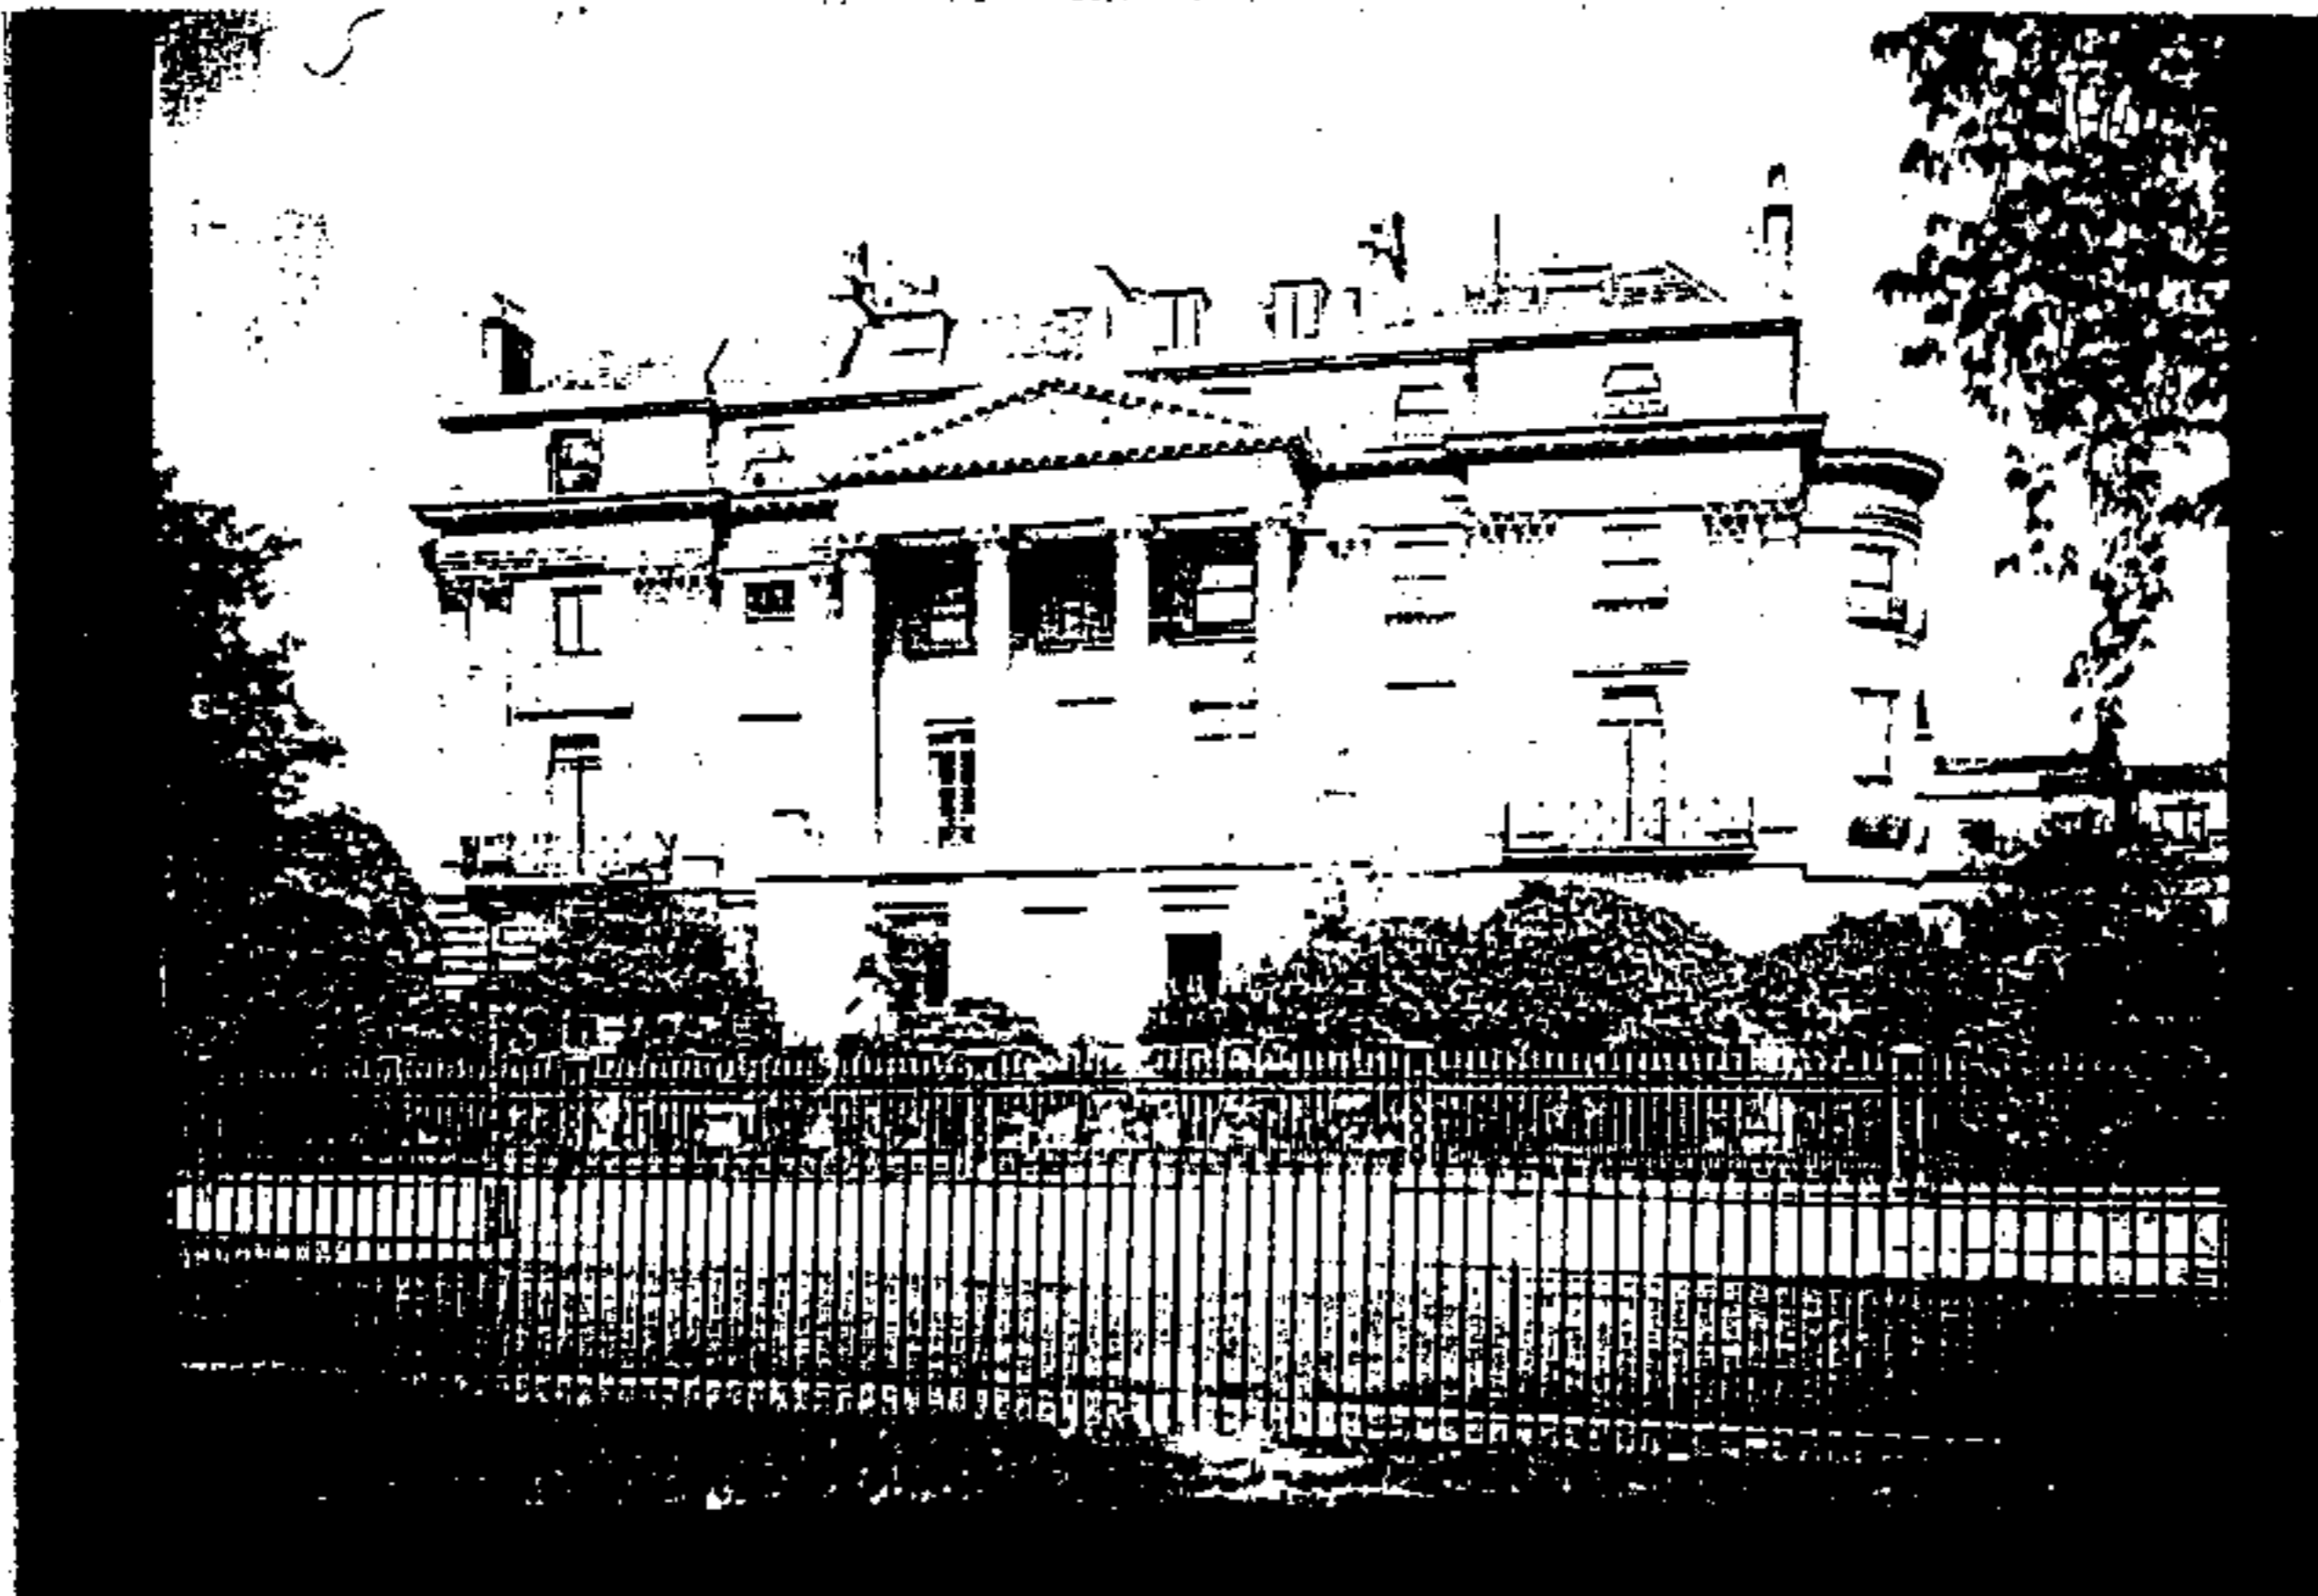
Photo no: H1

West Elevation (facing Regents Park) c. 1948

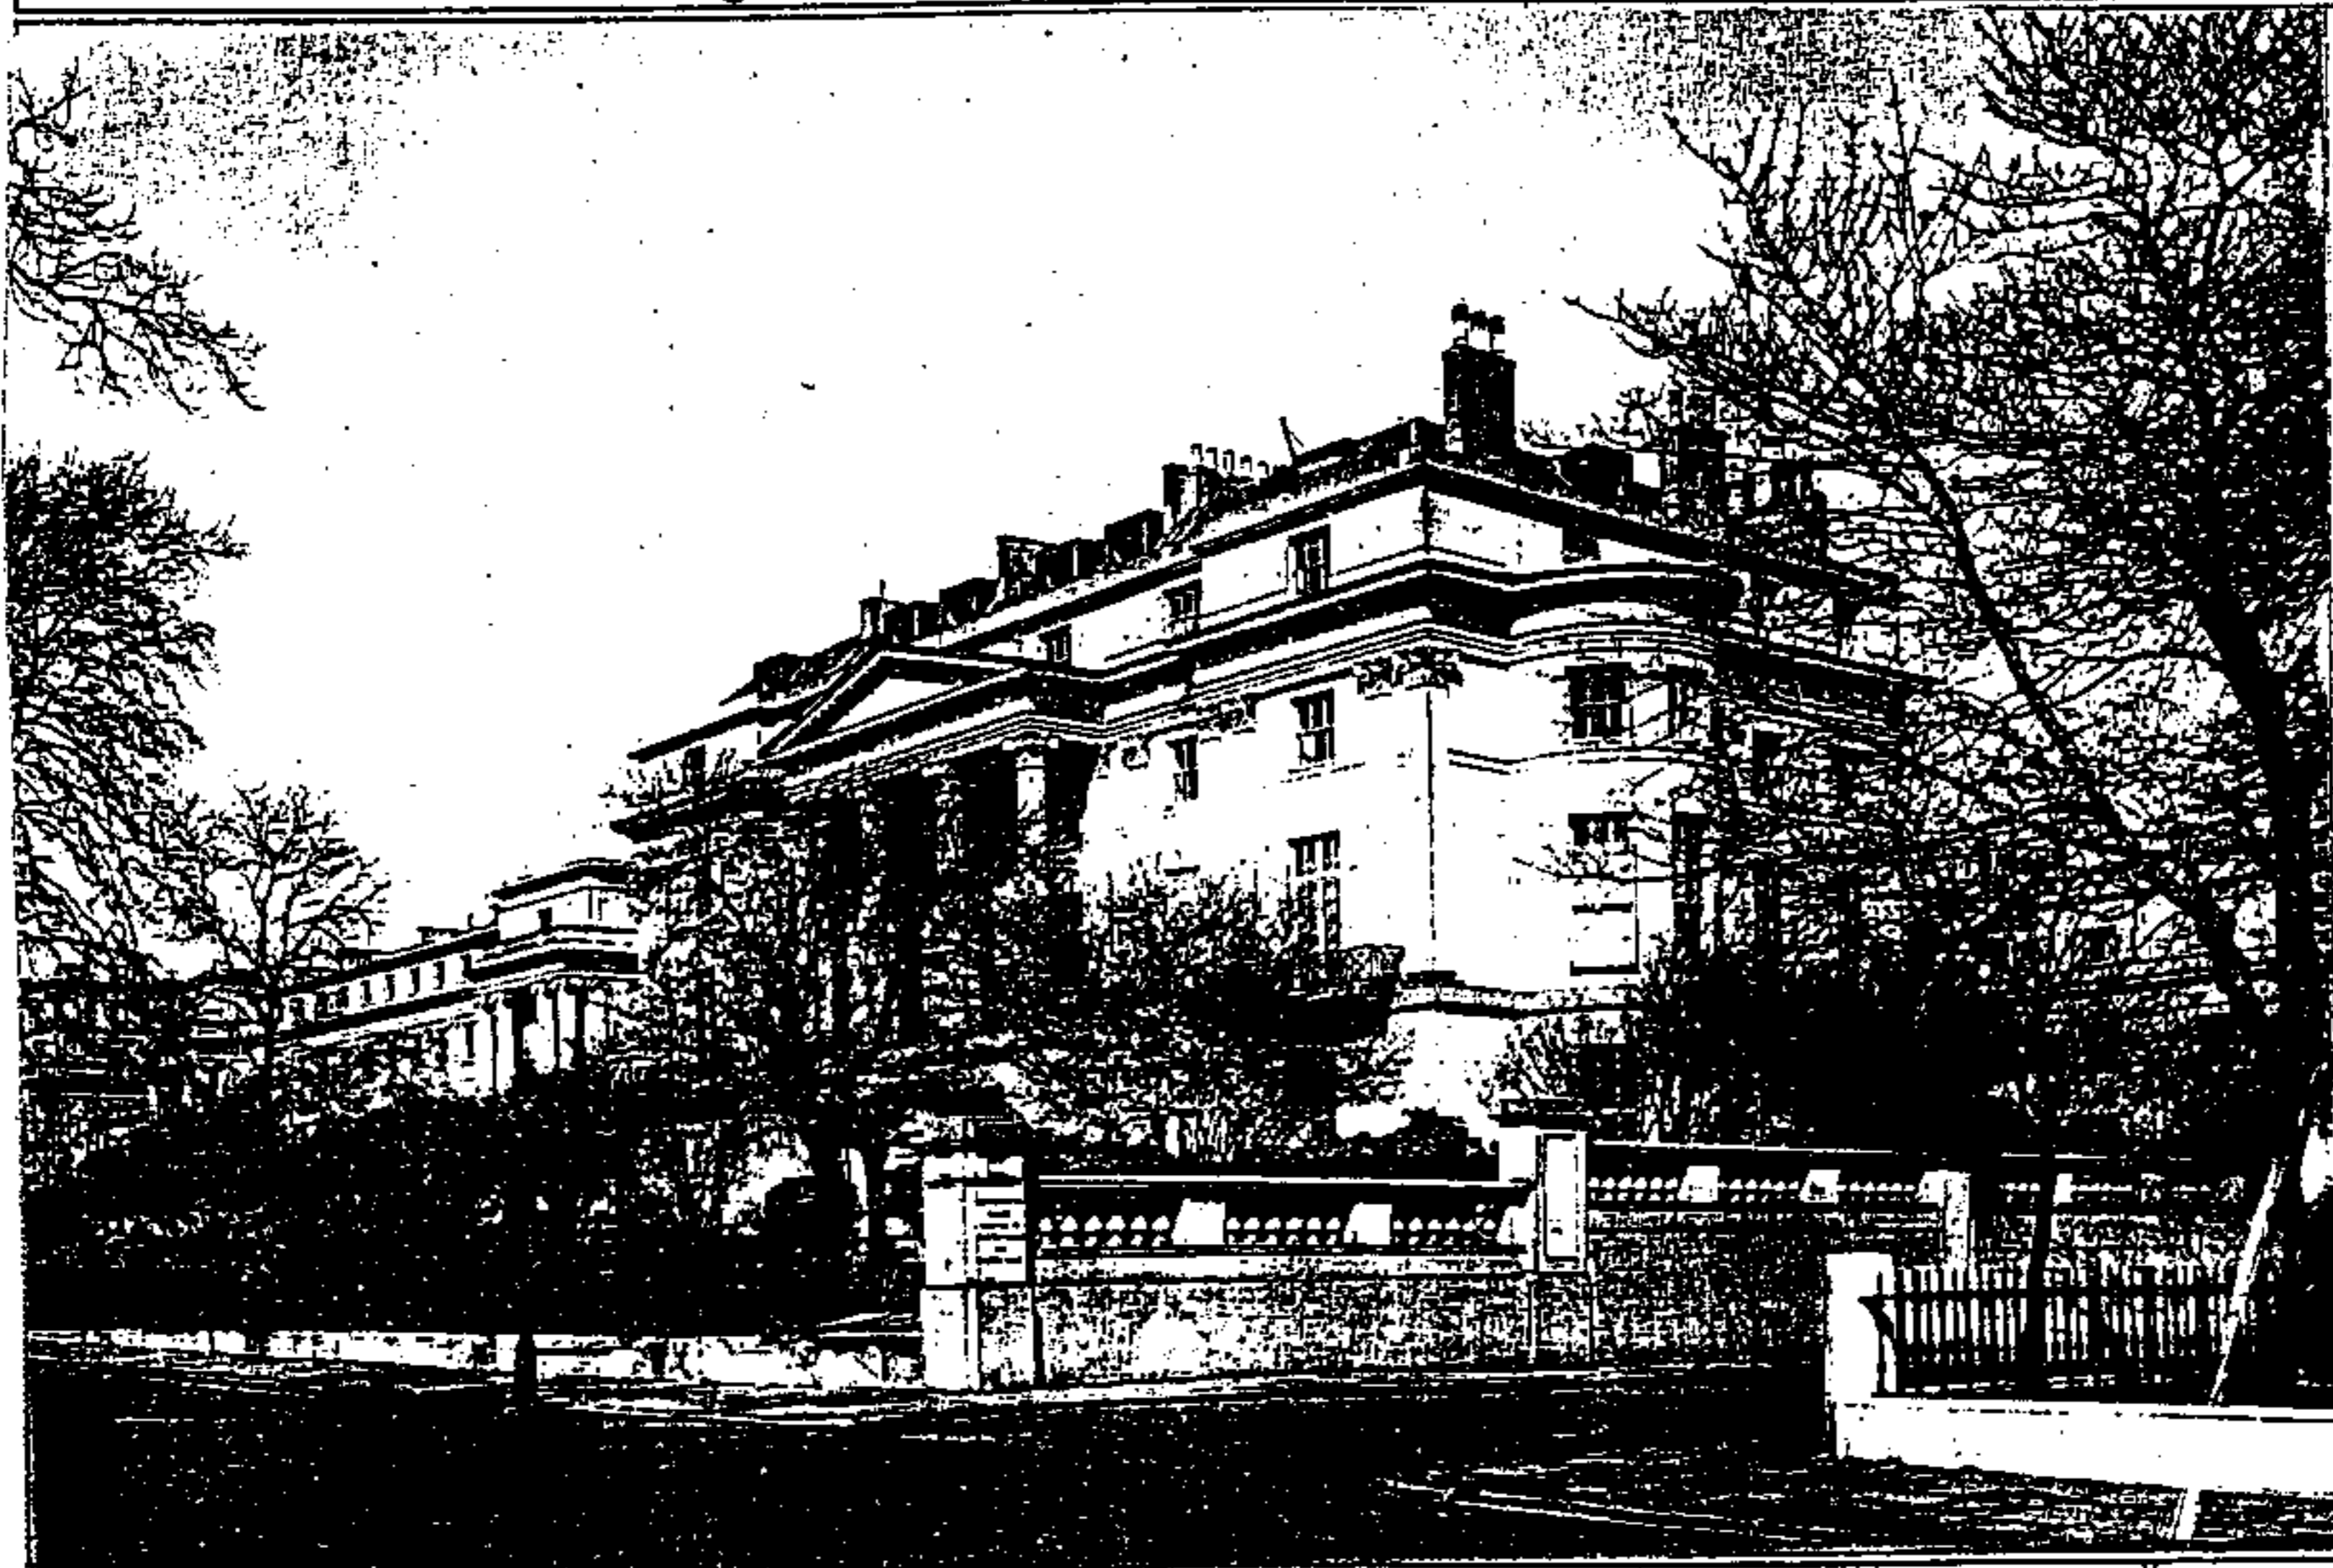
Photo no: H2

South West Elevation (from Outer Circle) c. 1955. HBMC
