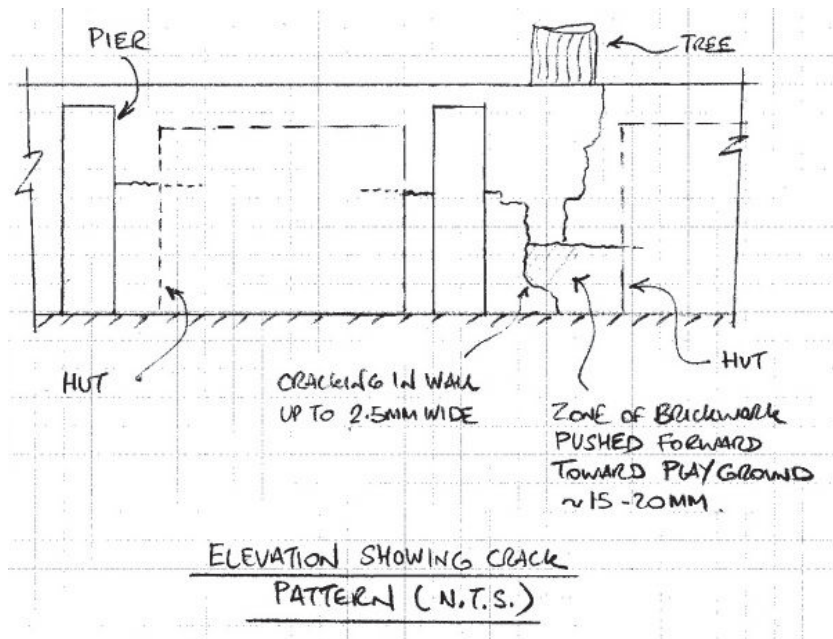
8.0 The wall has had remedial work in the past with signs of repointing, but has continued to move over time and has cracked in places. An elevation sketch of the wall is shown below:
