**METHOD STATEMENT FOR THE REPAIR OF THE MOULDED TREADS TO THE MAIN STAIRCASE.**

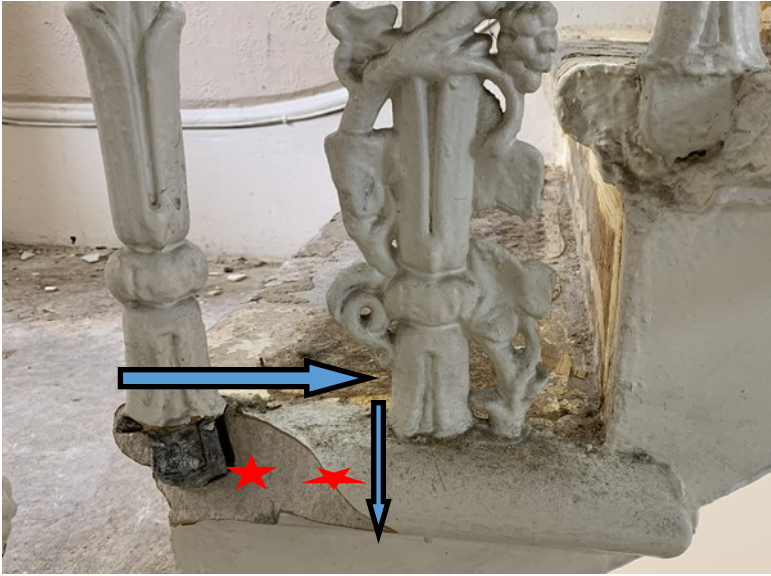
This photograph shows the typical damage to the Portland stone tread of the cantilevered staircase. The damage has been caused by the base of the iron balustrade spalling and bursting the stone at its weak point.

The proposed method repair would be for our skilled masons to carefully square cut the damaged areas along the lines shown by the blue arrows.

A new piece of Portland stone pre-cut off site to match the moulded leading edge and return of the tread will be fixed into position on stainless steel dowels. These dowels will be 6mm 304 grade stainless steel resin fixed into the existing tread as indicated on the photograph with a red star.

The new piece of stone will be fitted around the balustrade base and glued in position and pointed with fine lime putty mortar.

The balustrade will be resin fixed into the new stone indent and left ready for redecorations by others.
