SITE INVESTIGATION FACTUAL REPORT

Report No: [REDACTED]
Client: Sedgwick International UK - Maidstone
Site: 88 Albert Street
Client Ref: [REDACTED]
Date of Visit: 09/12/2019

Investigation Layout Plan

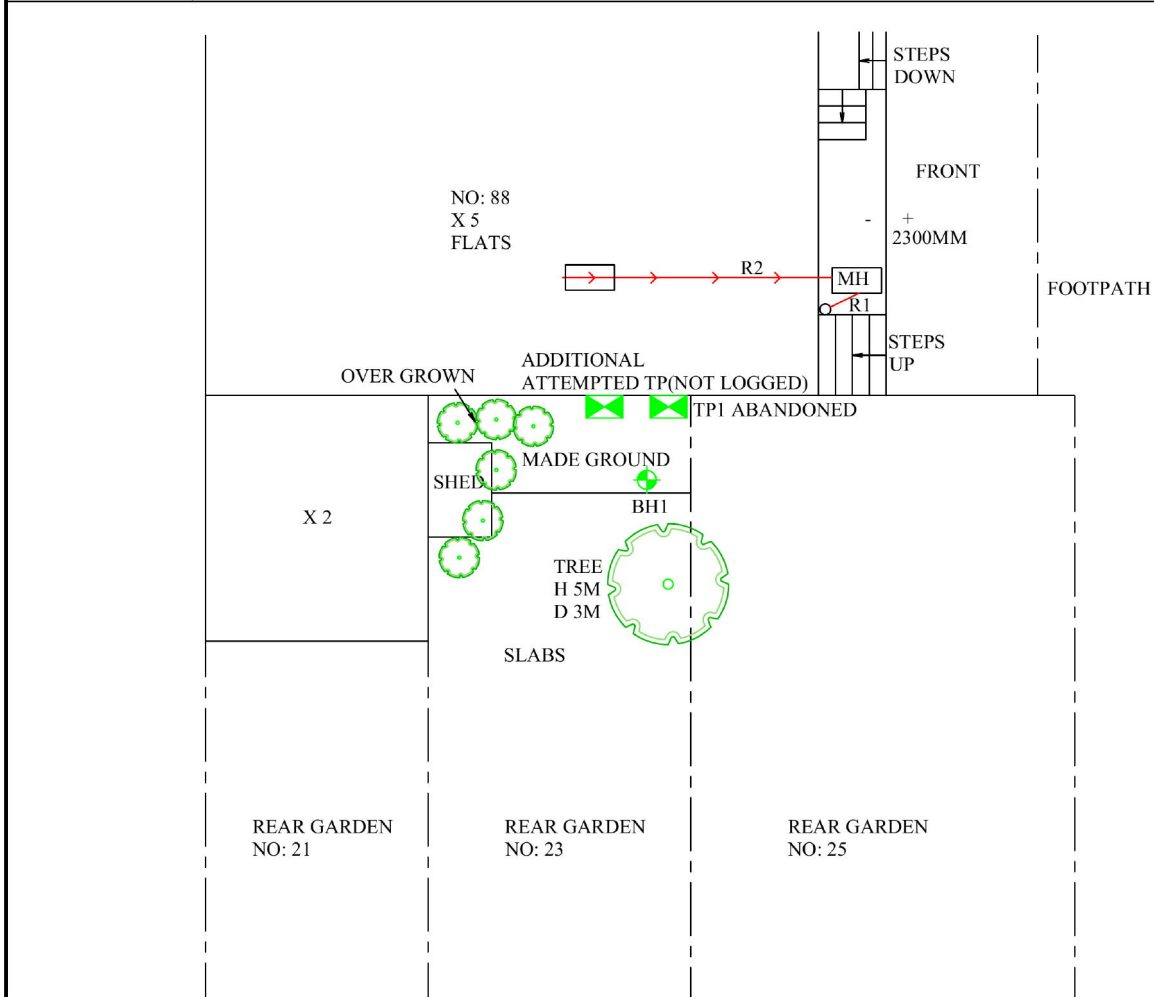
Remarks: TP/BH2 NOT CARRIED OUT, SHED AND VEGETATION OBSTRUCT PROPOSED POSITION

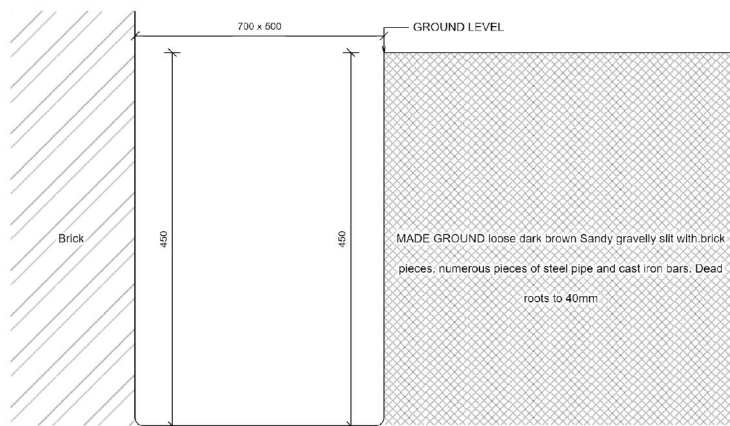
TRIAL PIT REF: TP1

Trial pit abandoned at 450mm

TP abandoned at 450mm made ground obstructs. An additional TP was attempted (see site plan) with similar results , not sketched. BH augered outside TP
