Window Survey Report

26a Rosslyn Hill, London, NW3 1PD

On behalf of Ridge & Partners LLP

Stride Treglown job no.	152565
Prepared by	Stephen James
Checked by	Chris Kemp
Date	15.04.19
Revision	A

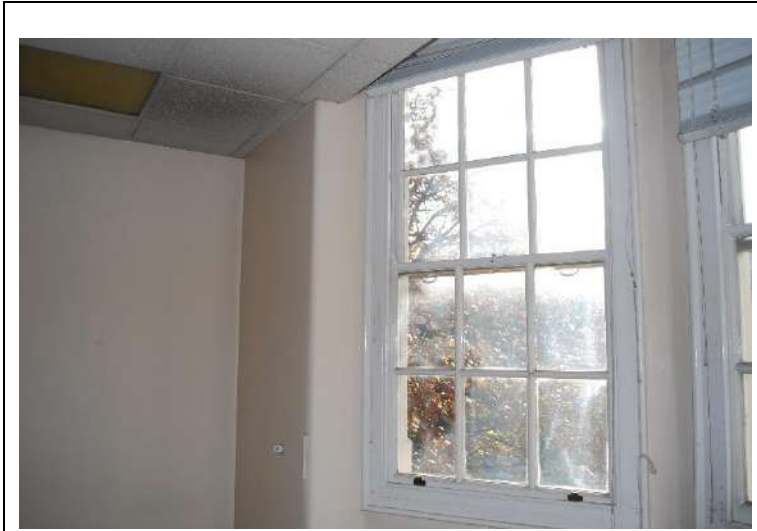
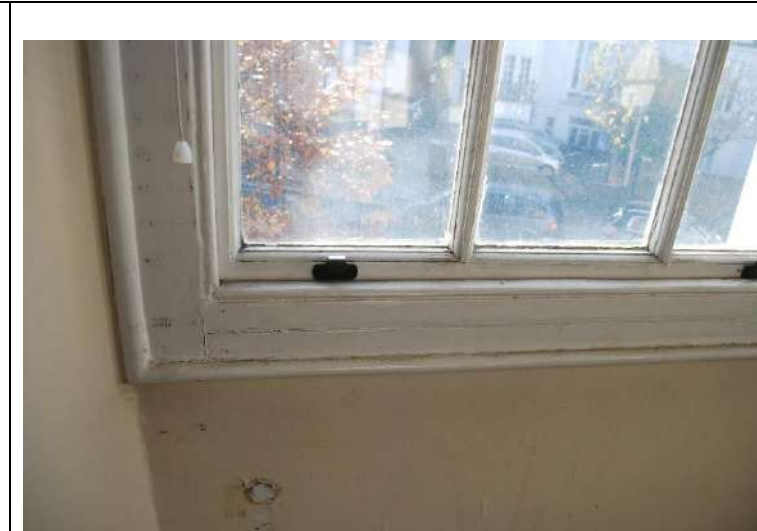
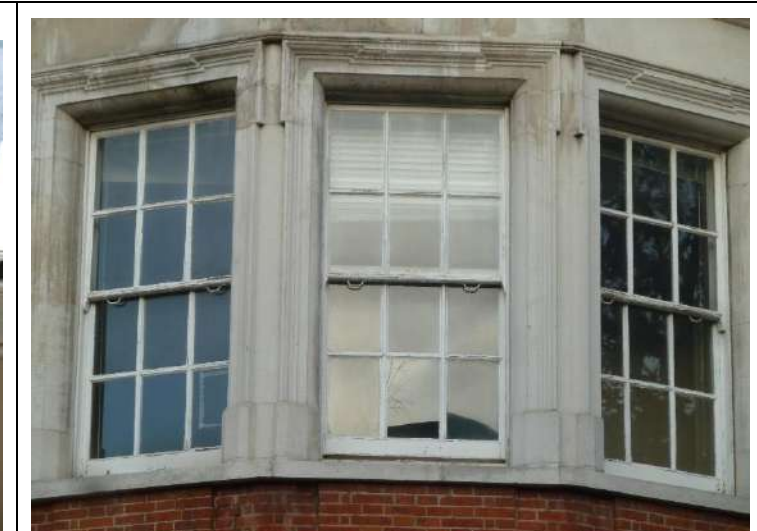
W32 (a)	W32 (b)	W32 (c)	W33 (a)

Ref.	Location	Description	Condition	Recommended Remedial Works	Photo Ref.
W32	South / Rosslyn Hill Elevation	Sliding sash windows with a painted timber construction featuring single glazing in a 6 over 6 arrangement. External metal pull handles to upper sash, internal finger lifts to lower sash and Brighton sash lock fitted to meeting rails. Approx. Size: 1.3m x 2.1m Glass Panes: 300mm x 460mm Approx. Sill height: 0.97m	<ul style="list-style-type: none"> The window is temporarily screwed shut internally. Top sash is jammed. Missing sash lock lever. No window restrictor fitted. Horizontal hairline crack in the internal apron. Cracked external paint finish particularly on meeting rail and bottom rail. Perished sealant between timber window sill and sub-sill. 	<ul style="list-style-type: none"> Overhaul top sash if required, counter-balance the weights and leave fully operational. Replace 1no. sash lock. Fill holes with wood filler. Rub down and redecorate all joinery inside and out. Renew sealant between the external sills. 	W32(a) – W32(c)

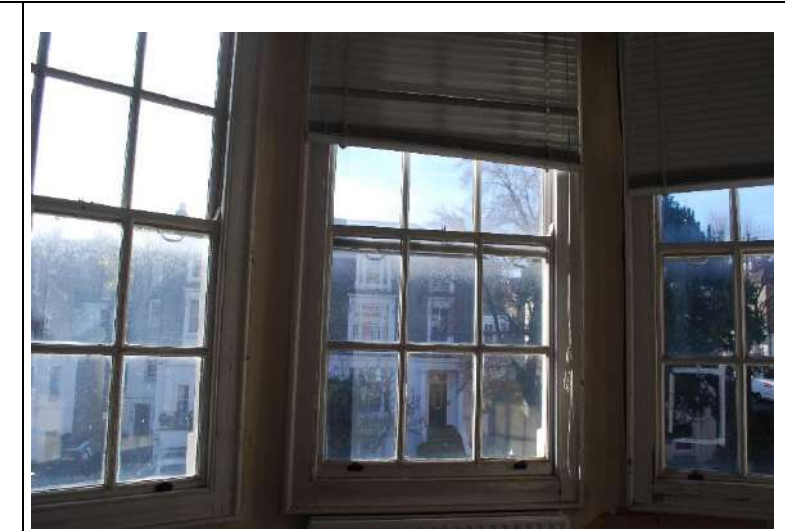
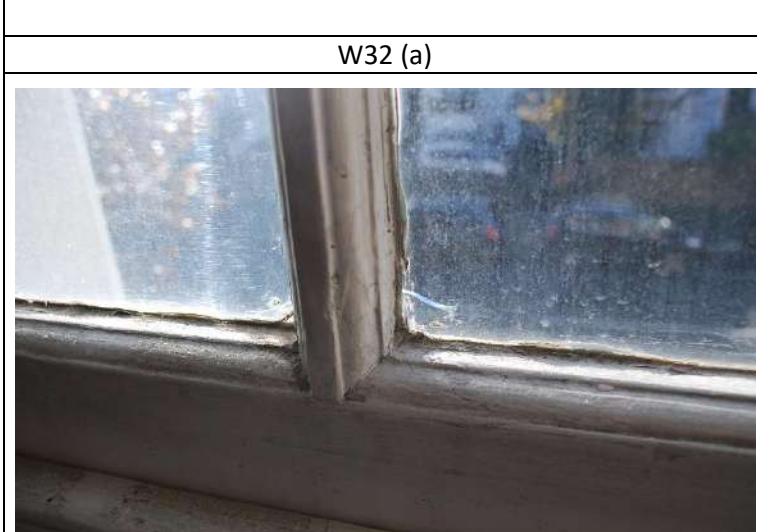
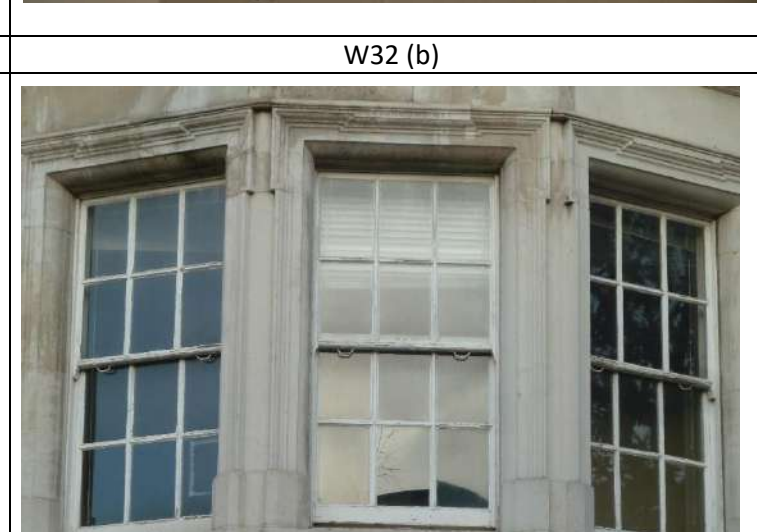
W33	South / Rosslyn Hill Elevation	Sliding sash windows with a painted timber construction featuring single glazing in a 6 over 6 arrangement. Window film applied to glazing. External metal pull handles to upper sash, internal finger lifts to lower sash and Brighton sash lock fitted to meeting rails. Approx. Size: 1.3m x 2.1m Glass Panes: 300mm x 460mm	<ul style="list-style-type: none"> The window is temporarily screwed shut internally. Bottom sash only moves by 20mm and pushes upper sash in the process. No window restrictor fitted. Missing sash lock lever. The meeting rails are not aligned. 1no. cracked glazing pane in the centre of the lower sash. Horizontal hairline crack in the internal apron. Cracked external paint finish generally. No British Standard markings on window film. 	<ul style="list-style-type: none"> Remove window sashes and overhaul. Allow to replace sash cords and counter-balance the weights. Install new pulley lining on completion, clean and wax window track. Replace 1no. sash lock. Replace 1no. cracked pane. Rub down and redecorate all joinery inside and out. Fill screw holes with wood filler. 	W33(a) – W33(c)

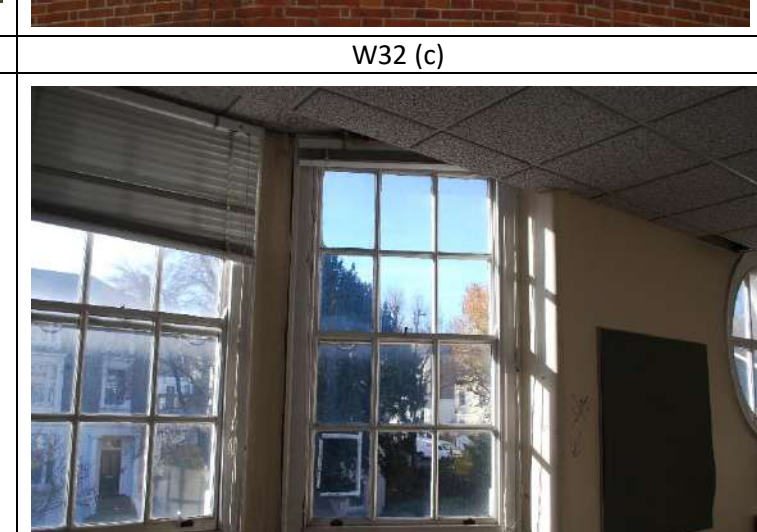
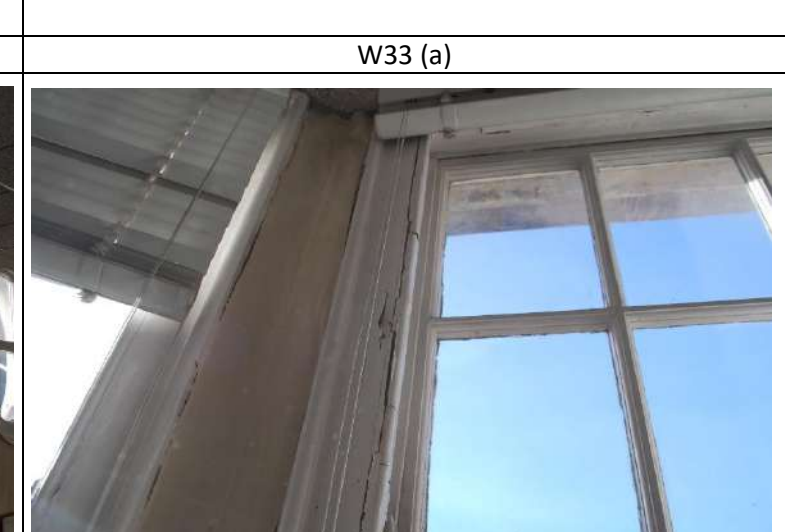
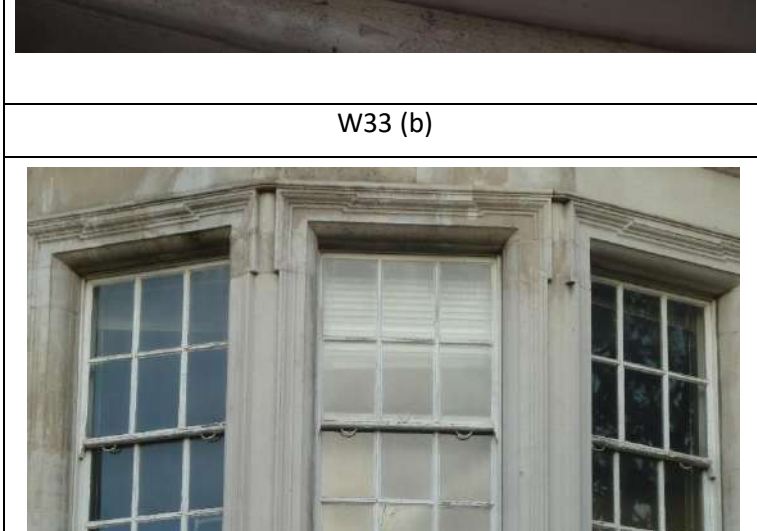
W33 (b)	W33 (c)	W34 (a)	W34 (b)

W34	South / Rosslyn Hill Elevation	Sliding sash windows with a painted timber construction featuring single glazing in a 6 over 6 arrangement. Window film applied to glazing.	<ul style="list-style-type: none"> The window is temporarily screwed shut internally. The top sash requires easing and adjusting. No window restrictor fitted. Area of decay to the pulley lining. 	<ul style="list-style-type: none"> Remove pulley lining and inspect condition of upper sash cords and weights. Allow to overhaul, counter-balance the weights and 	W34(a) – W34(c)

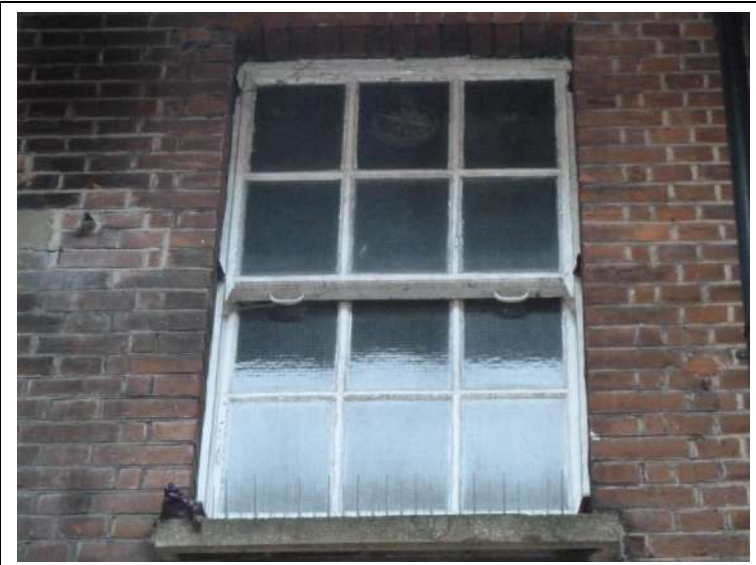
W51 (c)	W52 (a)	W52 (b)	W53 (a)

W50	North Elevation	Fixed metal framed clerestory windows in the raised walkway featuring obscure Georgian wire glass.	<ul style="list-style-type: none"> Generally in satisfactory condition albeit dirty frames. 	<ul style="list-style-type: none"> Clean windows as part of routine maintenance. 	W50(a) – W50(b).
W51	East Elevation	Sliding sash window with a painted timber construction featuring obscure Georgian wire single glazing panes in a 6 over 6	<ul style="list-style-type: none"> Both sashes are jammed shut. 1no. fraying sash cord. No window restrictors fitted. 	<ul style="list-style-type: none"> Remove pulley lining to inspect the condition of the cords and replace 1no. cord. Overhaul and counter- 	W51(a) – W51(c)

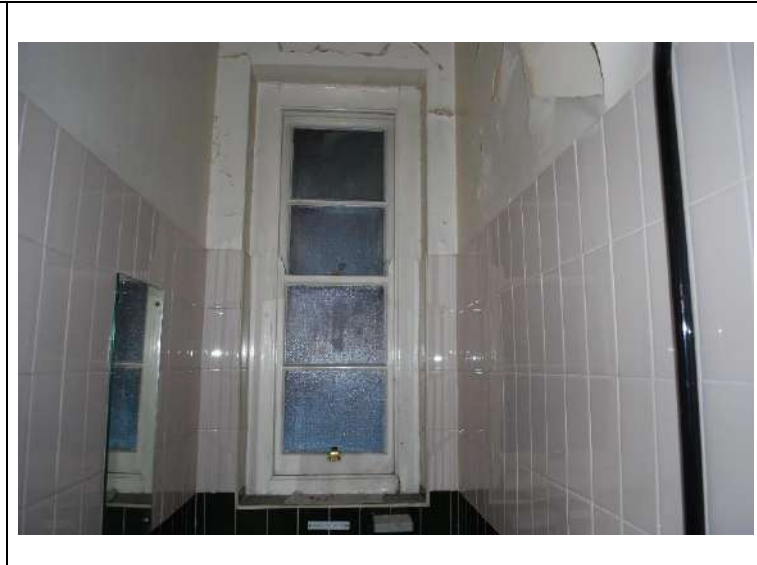
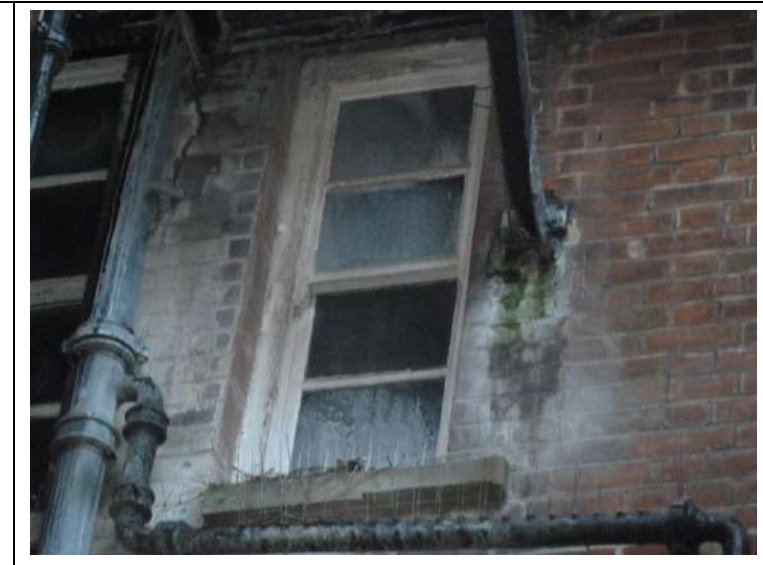
Ref.	Location	Description	Condition	Recommended Remedial Works	Photo Ref.
		<p>arrangement. A high level fan is present through the glazing.</p> <p>External metal pull handles to upper sash, internal finger lifts to lower sash and Brighton sash lock fitted to meeting rails.</p> <p>Approx. Size: 1.1m x 1.8.m Approx. Sill height: 1m</p>		<p>balance the weights. Install replacement pulley box lining on completion, clean and wax window track.</p>	
W52	East Elevation	<p>Sliding sash window with a painted timber construction featuring single glazing in a 2 over 2 arrangement.</p> <p>External metal pull handles to upper sash, internal finger lift to lower sash and sash lock fitted to meeting rails.</p> <p>Approx. Size: 0.6m x 1.5m Approx. Sill height: 1.21m</p>	<ul style="list-style-type: none"> • Top sash is jammed shut. • No window restrictor fitted. • Bottom sash falls when lifted. • RHS bead is loose and partly decayed (seen internally). • Hairline open joints in internal joinery. • Stained and flaking paint decoration to exterior. 	<ul style="list-style-type: none"> • Remove pulley lining to inspect the condition of the cords and weights and allow to replace sash cords. Overhaul and counter-balance the weights. Install replacement pulley box lining on completion, clean and wax window track. • Replace 1no. decayed bead. • Rub down and redecorate all joinery inside and out 	W52(a) – W52(b)

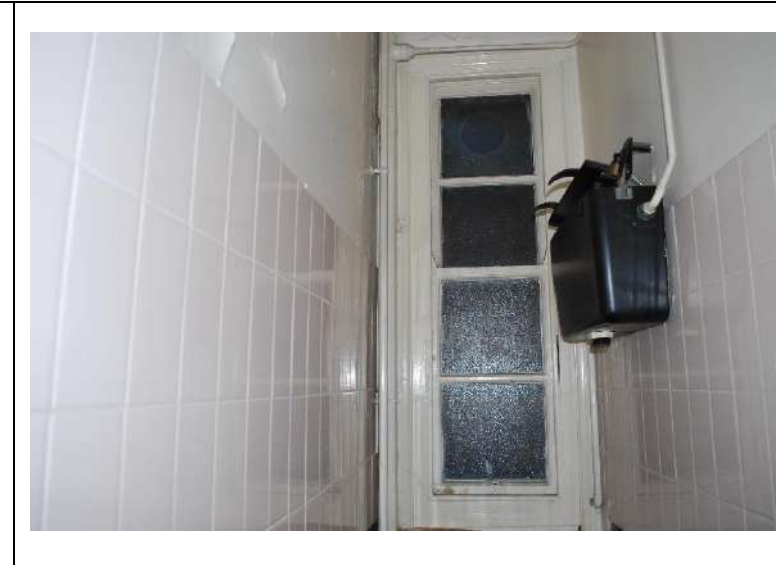
W53	East Elevation	<p>Sliding sash window with a painted timber construction featuring single glazing in a 2 over 2 arrangement.</p> <p>External metal pull handles to upper sash, and internal finger lift to lower sash.</p> <p>Approx. Size: 0.6m x 1.5m</p>	<ul style="list-style-type: none"> • Both sashes are jammed shut. • Worn exterior paint decoration. • Broken window board. • Open joint between beading and RHS frame (seen internally). • 1no. patch infill denoting pre-existing fan through glazing. 	<ul style="list-style-type: none"> • Remove pulley lining to inspect the condition of the cords and weights and allow to replace sash cords. Overhaul and counter-balance the weights. Install replacement pulley box lining on completion, clean and wax window track. 	W53(a)

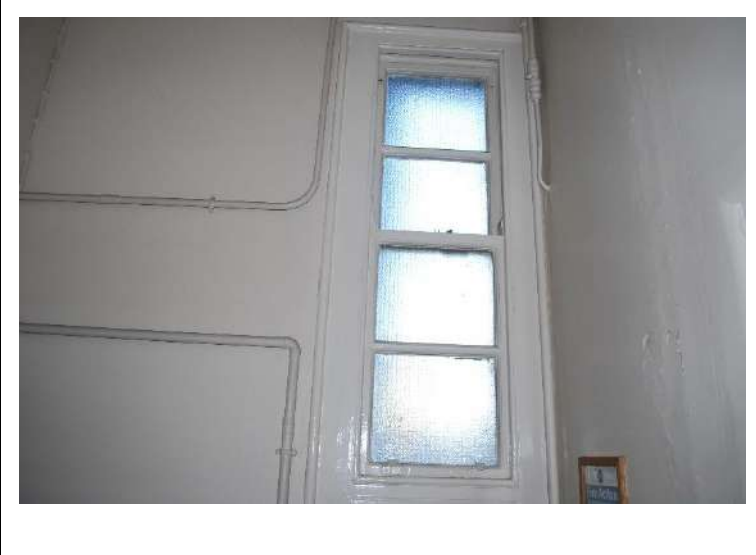
W54 (a)	W55 (a)	W55 (b)	W55 (c)

Ref.	Location	Description	Condition	Recommended Remedial Works	Photo Ref.
				<ul style="list-style-type: none"> • Rub down, prime and redecorate all joinery inside and out • Caulk open joints and allow for additional fixings through the beadings 	
W54	North Elevation	<p>Sliding sash window with a painted timber construction featuring obscure Georgian wire single glazing in a 2 over 2 arrangement.</p> <p>Internal finger lifts to lower sash and Brighton sash lock fitted to meeting rails.</p> <p>Approx. Size: 0.6m x 1.5m Approx. Sill height: 0.95m</p>	<ul style="list-style-type: none"> • The window is jammed shut. • Sash cords are painted. • Flaking paint decoration and holes in beading. 	<ul style="list-style-type: none"> • Remove pulley lining to inspect the condition of the cords and weights and allow to replace sash cords. Overhaul and counter-balance the weights. Install replacement pulley box lining on completion, clean and wax window track. • Rub down and redecorate all joinery inside and out • Fill holes with a wood filler. 	W54(a)

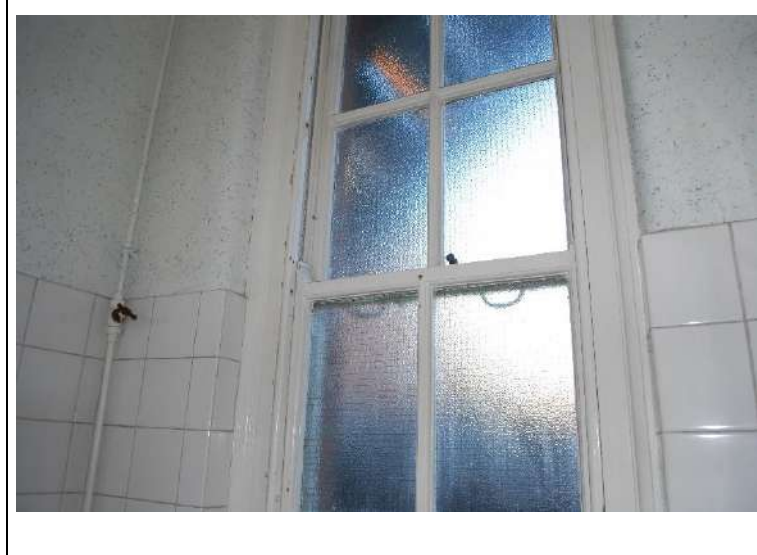
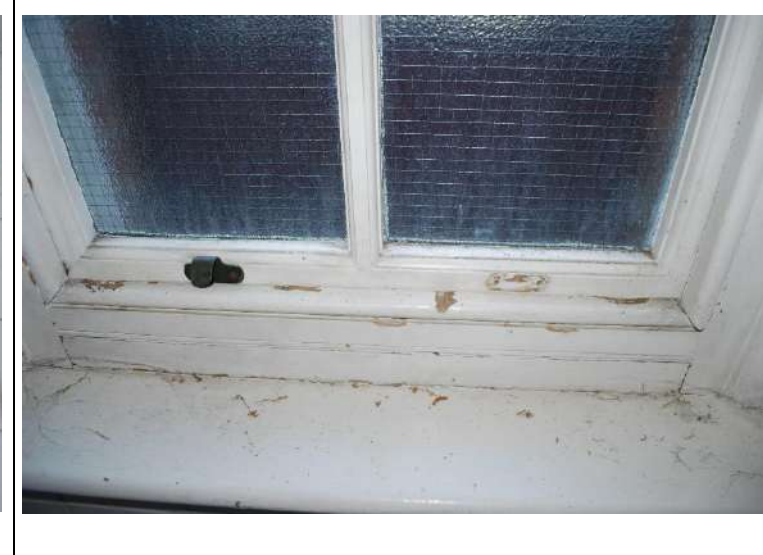
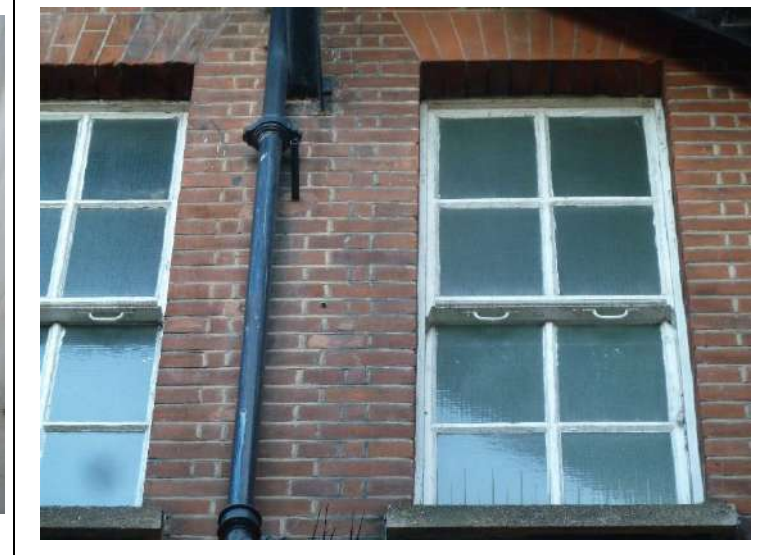
W55	North Elevation	<p>Sliding sash window with a painted timber construction featuring obscure Georgian wire single glazing in a 4 over 4 arrangement.</p> <p>External metal pull handles to upper sash, internal finger lifts to lower sash and Brighton sash lock fitted to meeting rails.</p>	<ul style="list-style-type: none"> • The window is temporarily screwed shut internally. • Window operates without issue. • No window restrictors fitted. • Indentations along the sash lining, vertical beading and internal apron. • 1no. missing finger lift. • Flaking external paint decoration. • Open joint between external brickwork and timber window frame. 	<ul style="list-style-type: none"> • Undertake wood filling and caulk repairs to open joints and holes. Allow for additional fixings through the beadings. • Replace finger lifts. • Rub down and redecorate all joinery inside and out • Rake out and renew the external mortar pointing around the window junction. 	W55(a) – W55(c)

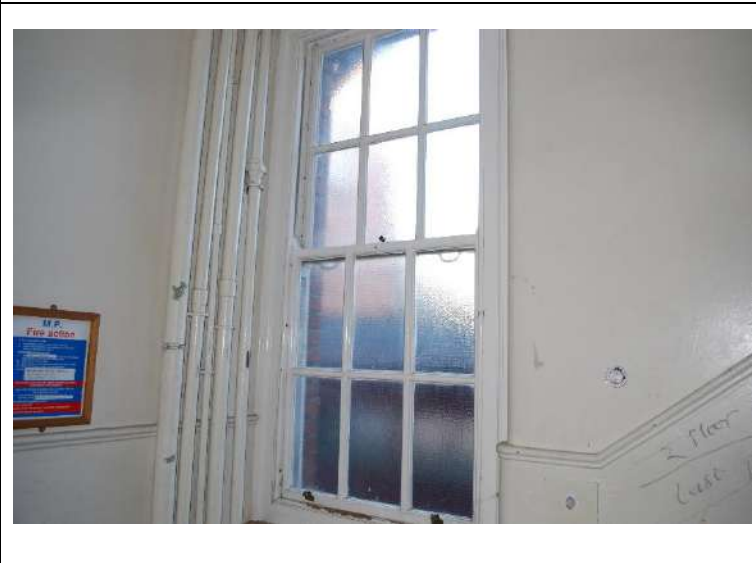
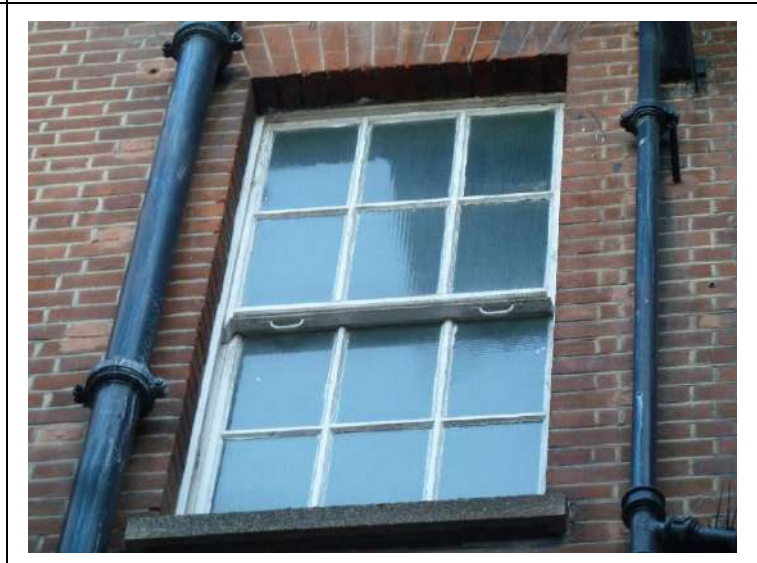
W56 (a)	W56 (b)	W57 (a)	W57 (b)

Ref.	Location	Description	Condition	Recommended Remedial Works	Photo Ref.
W56	North Elevation	<p>Sliding sash window with a painted timber construction featuring obscure Georgian wire single glazing in a 6 over 6 arrangement.</p> <p>External metal pull handles to upper sash, internal finger lifts to lower sash and Brighton sash lock fitted to meeting rails.</p> <p>Approx. Size: 1.1m x 2.1m</p>	<ul style="list-style-type: none"> The window is temporarily screwed shut internally. Top sash is jammed shut. Open joint between external brickwork and timber window frame. No window restrictor fitted. Worn internal paint finish. Glazing intact. Flaking exterior paint decoration. 	<ul style="list-style-type: none"> Overhaul top sash if required, counter-balance the weights and leave fully operational. Rake out and renew the external mortar pointing around the window junction. Rub down and redecorate all joinery inside and out. Fill screw holes with a wood filler. 	W56(a) – W56(b)
