## Visit Report

07 February 2014

16, Downside Crescent  
London  
NW3 2AP

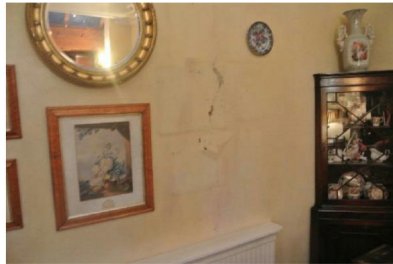
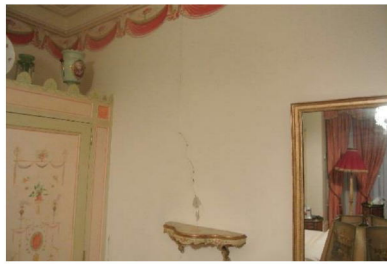
<b>Nature and Extent of Damage</b>    	<p>It is apparent that there has been downward and rotational movement of the rear single storey extension relative to the rear elevation of the main building resulting in a vertical tapering crack to the left hand flank wall at the junction between the structures.</p> <p>Within the first floor rear bedroom, there is cracking to the rear elevation beneath the windows, together with a crack above the left hand window which extends up to the cornice to the left hand party wall alcove. The crack extends along the cornice to the rear wall and at the juncture between the rear elevation and the internal cross wall to the kitchen. Whilst the cracking beneath the rear windows is likely to have developed as a result of longterm deflection of the supporting beam / bressumer which extends across the ground floor opening, it is possible that the cracking to the rear left hand corner could have developed as a result of slight foundation movement to the rear left hand corner of the main building.</p> <p>There is also slight cracking within the rear bedroom within the second floor flat.</p> <p>There is a longstanding crack within the ground floor flat to the main internal loadbearing wall between the front bedroom and rear reception room, which</p>

extends up within the first floor flat. Whilst the precise cause of this crack has not been formally established, the crack is considered to have been present for a number of years and was highlighted within the Engineers report from 2008. In addition the crack width monitoring exercise which was undertaken between March 2012 and August 2013 has not demonstrated any progressive movement.

It is possible that the cracking could have developed as a result of movement to the neighbouring property or as a consequence of subsequent underpinning. However in the absence of any indications of progressive movement only localised repairs would appear necessary.

We would also propose a relatively robust repair to the crack to the internal cross wall between the ground floor front bedroom and rear reception room incorporating the provision of stainless steel helibars at horizontal centres across the height of the crack.

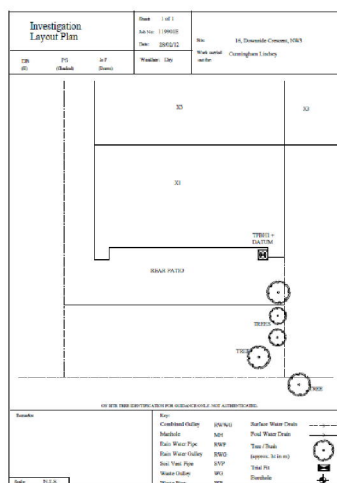
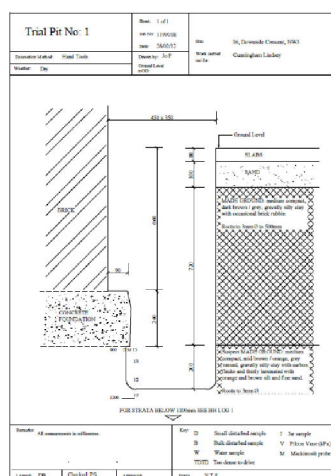
The trial hole to the rear of the extension revealed a concrete foundation to a depth of 900mm. Both sets of investigations involved a trial hole to the rear left hand corner of the extension and whilst the earlier investigation confirmed that the underlying subsoil was a firm silty CLAY, the subsequent excavation revealed a suspected made ground to a depth of 1.1m. After further reviewing the results of the earlier investigations and the actual location of the trial hole we consider that the subsequently identified made ground is likely to represent the back filling of the earlier trial hole.

A borehole was sunk to a depth of 8.0m with soil testing to a depth of 5.0m. The borehole revealed a firm to stiff silty CLAY throughout.

Soil analysis was undertaken and the subsoil has been classified as being of high to very high plasticity and as such the subsoil will be highly susceptible to volumetric changes due to variations in moisture content.

Based upon the results of the laboratory testing it would appear that the subsoil was desiccated at a depth of 2.5m.

Roots were noted at the underside of the foundation and within the borehole to a depth of 2.7m. Botanical analysis of root samples was undertaken and this identified roots from the *Fraxinus* species (Ash) and also *Taxodiaceae* (inc Redwood, Wellingtonia, cedar).

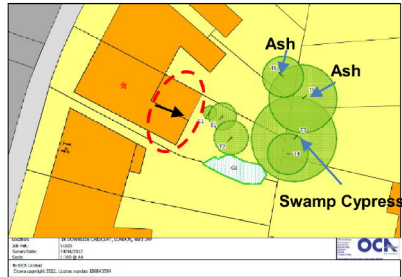
Damage to the rear of the property is considered to have developed as a result of clay shrinkage subsidence exacerbated by the moisture demands of adjacent vegetation. It is considered that foundation stability could be achieved if a programme of tree management were to be undertaken. An arboricultural report was therefore commissioned upon vegetation within potential influencing distance of the property and OCA UK Ltd had recommended the felling of the Swamp Cypress identified as T3 and two Ash tree (T5 and T6). The trees are under the control of three separate neighbours.

During the course of the original claim it had been established that the property is located within a Conservation Area and a notification was made to Camden Council seeking consent to fell the Swamp Cypress and an Ash tree. Objections were raised and Tree Preservation Orders were placed on both trees.

Following consideration of the arboricultural report an application was subsequently made to fell the Ash tree within the Conservation Area but in June 2013, the Council also placed a Tree Preservation Order on this tree.

A formal application was therefore made to fell all three protected trees but the council refused consent.

With regard to the issue of tree removal, there are several trees within influencing distance of the rear extension and even if consent could be obtained from Camden Council to fell the protected trees, we consider that it is unlikely that the Third Party tree owners would agree to actually remove the trees. The implicated trees are under the control of three separate neighbours and we are aware from earlier correspondence that they are keen for the trees to be retained.

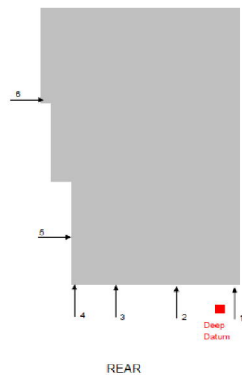
A programme of level monitoring has been undertaken March 2012 through to August 2013 and this has demonstrated a pattern of cyclical movement indicative of vegetation related clay shrinkage with downward movement over the summer period and subsequent ground recovery over the winter months.

In addition a programme of crack width monitoring was undertaken incorporating the cracking to the internal cross wall between the ground floor front bedroom and rear lounge, a crack adjacent to the first floor bedroom window together with the vertical crack between the rear extension and the main building. The monitoring of the cracking to the internal cross wall and within the rear first floor bedroom has not demonstrated any significant progression, whereas the crack between the main building and rear extension has shown a pattern of cyclical movement with the crack opening during the summer and closing over the winter.

It would therefore appear that it is only the rear single storey extension that continues to be affected as a result of vegetation related subsidence.
