Arboricultural Consultant: Kim Gifford

**Picus Sonic Tomographic Test Report**  
**59 Redington Road NW3.**

**1.1 Test date:** 27<sup>th</sup> August 2020 by Mr. Kim Gifford, undertaken in the area of test and at the time of inspection.

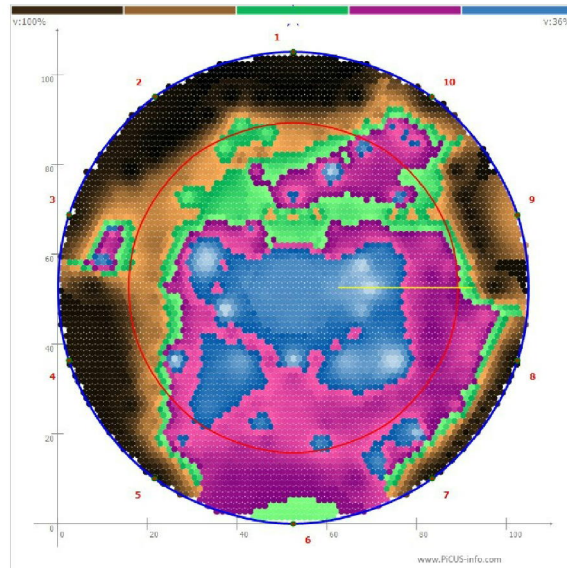
Test 1 @ level: 50cms approximately from ground level.

The measuring point readings give evidence of sound velocities overall in the area of test representation showing as altered timber. The tomographic images shown above has a percentage amount of decayed timber. With reference to the 'colour chart see figure 2', the slower sonic speed of sound is represented by three bands of data representation blue/violet/white being the slowest altered/decayed timber, green being faster altered timber, brown being fast sonic-speeds solid timber.

The resulting Picus test is of acceptable limits in relation the altered timber. This ratio called a 'trunk ratio' TR (*reference Claus Mattheck*) has been calculated to be a guideline in terms of stability and rigidity of cylindrical structure. Although a debated theory in arboriculture in general terms the TR of 30% is an average.

It is evident that this specimen has decayed and stressed timber across in the trunk at 150cms.

In conclusion the overall condition of this Oak has some structural defect however enough sustainable wood to maintain its structural integrity at the time of inspection.

It would be appropriate to recommend that the Oak should be managed on a two-year cycle to reduce the stress from the decayed areas. Crown reduce overall by 1m to 2m.

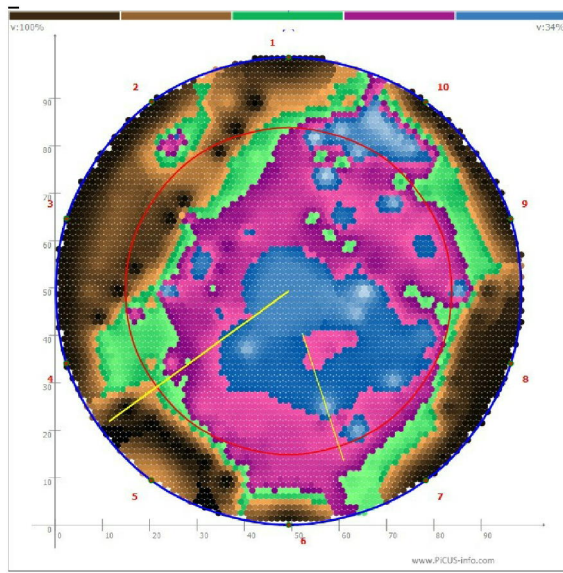
**Test 1 @ level: 50cms approximately from ground level.**

The measuring point readings give evidence of sound velocities overall in the area of test representation showing as altered timber. The tomographic images shown above has a percentage amount of decayed timber. With reference to the 'colour chart see figure 2', the slower sonic speed of sound is represented by three bands of data representation blue/violet/white being the slowest altered/decayed timber, green being faster altered timber, brown being fast sonic-speeds solid timber.

The resulting Picus test is of acceptable limits in relation the altered timber. This ratio called a 'trunk ratio' TR (*reference Claus Mattheck*) has been calculated to be a guideline in terms of stability and rigidity of cylindrical structure. Although a debated theory in arboriculture in general terms the TR of 30% is an average.

It is evident that this specimen has decayed and stressed timber across in the trunk at 150cms.

In conclusion the overall condition of this Oak has some structural defect however enough sustainable wood to maintain its structural integrity at the time of inspection.

It would be appropriate to recommend that the Oak should be managed on a two-year cycle to reduce the stress from the decayed areas. Crown reduce overall by 1m to 2m.

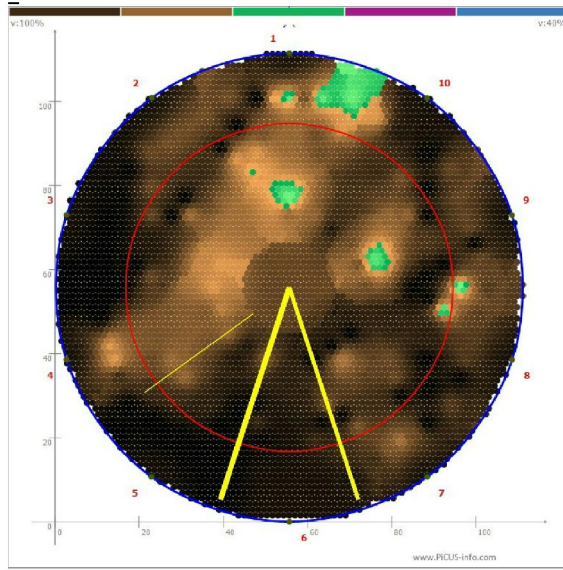
Test 1 @ level: 30cms approximately from ground level.

The measuring point readings give evidence of sound velocities overall in the area of test representation showing as sound timber. The tomographic images shown above has a percentage amount of sound timber. With reference to the 'colour chart see figure 2', the slower sonic speed of sound is represented by three bands of data representation blue/violet/white being the slowest altered/decayed timber, green being faster altered timber, brown being fast sonic-speeds solid timber.

The resulting Picus test is of acceptable limits in relation the altered timber. This ratio called a 'trunk ratio' TR (*reference Claus Mattheck*) has been calculated to be a guideline in terms of stability and rigidity of cylindrical structure. Although a debated theory in arboriculture in general terms the TR of 30% is an average.

**It is evident that this specimen is in a normal condition for its age and species.**

**Remedial treatment will be required over a period of time for instance removal of deadwood or selective pruning of overextended branches as required in the future.**
