Picus Sonic Tomographic Test Report
59 Redington Road NW3.

1.1 Test date: 27th August 2020 by Mr. Kim Gifford, undertaken in the area of test and at the time of inspection.

1.6 Oak (Quercus robur)

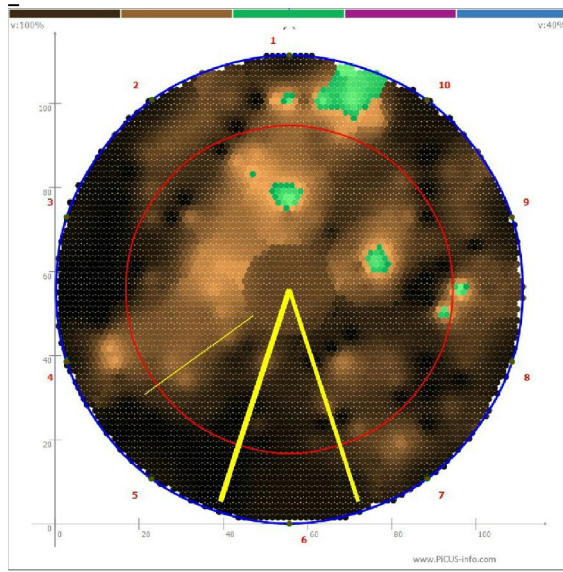
Test 1 @ level: 30cms approximately from ground level.

The measuring point readings give evidence of sound velocities overall in the area of test representation showing as sound timber. The tomographic images shown above has a percentage amount of sound timber. With reference to the 'colour chart see figure 2', the slower sonic speed of sound is represented by three bands of data representation blue/violet/white being the slowest altered/decayed timber, green being faster altered timber, brown being fast sonic-speeds solid timber.

The resulting Picus test is of acceptable limits in relation the altered timber. This ratio called a 'trunk ratio' TR (*reference Claus Mattheck*) has been calculated to be a guideline in terms of stability and rigidity of cylindrical structure. Although a debated theory in arboriculture in general terms the TR of 30% is an average.

It is evident that this specimen is in a normal condition for its age and species.

Remedial treatment will be required over a period of time for instance removal of deadwood or selective pruning of overextended branches as required in the future.
