**TECHNICAL REPORT ON A SUBSIDENCE CLAIM**

**SUBSIDENCE CLAIM**

DATE 22 October 2019

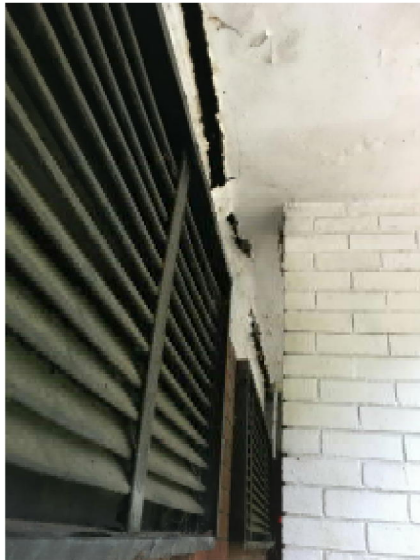
Beneath staircase

Staircase to the left hand side is showing movement away from the main building <60mm.  
Staircase to the right hand side is showing some minor (historic) movement <3mm.

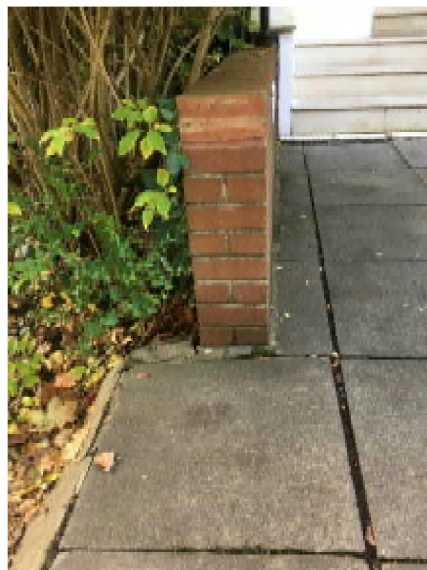
Path leading to front steps at entrance 12-23 Mourne House has dropped and dwarf wall has rotated outwards (to be dealt with under a separate claim).

Rotation of dwarf wall at entrance
