Addendum Arboricultural Report

Subsidence Damage Investigation at:

CLIENT: Crawford & Company
 CLIENT REF: [REDACTED]
 MWA REF: [REDACTED]
 MWA CONSULTANT: [REDACTED]
 INITIAL REPORT DATE: 02/12/2019
 REVISION DATE: Add 01 20/07/2020

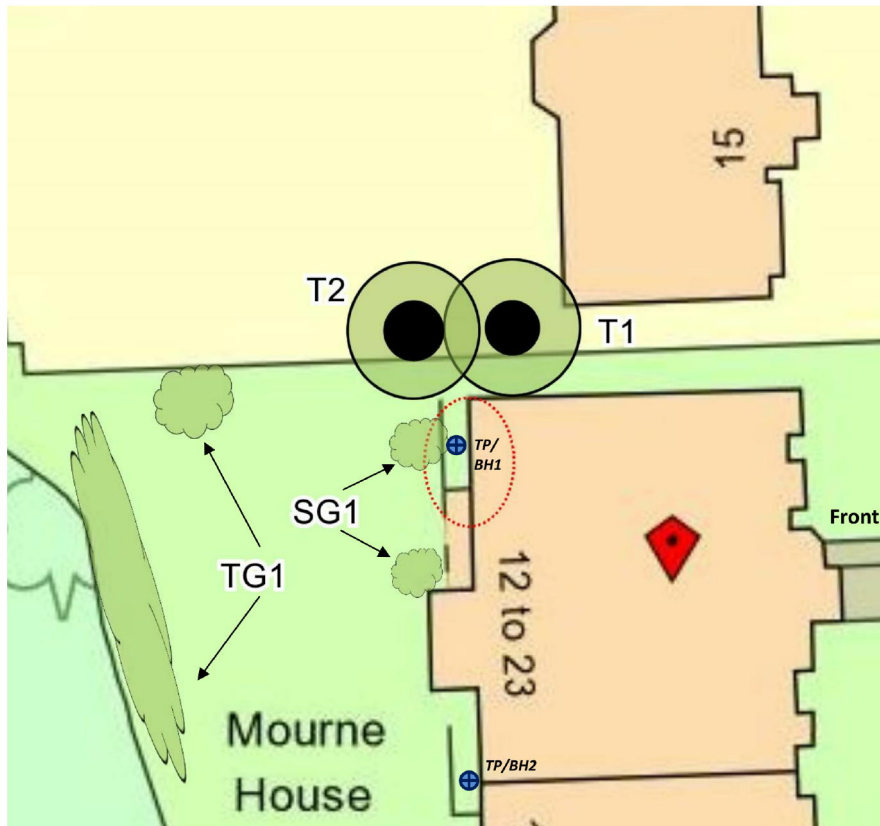
Site Plan

Approximate areas of damage

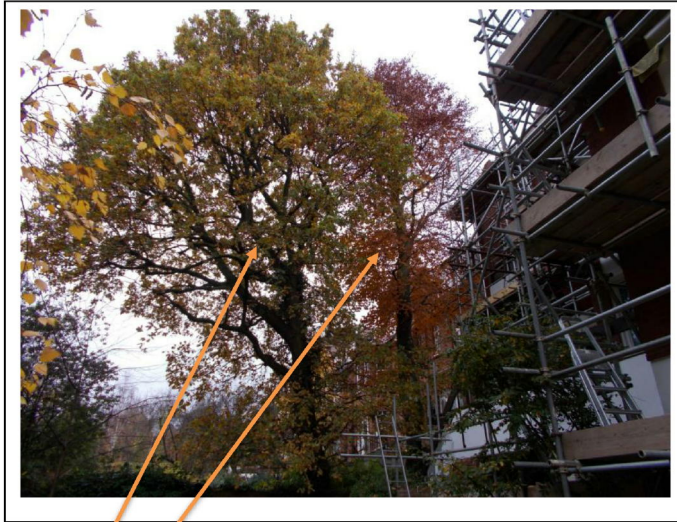
Roots were observed to a depth of 1500mm bgl in TP/BH1 and recovered samples have been positively identified (using anatomical analysis) as *Quercus spp.*, the origin of which will be T2, confirming the influence of this tree on the soils below the foundations.

The site investigation, root identification and monitoring data clearly implicate T2 in the current damage.

T1 is a large tree in very close proximity to the dwelling but has a significantly smaller crown spread than T2 and is of a species (beech) that is less often implicated in subsidence damage than oak. This does not however exclude the tree from being a contributor in the damage.

Based on the technical reports currently available, engineering opinion and our own site assessment we conclude the damage is consistent with shrinkage of the clay subsoil related to moisture abstraction by vegetation. Having considered the available information, it is our opinion that T1 and T2 are the principal cause of or are contributing to the current subsidence damage.

View of T2 and T1

| Tree No. | Species | Ht. (m) | Dia. (mm) | Crown Spread (m) | Dist. to building (m) | Age Classification | Ownership |
|---|---|--|---|---|---|---|--|
| Recommendation | | PROVISIONAL - Remove (fell) to near ground level subject to the effects of removing T2 being assessed. | | | | | |
| Recommendation | | Remove (fell) to near ground level and treat stump to inhibit regrowth. | | | | | |

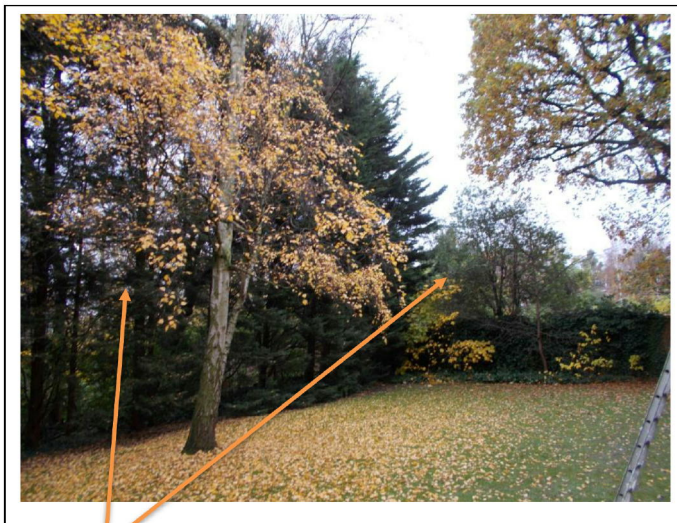
Other vegetation recorded presents a potential future risk to building stability and management is therefore recommended. There are several well managed shrubs and small trees in both the front and rear garden that are not noted within the report; this vegetation should continue to be managed at its current dimensions by periodic pruning.

View of TG1

| Tree No. | Species | Ht. (m) | Dia. (mm) | Crown Spread (m) | Dist. to building (m) | Age Classification | Ownership |
|---|--|--|---|---|---|---|---|
| Recommendation | | Maintain broadly at no more than current dimensions by periodic pruning. | | | | | |

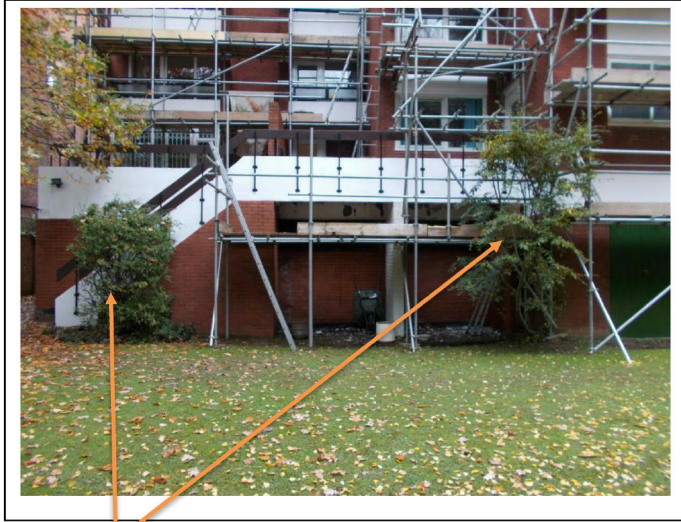
View of SG1

| Tree No. | Species | Ht. (m) | Dia. (mm) | Crown Spread (m) | Dist. to building (m) | Age Classification | Ownership |
|---|--|--|---|---|---|---|---|
| Recommendation | | Maintain broadly at no more than current dimensions by periodic pruning. | | | | | |
