Project: 40204

Parnell House
Camden
London
WC1A 1JB

Roof Survey Report & Recommendations

Roof areas covered by this report: Roof 1, 2 & Walkways.

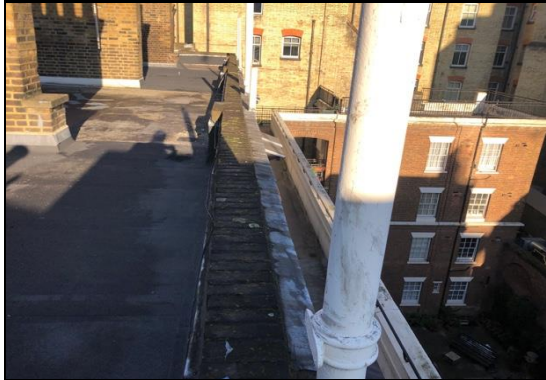
Photograph No. 1

Roof 1 – the original asphalt covering has been overlaid multiple times indicating it is beyond economical repair.

- We recommend stripping the existing system back to the asphalt covering and installing a new bituminous membrane system.
- We recommend installing the Langley TA-30-W system including bituminous vapour barrier, flatboard insulation (to achieve the required U-value 0.18 W/²K) with underlay and mineralised cap sheet to achieve a 30-year insurance backed guarantee.

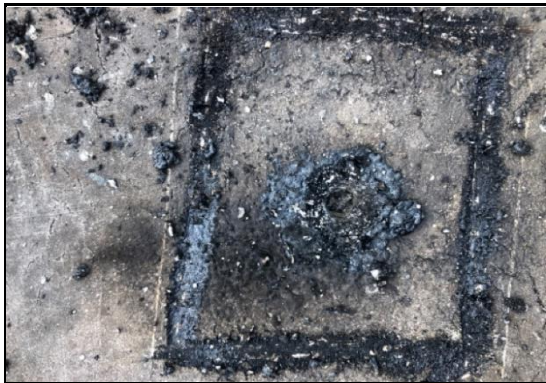
Photograph No. 2

Core sample revealed a concrete deck beneath the asphalt.

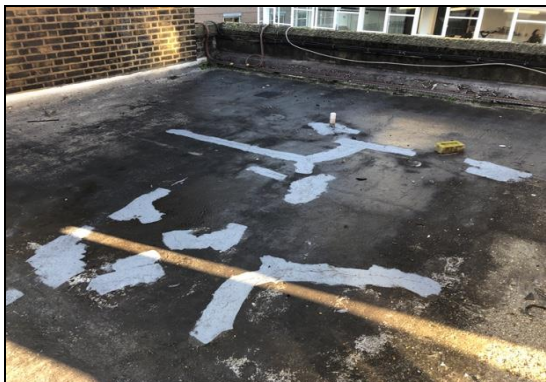
Photograph No. 3

Multiple failed repairs indicate a history of ingress.

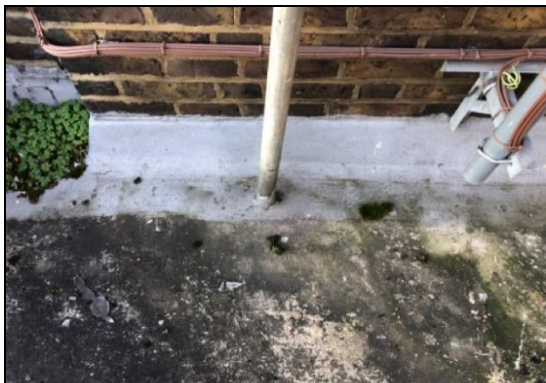
Photograph No. 4

There are multiple penetrations that are redundant, are contributing to ingress and have been repaired.

- The system should be continued up the parapet but terminated to the upstand and weathered with Paraflash lead free system.
- All cables and plant should be removed to facilitate works, all redundant plant and penetrations should be identified and removed.

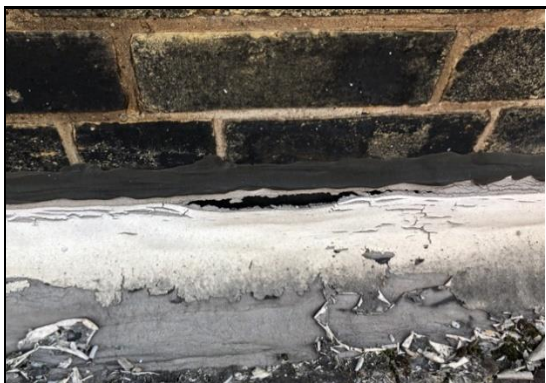
Photograph No. 5

Failing upstands will be allowing ingress to penetrate the system.

- All upstand details should receive a new chase and terminated with Paraflash and Langley Gapseal. Cavity trays will need to be raised to account for the height of the new system.

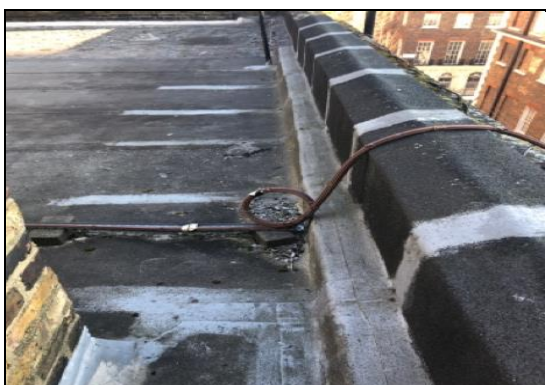
Photograph No. 6

The building has listed status so the parapets cannot be changed aesthetically. The parapets have been subject to multiple repairs and require attention.

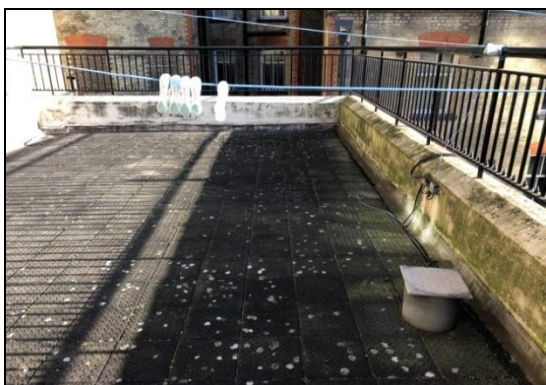
Photograph No. 7

Roof 2 – promenade tiles suggest the area is used by the tenants. The asphalt roof covering also has some insulation within the build-up.

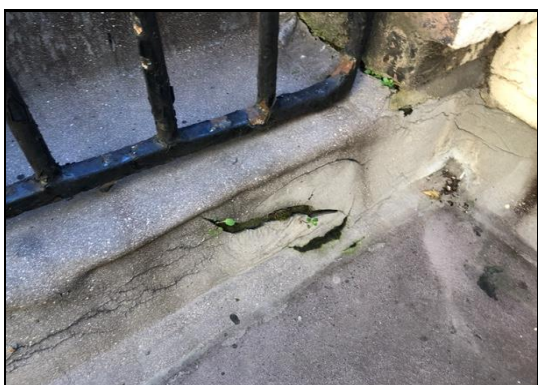
Photograph No. 8

Splits have formed in the main roof covering indicating issues within the build-up. Railings will have to be raised to facilitate works.

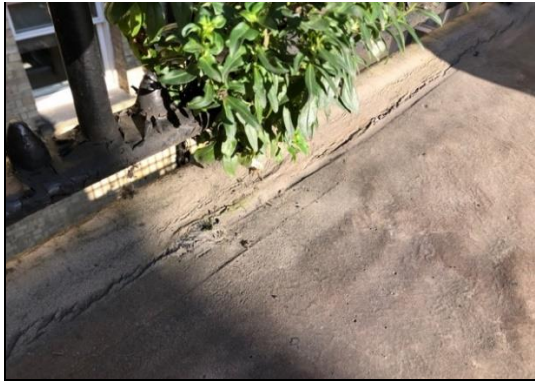
Photograph No. 9
Trees have taken root in the upstands.

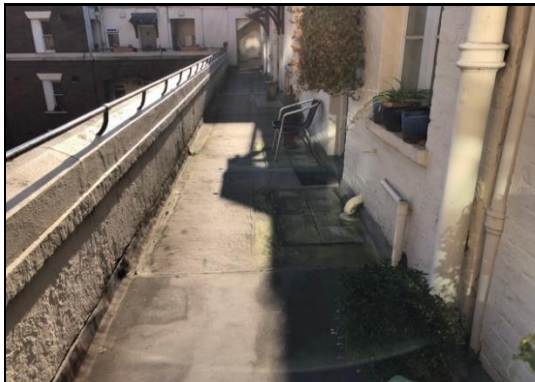
Photograph No. 10
Walkways – the original asphalt covering has been overlaid with a liquid covering indicating a history of ingress.

- We recommend stripping the existing system back to the asphalt covering and installing a new PMMA fast curing system.
- We recommend installing the Langley PR-15 with slip-inhibiting finish to achieve a 15-year insurance backed guarantee.
- The system should be continued up the parapet but terminated to the upstand and sealed with Langley Gapseal.
- All cables and plant should be removed to facilitate works, all redundant plant and penetrations should be identified and removed.
- The system should be sealed to the existing outlets.
- The system should be terminated to the underside of the door thresholds.

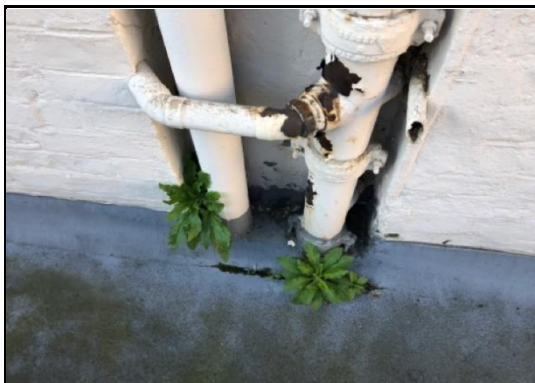
Photograph No. 11
Plants have taken root in the splits and penetrations of the asphalt.

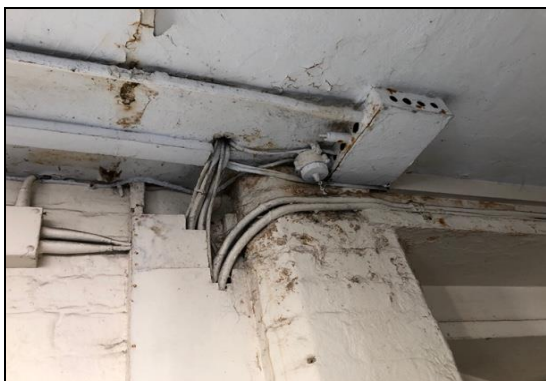
Photograph No. 12
Ingress can be seen on the lower floors indicating the walkways require attention.

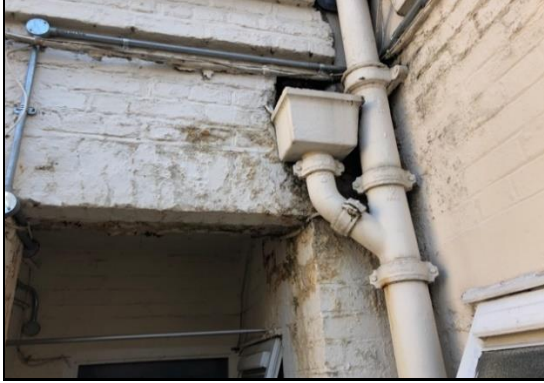
Photograph No. 13

Roof 1 & 2 – significant staining to the walls indicated the roof areas are failing.
