Arboricultural Appraisal Report

Subsidence Damage Investigation at:

1C Spencer Rise
London
NW5 1AR

CLIENT: Crawford & Company
CLIENT REF: [REDACTED]
MWA REF: [REDACTED]
MWA CONSULTANT: Andy Clark
REPORT DATE: 02/09/2020

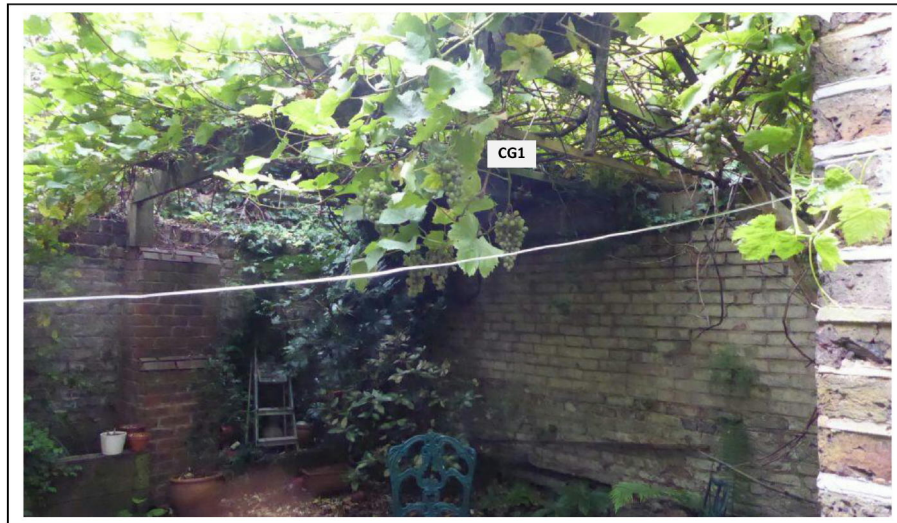
The origin of the Vitaceae spp. roots retrieved at the rear will be the CG1 grape vine. Although testing negative for Starch, the probably Prunus spp. roots retrieved at the property frontage will likely originate from the policy holders T3 Bird Cherry, but may also originate from the Local Authority T4 Bird Cherry. No Cupressaceae spp. or Taxodiaceae spp. vegetation were observed.

Having considered the information currently available, it is our opinion that CG1, T1 and SG1 at the rear and T3 and SG3 at the property frontage will all be contributory factors in the current damage to varying degrees. The T4 Local Authority tree may also be involved, but at present this is equivocal.

View of CG1 grape vine trained over rear pergola

If an arboricultural solution is to be implemented to mitigate the influence of the implicated trees/vegetation we recommend that CG1, T1 and SG1 at the rear and T3 and SG3 at the property frontage are all removed in the first instance. If movement persists however then attention will need to turn to the Local Authority T4. Other vegetation recorded presents a potential future risk to building stability and management is therefore recommended.

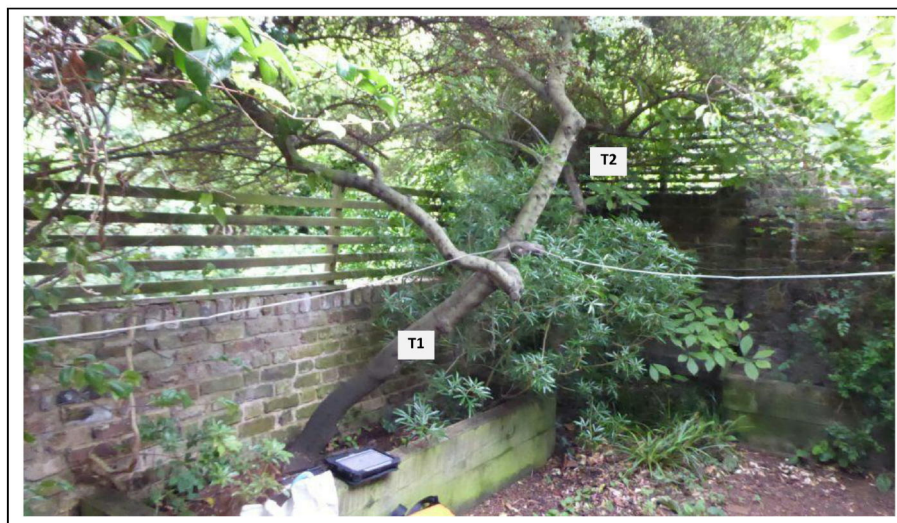
Irrespective of the identification of recovered root samples, the roots of the T1 Ceanothus and the SG1 shrub group at the rear will also be present below the foundations of the rear projection and influencing soil moisture and volumes.

View of T1 Ceanothus and T2 Cherry with Magnolia

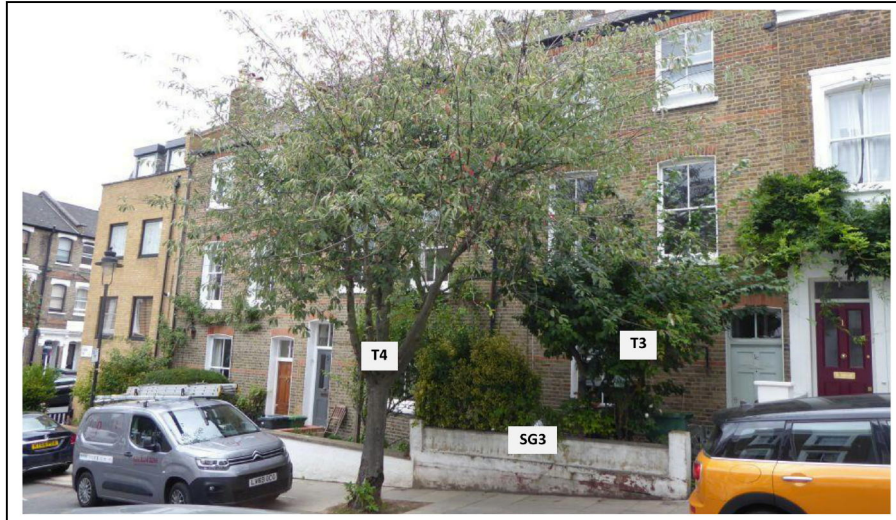
Overview of T3 and T4 Bird Cherry and SG3 mixed spp. shrub group
