TECHNICAL REPORT ON A SUBSIDENCE CLAIM

1C Spencer Rise
London
NW5 1AR

DATE 17th January 2020

TECHNICAL REPORT

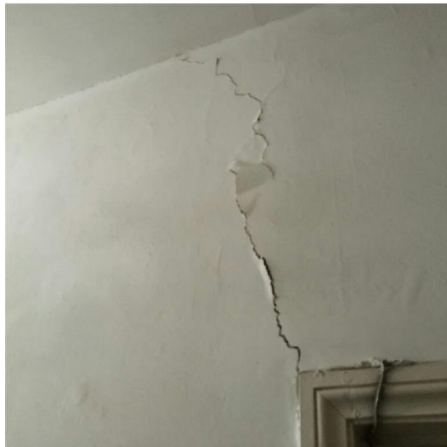
Crack in the hall

3mm vertical crack over the door to the ground floor front room, together with hairline parallel crack

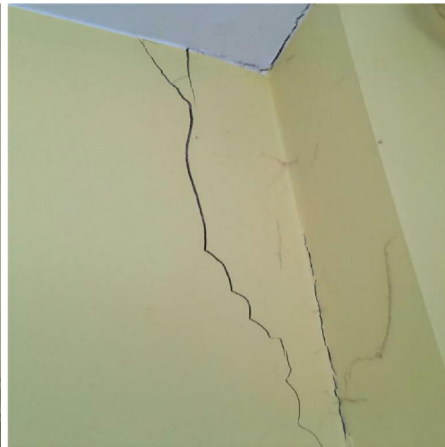
Crack in the ground floor rear kitchen

3mm vertical crack to the party wall

2mm crack across the top of the front wall

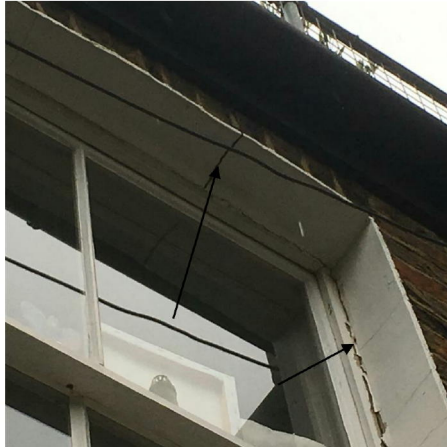
Cracking at the mid length of the flank wall of the back addition

3mm vertical crack under the kitchen window, extending up the side of the window frame, up the window above, and then to the eaves.

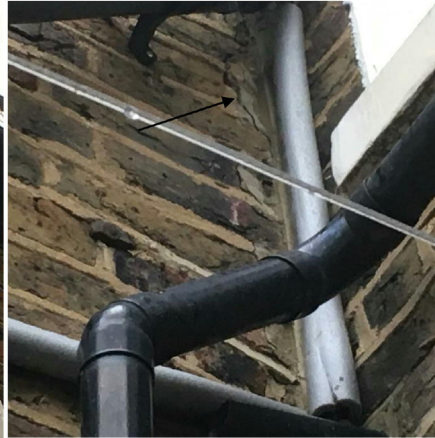
Crack in the corner of the back addition and the main house

3mm vertical crack in the corner between the main body of the house and the back addition. there is evidence of previous repairs.

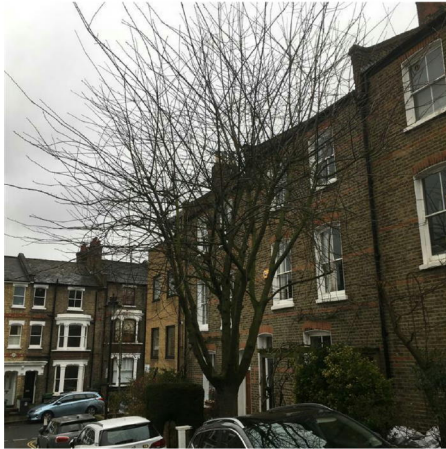
The timing of the event, the presence of shrinkable clay beneath the foundations and the proximity of vegetation where there is damage indicates the shrinkage to be root induced. This is a commonly encountered problem and probably accounts for around 70% of subsidence claims notified to insurers.

Street tree

Although the cause of the movement needs to be dealt with, we note the involvement of a Local Authority tree.

Investigations would involve trial pit(s) to determine the depth and type of footings, boreholes to determine the nature of the subsoil/influence of any roots and monitoring to establish the rate and pattern of movement. It may also be necessary to obtain a specialist Arboricultural Report.

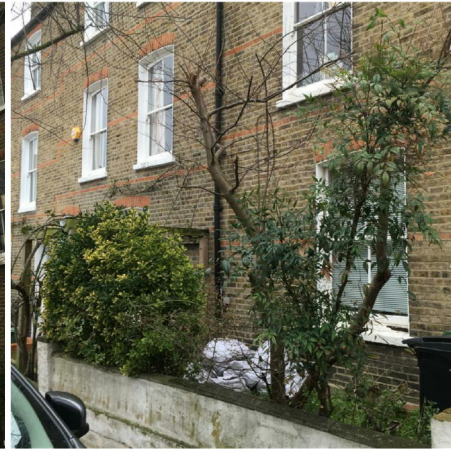
Vegetation in the front garden

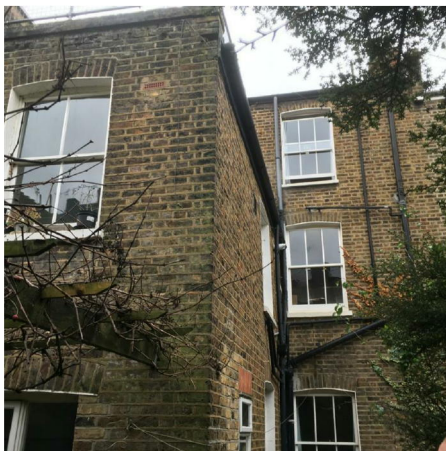
Rear elevation

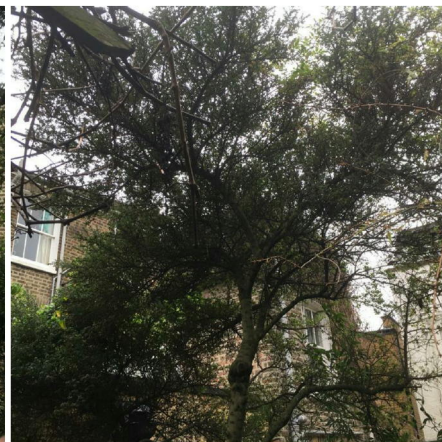
Ceanothus in the rear garden

These investigations will also identify if there is subsidence towards the rear due to the influence of the Ceanothus.

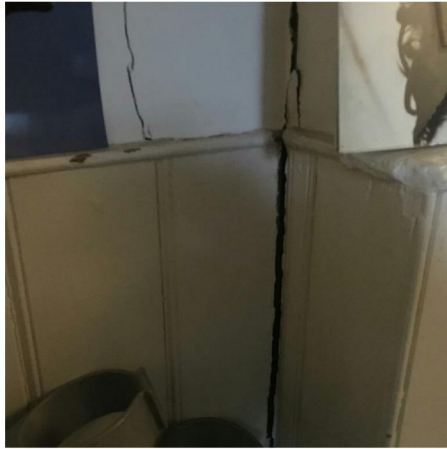
Cracking on the first floor landing

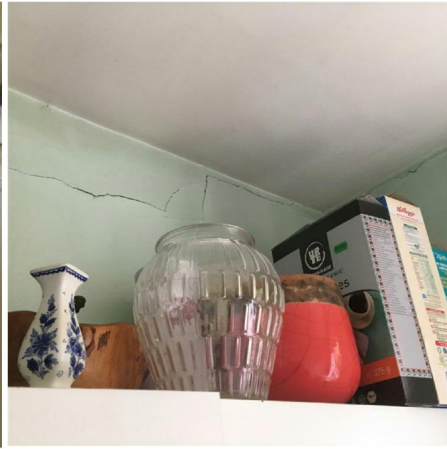
2mm crack in the front left corner
1mm horizontal crack along the top of the left hand wall

Cracking in the first floor kitchen

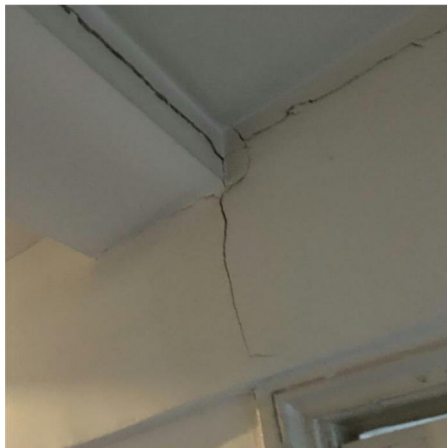
Cracking on the first floor landing

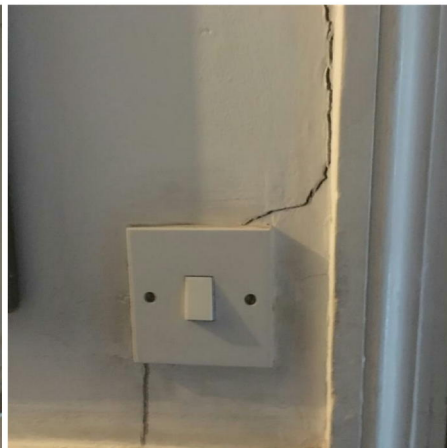
Cracking on the first floor landing
