## SITE INVESTIGATION FACTUAL REPORT

Report No: [REDACTED]  
Client: Crawford Claims Management  
Site: 1c Spencer Rise, London  
Client Ref: [REDACTED]  
Date of Visit: 10/06/2020

# Investigation Layout Plan

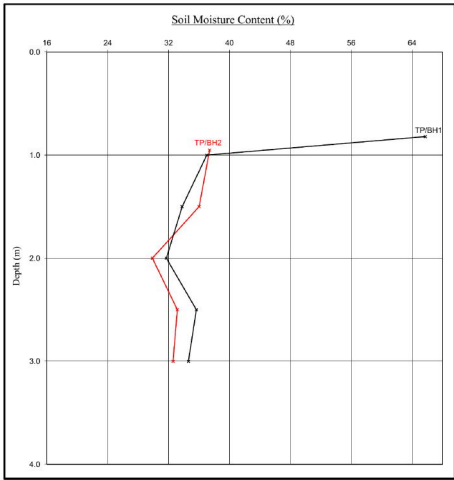
Moisture Content Profiles

Notes:  
1. If plotted,  $0.4LL$  and  $PL-2$  (after Driscoll, 1983) should only be applied to London Clay (and similarly overconsolidated clay) at shallow depths.  
2. Unless specifically noted the profiles have not been related to a site datum.

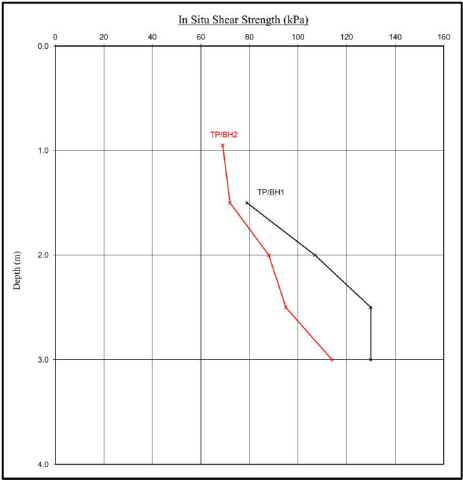
Shear Strength Profiles

Note:  
1. Unless otherwise stated, values of Shear Strength were determined in situ by CET using a Picon Hand Vane the calibration of which is limited to a maximum reading of 140 kPa.  
2. Unless specifically noted the profiles have not been related to a site datum.
