LOCKER & RILEY

Koko, Camden, London.

Project Title: *Koko*

L&R Reference: J2016 Koko.

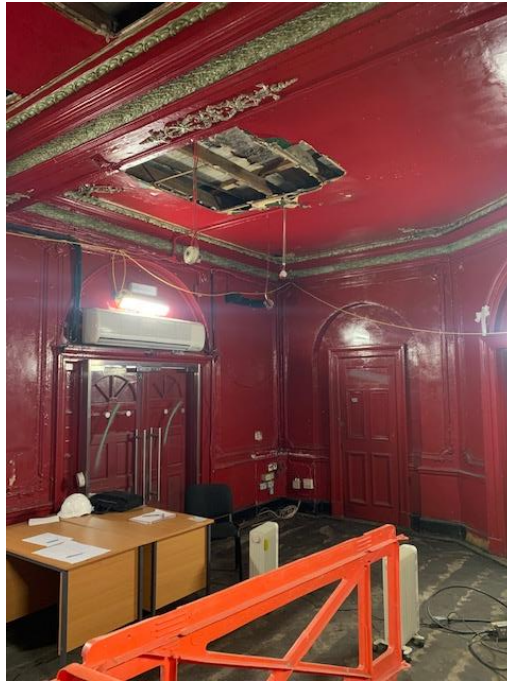
- The walls and ceiling soffits are coated with thick red paint. In many areas this has ‘blistered’ due to the trapped moisture held in the masonry walls behind. The Report by *Catherine* Hassall (March 2020) confirms that the red surface paint covers a succession of applications including to some surfaces a gypsum skim coat. The removal of these paint layers by chemical and mechanical means would be time consuming and expensive with an uncertain outcome given the damp status of the plaster substrate.

- The complete removal of the wall plaster to reveal the masonry substrate is the only way to ensure successful drying out. Retention of wall plaster greatly hinders and prevents the loss of trapped moisture in the masonry which will leave a legacy of potential efflorescence of salts, conditions suitable for fungal attack on timber and the appearance of ‘damp patches’ and discolouration on completed decorated walls.

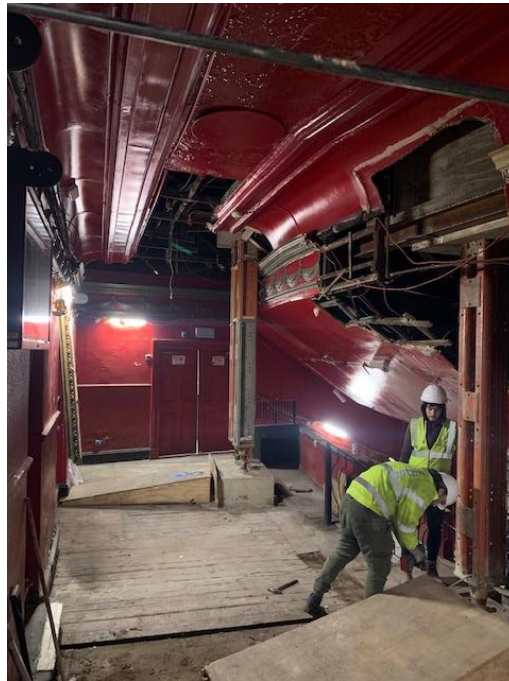
- The insertion of structural piers was permitted by Planning Application nr 2019/0695/L and granted on 15th May 2019. There has been some loss of plaster fabric due to their insertion but this has greatly been compounded by the damage caused by the fire and water penetration since January 2020.

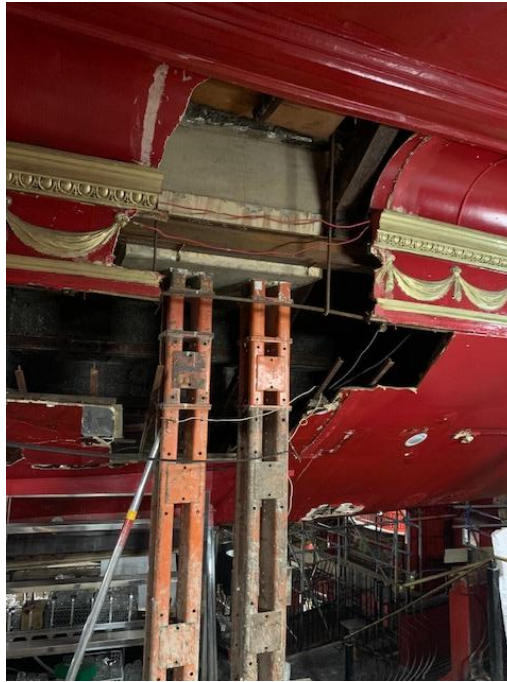
- The walls are plain with a simple dado rail and skirting. Much of the wall surface has been painted over a textured (paper?) surface with a thick gloss red paint.

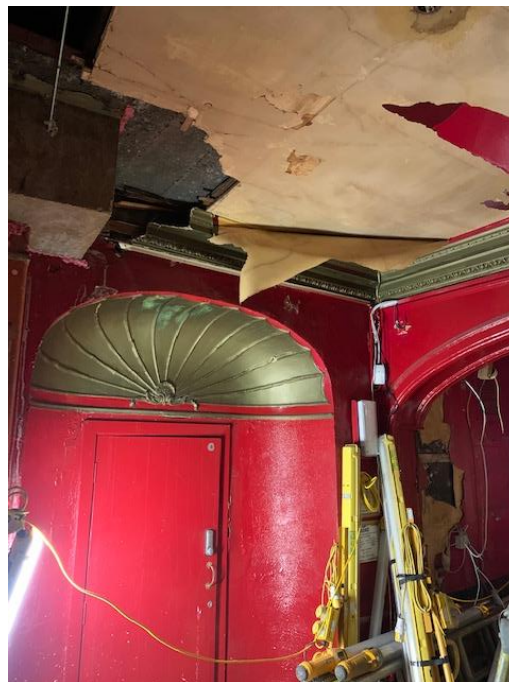
- The Entrance Hall/Foyer on the Ground Floor of the Theatre. The area is divided by four wide plain arches and pilasters into five bays. Each bay has a plain fibrous plaster flat ceiling with a egg and dart cornice to the perimeter. The North elevation has two matching profiled fibrous plaster niche heads above door openings into the main auditorium.
- The insertion of structural piers was permitted by Planning Application nr 2019/0695/L and granted on 15th May 2019. There has been some loss of plaster fabric due to their insertion but this has greatly been compounded by the damage caused by the fire and water penetration since January 2020.

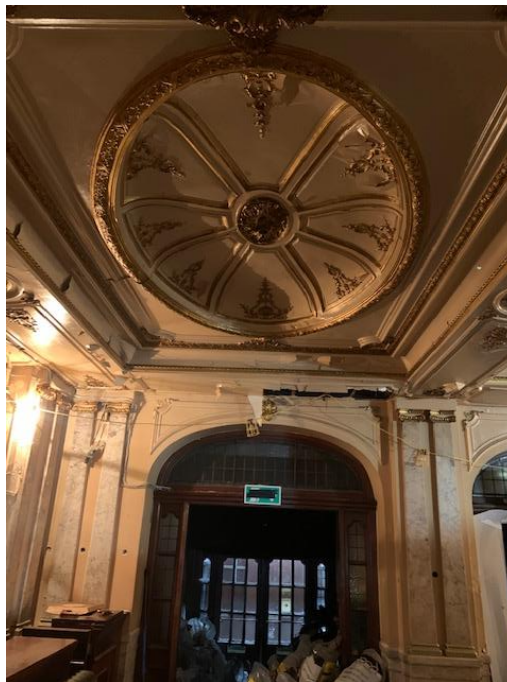
- This Foyer area consists of three bays each containing a shallow oval dome and an enriched cove to the perimeter. The dividing beams have decorative elements in relief. The walls are decorated with marble pilasters and panels with ornate quadrant corners.
- The ceilings, cornice and beams are of fibrous plaster construction suspended from the concrete slab above on timber joists and noggins. The recent ingress of water has caused the failure and loss of some sections of ceiling soffit. Further areas appear to be in a poor condition and are at risk of collapse.

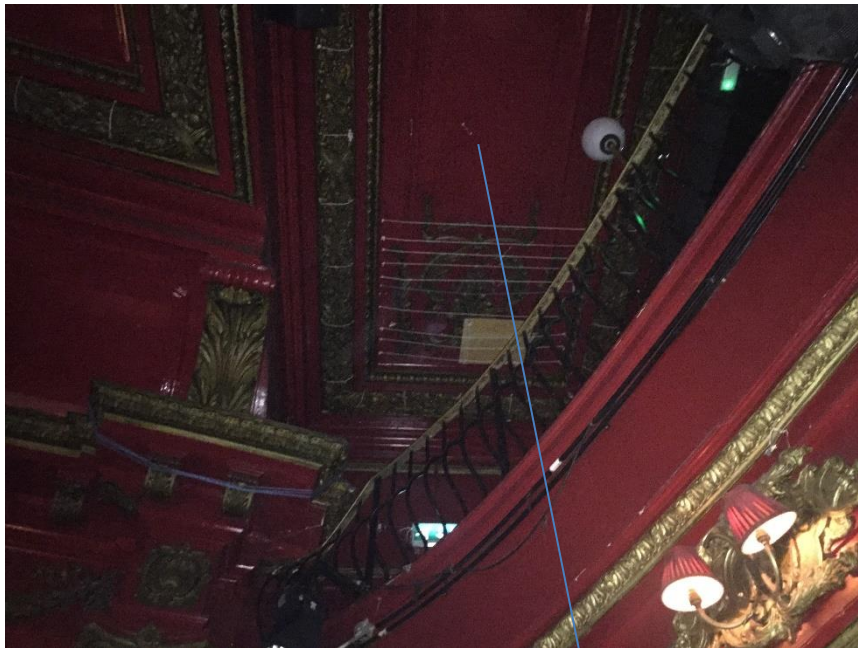
Rectangular shaped soffit believed to be badly affected by water ingress.

- This area lies to the far western side of the main auditorium and consists of a rectangular area of three coffers. The works to secure, repair and replace missing and damaged sections was partially completed in the L&R contracted works carried out in the Autumn of 2019.
- We have noted that this area has been badly affected by water ingress as a consequence of the January 2020 fire. Subject to further inspection it is considered that this flat coffered ceiling will be lost and should be carefully removed. The removal of these plaster sections will also benefit the drying out process and allow access for other trades.
- Samples and squeezes of the existing fibrous plaster mouldings will be required so that new moulds and replacement fibrous plaster casts made and installed all to match the existing.

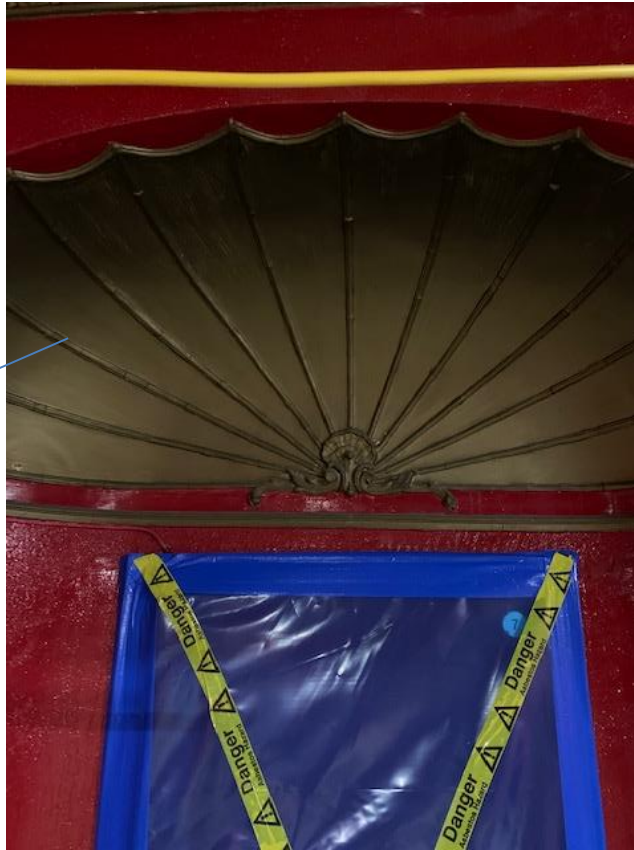
Decorative
niche hood.

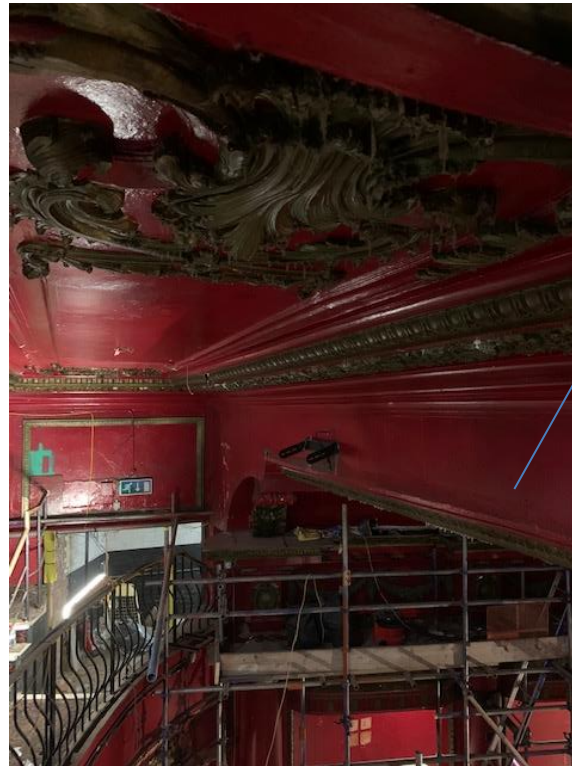
- Close investigation from below reveals that the original plaster face with its layer of red paint is structurally weak in places. In particular the red painted fibrous plaster downstand to the Auditorium dome itself was found to be in a

Red painted downstand in a very poor condition.

- L&R would confirm its earlier recommendation that the fibrous plaster soffit with its decorative enrichments forming two matching bays and to include the red painted downstand and black painted upstand should be carefully taken down and replaced with new sections to match the existing.
- L&R have reached this conclusion on the basis of the widespread and significant water ingress as a consequence of the fire in January 2020. Water ingress and persistent damp conditions are well known factors leading to the degradation and eventual failure of hessian embedded within the fibrous plaster casts and supporting wads. The combination of this threat and that highlighted in the H&R Report of the legacy risk of timber decay in the supporting structure supports this recommendation.

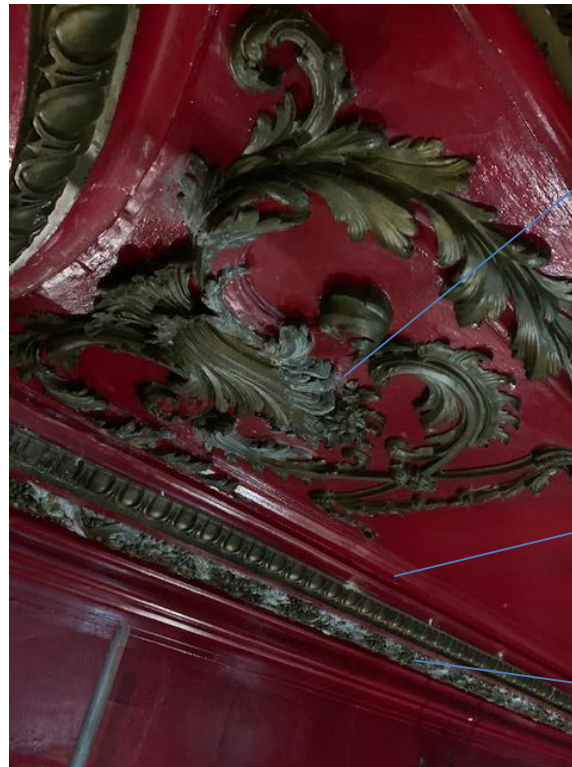
Large
scroll
enrichment
.

Egg and Dart
enriched cornice.

Enriched band.

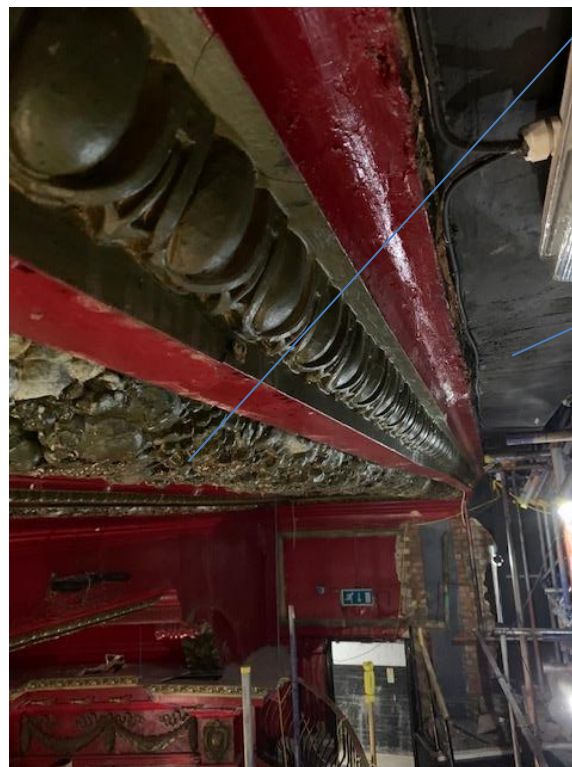
very poor condition. The black soffit and upstand on the other side is in a similar poor condition.

Black soffit and
upstand.

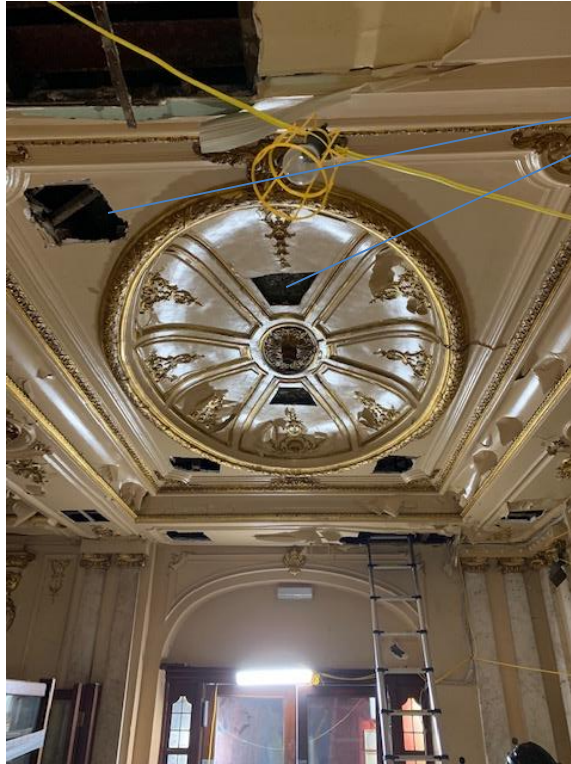
Inspection
holes.

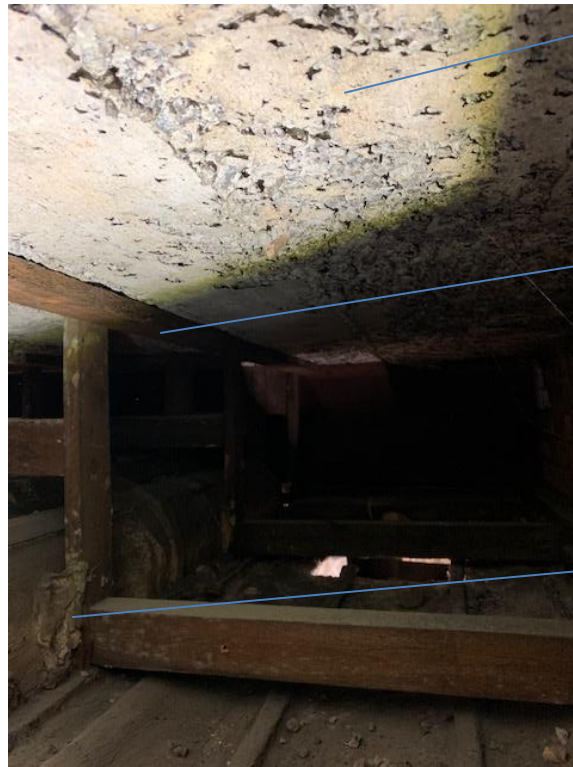
Clinker concrete soffit.

Timber battens secured with nails to the clinker soffit.

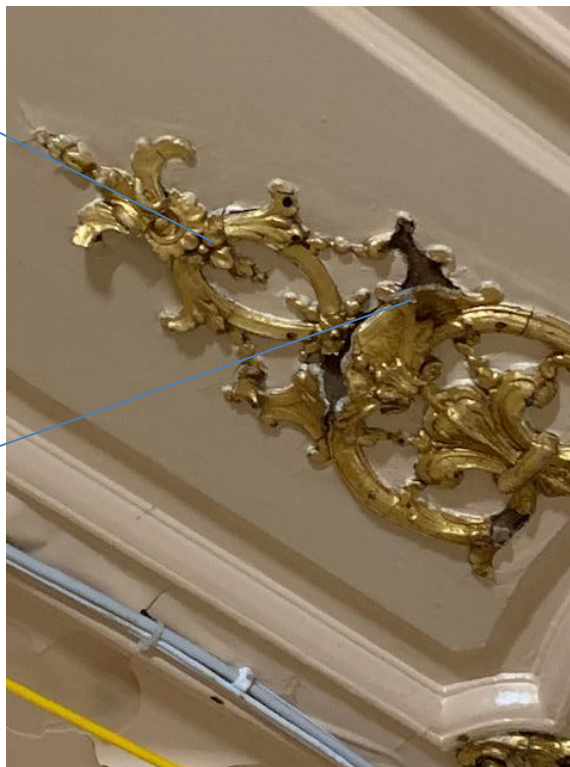
G-17 Entrance Foyer.

- Some of the 'gold painted' enrichments are made of composition and applied to the fibrous plaster soffit. The damp conditions have caused some sections of moulding to detach and are lost and missing.

Decorative element of composition applied to beam soffit.

Section of detached composition detail.

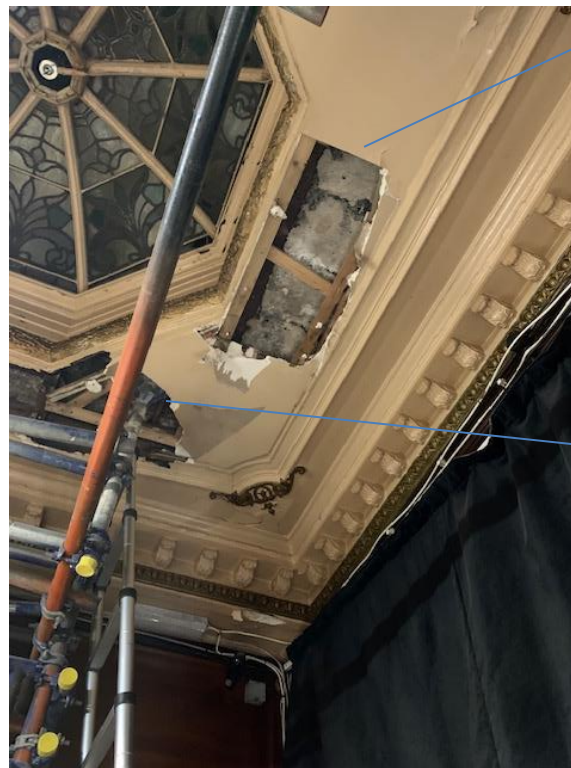
- Some damage has been caused to the plaster soffit by the insertion of supporting scaffolding in order to reach the concrete clinker behind. This loss of plaster has exposed the clinker soffit and the timber supporting structure. It was noted that some of the flat soffit has been 'repaired' with modern plasterboard which would indicate some earlier issues with water ingress.

- The existing plaster soffit appeared to be in a reasonable condition with fewer indications of water inundation and damp. Of greater concern was the timber supporting structure and its anchorage to the clinker concrete soffit which appeared to be in a fragile and weak condition. Some of these timber supports appeared to be contemporary with the plasterboard repairs.

Section of
'modern'
plasterboard
repair with
timber
supports.

Loss and
damage
caused by
insertion of
structural
scaffolding.
