KOKO THEATRE

CAMDEN HIGH STREET

An examination of the paint in rooms at the west end of the building, below the Dome, to determine the types of paint used since 1900, to identify areas where lead paints have been used, and establish if early paint layers have survived

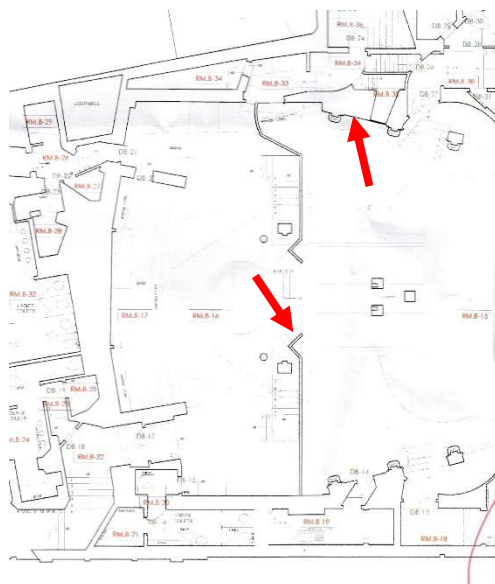
BASEMENT AREA - ROOM B.16

Lead paint Found on the walls and the figures set against the walls.
Not found on the suspended ceiling above the stage or the figure in front of the stage.

Original paint Cream oil paint was applied to the walls and figures in 1900.

Early C20th paints Three lots of oil paint based on lead white were used on the walls.

Later C20th paints Six lots of alkyd paints, some with varnishes, were used on the walls. 'Gold' paint, based on copper filings in a shellac medium, was used on the figures and wall mouldings.

Most recent red paint The red seen today on the walls is not a standard house paint. It is still flexible, with a rubbery texture and is unaffected by a range of solvents.

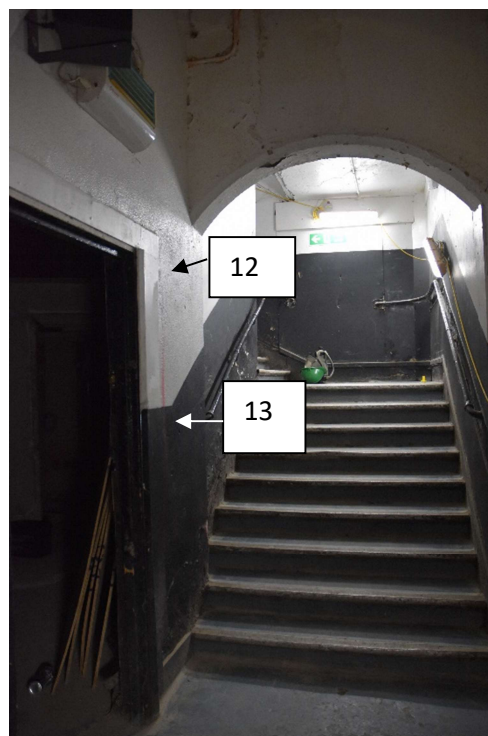
SOUTH STAIRS
BASEMENT TO GROUND FLOOR
B-18

Two samples were taken from the north wall: one above the painted dado and one on the painted dado

Lead paint	Present in both samples
Original paint	Red distemper.
Early C20th paints	Three lots of oil paint based on lead white .
Later C20th paints	Six lots of alkyd paint some based on lithopone white, some on titanium dioxide white.
Most recent paints	Two lots of emulsion paint

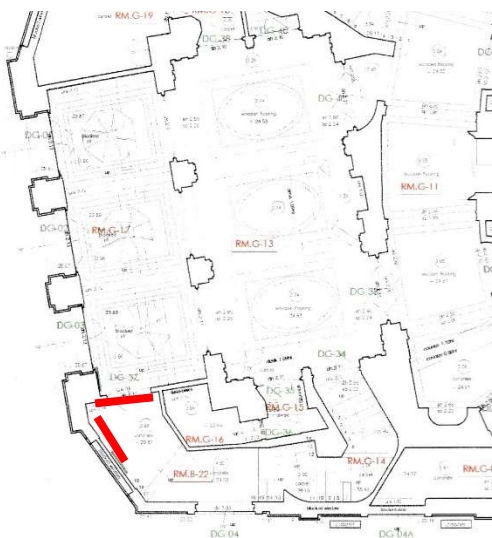
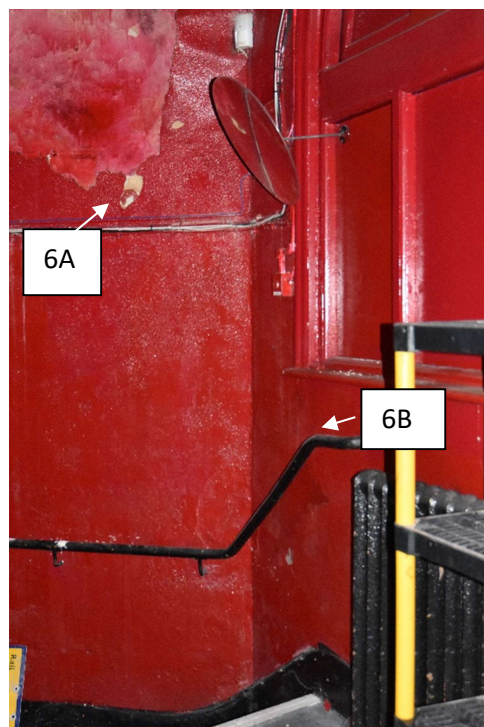
SOUTH STAIRS - BASEMENT TO GROUND FLOOR ROOM B.22

Lead paint	Present on the walls, sealed under the later plaster skim coat.
Original paint	Coat of distemper which may have been a temporary scheme, followed by pink, lead-based oil paint on the walls. Treatment of ceiling unknown
Early C20th paints	Two lots of oil paint based on lead white.
Later C20th Paints	Four lots of alkyd paint , including one with a textured finish.
Later C20th re-plastering	A skim coat of gypsum plaster was applied over early paint layers at some point in the late C20th. Since then the area has been painted twice.

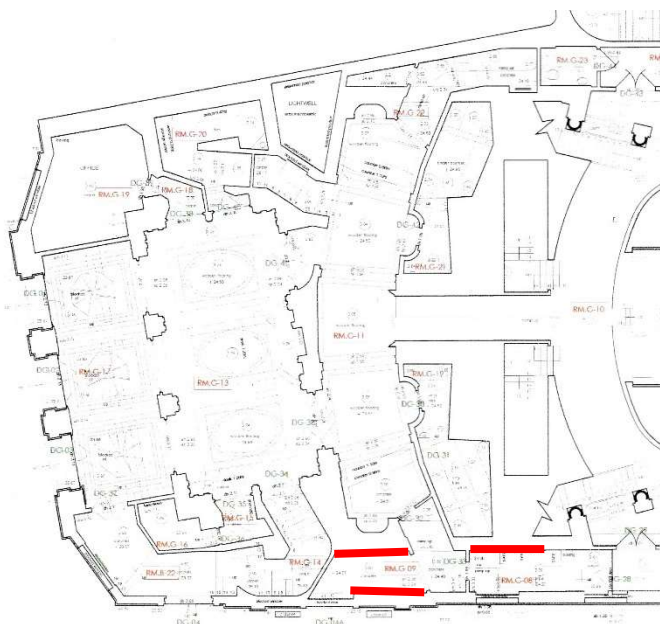
GROUND FLOOR – SOUTH ROOMS G08 & G09

Lead paint	Present on the walls of both rooms
Original paint	Cream coloured oil paint based on lead white
Early C20th schemes	Two more lead-based oil paints
Later C20th schemes	Alkyd paints based on titanium white, including the textured paint used throughout Koko
Most recent paints	Three lots of emulsion paint

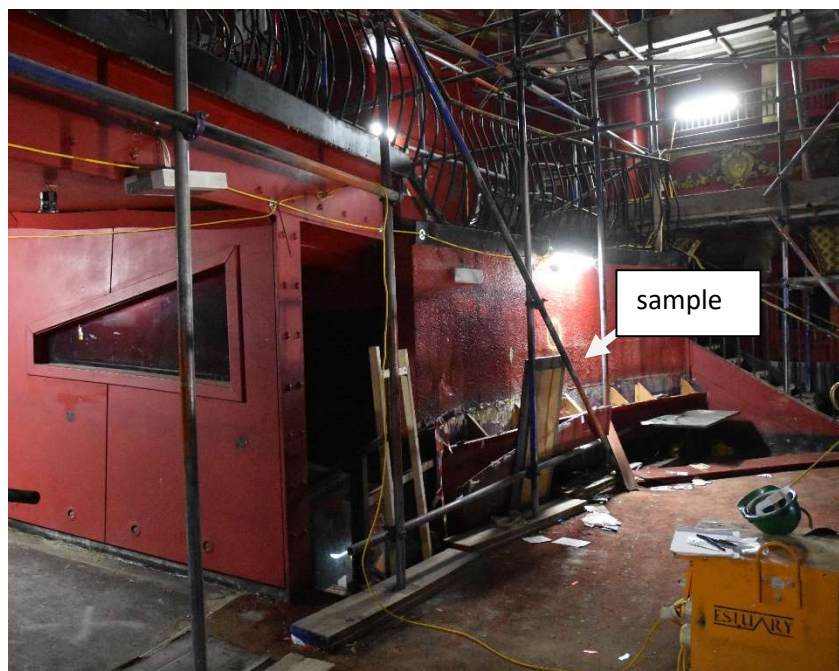
GROUND FLOOR BALCONY G10

The walls in this area have all been recently re-plastered, or faced with hardboard, so no early paints have survived.

One sample was taken from the west wall, where the wall has a textured finish. Underneath the most recent paints, which were applied over textured plaster, is an earlier textured alkyd paint applied over smooth gypsum plaster.

No lead paint in G10

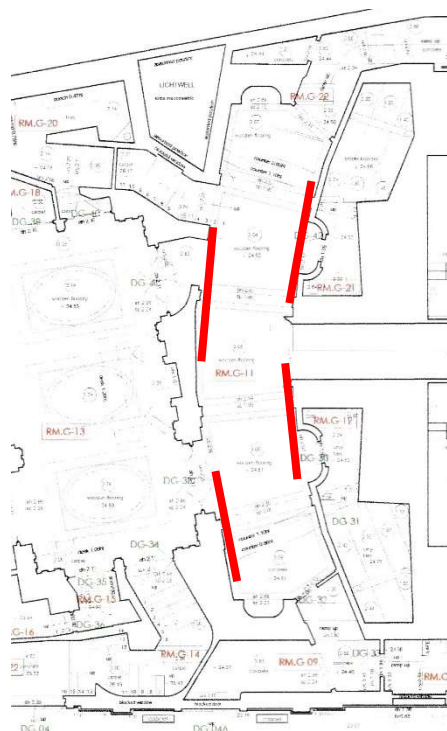
GROUND FLOOR – LOBBY BETWEEN ENTRANCE & AUDITORIUM ROOM G.11

No original paint was found in the samples from the walls and it is likely that lining paper was used, and that when this was removed in the later C20th the early paints were all lost.

Present only in samples taken from gold arched tops of the niches. None on the walls or arches.

The red seen today on the walls is not a standard house paint. It is still flexible, with a rubbery texture and is unaffected by a range of solvents

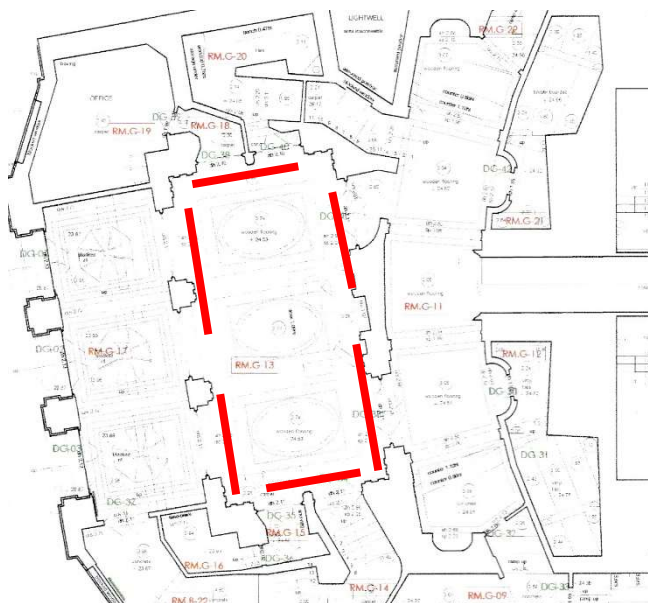
GROUND FLOOR MAIN ENTRANCE ROOM G.13

This room has never been stripped or re-plastered, and the early paint schemes are present on all surfaces.

Lead paint	Present on the ceiling and on the plaster walls. At least five layers of lead paint.
Original paint	Cream oil paint on ceiling, buff oil paint on walls, and mouldings picked out in gold leaf, using an oil size.
Early C20th paints	Four lots of oil paint based on lead white . The original oil gilding now covered with 'gold' paint in a shellac medium.
Later C20th paints	Three lots of alkyd paint based on titanium dioxide white. 'Gold' paint in a shellac medium used on mouldings

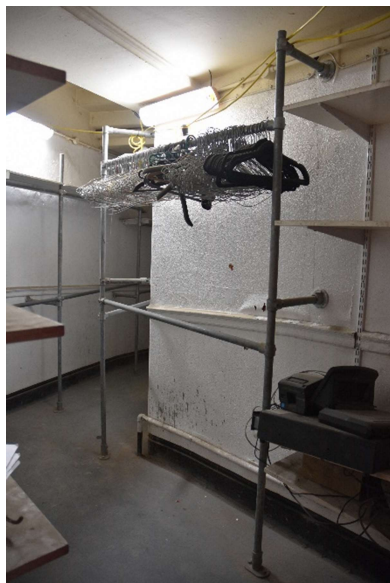
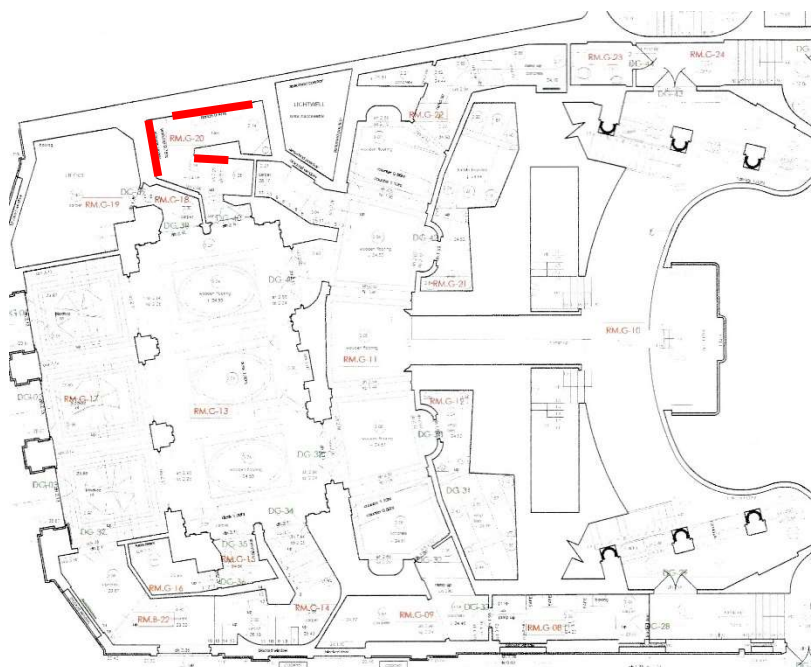
GROUND FLOOR – G20

The room appears to have been re-plastered at some point in the later C20th and no early paints were found.

Lead paints	none present
Original scheme	no longer present
Early C20th schemes	no longer present
Later C20th schemes	alkyd paints based on titanium white
Most recent paint	white emulsion

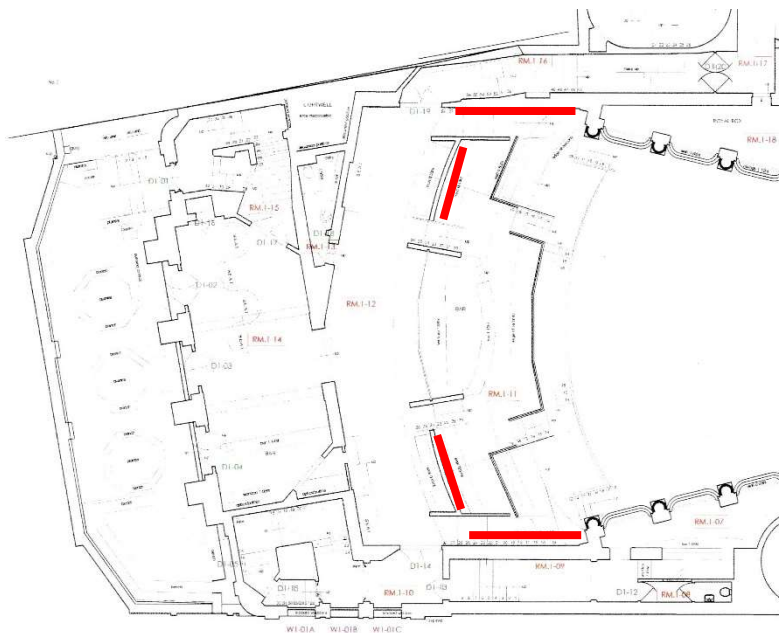
FIRST FLOOR BALCONY ROOM 1.11

This is only present on the front of the second floor balcony and on the north and south walls

N & S walls painted with red distemper
Balcony front painted with cream oil paint topped with a yellow glaze.

Four lots of lead-based oil paint found on the balcony front and north and south walls

Extensive re-plastering took place after the Second World War, followed by four lots of alkyd paints, some with a gloss finish.

The red seen today is not a standard house paint. It is still flexible, with a rubbery texture, and is unaffected by a range of solvents

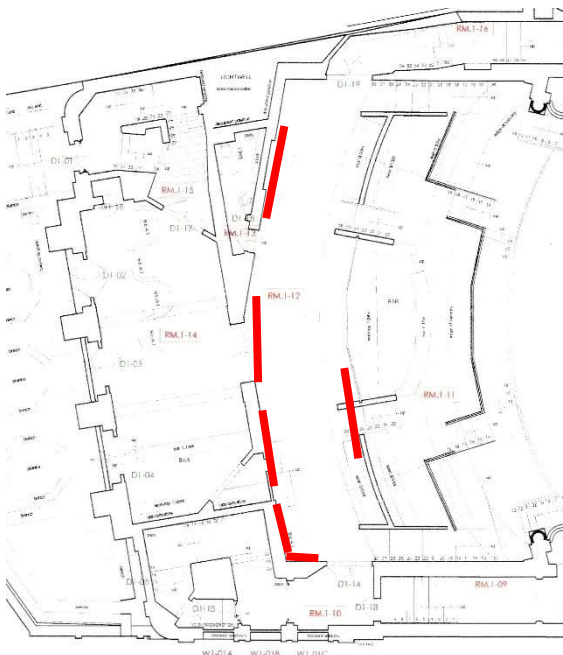
FIRST FLOOR – LOBBY AT BACK OF AUDITORIUM ROOM 1.12

Lead paint	Present in all samples from walls and ceilings.
Original paint	A cream coloured oil paint with red and yellow oil glazes on the surface.
Early C20th paints	Two lots of oil paint, one with a glazed surface.
Later C20th paints	Four lots of alkyd paint. On the last two occasions the mouldings have been picked out in 'gold' paint consisting of copper filings in a shellac medium.
Most recent scheme	The red seen today on walls, ceiling and joinery is not a standard house paint. It is still flexible, with a rubbery texture, and is unaffected by a range of solvents

The only feature which did not have original paint layers was the moulding between the cove and the ceiling

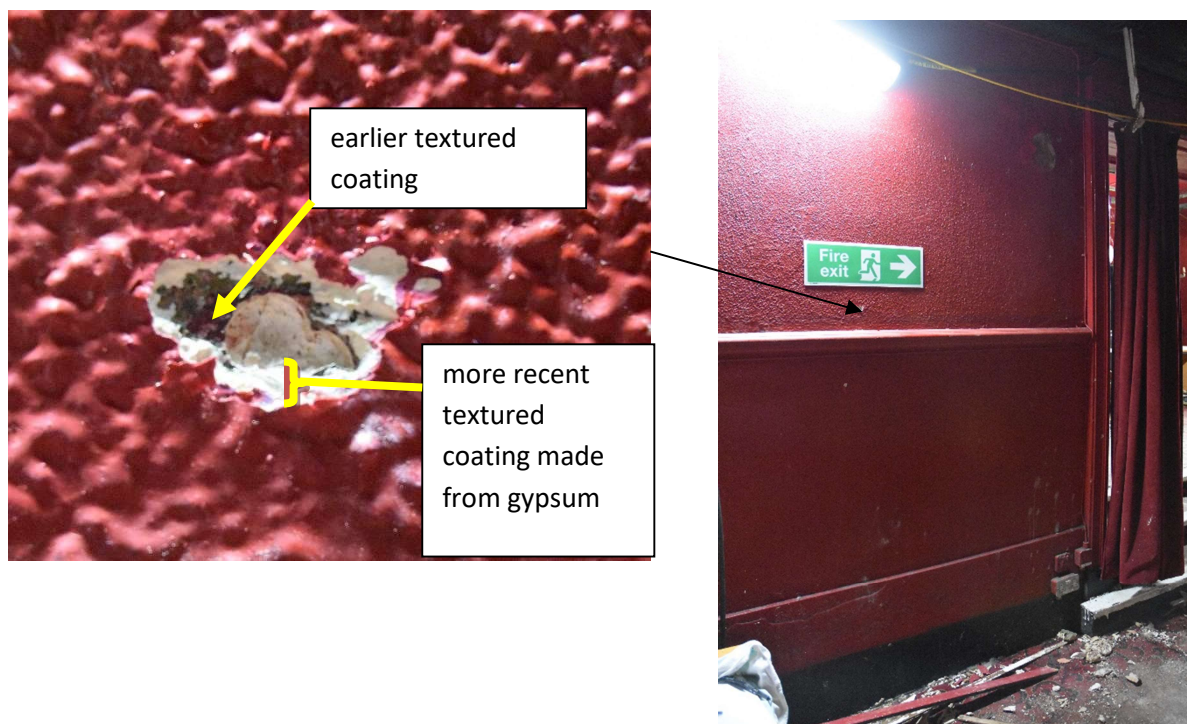
Like many rooms in Koko, the walls have been given a textured finish in the later C20th, but in this room two lots of textured coating were applied.

The first textured coating was the one applied throughout the building, involving a paint mixed with small granules.

The second textured coating, which was only applied in this room and in G.10 on the floor below, followed structural work. The texture was created with gypsum plaster

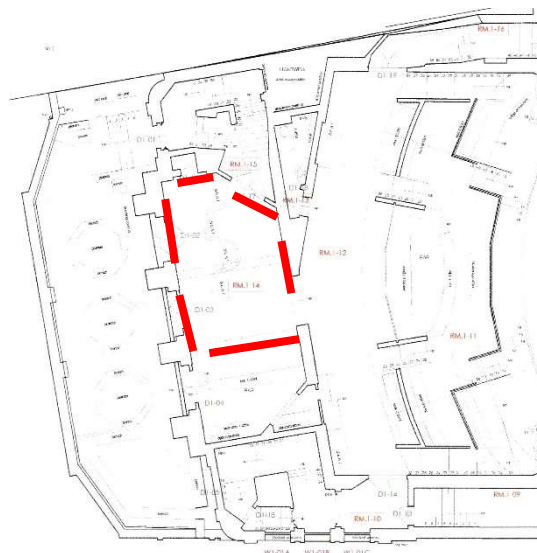
FIRST FLOOR – ROOM 1.14

Lead paint	Present on all surfaces – walls, ceiling and joinery.
Original paint	The original paint scheme is still present on all surfaces under layer layers. The 1900 decoration involved cream coloured oil paint on the plaster walls and ceilings. Brown varnish was used on all the joinery.
Early C20th paints	Five lots of oil paint based on lead white
Later C20th paints	Six lots of alkyd paint most based on titanium dioxide white.
Most recent paint	The red seen today on walls, ceiling and joinery is not a standard house paint. It is still flexible, with a rubbery texture and is unaffected by a range of solvents.

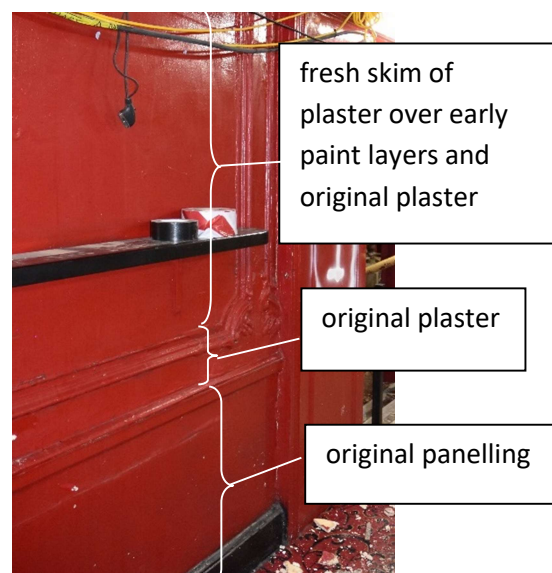
Partial re-plastering in the late C20th

The wall panels above the dado were given a fresh coat of gypsum plaster. This sealed in all the earlier paint layers.

On top of that fresh plaster are just sets of paint layers.

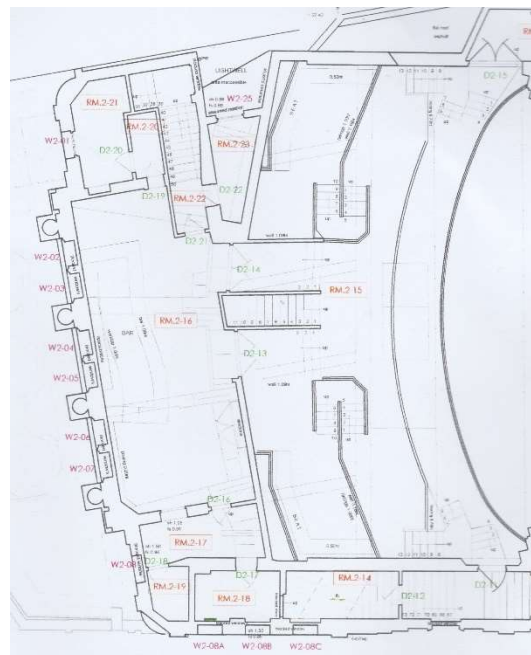
SECOND FLOOR BAR ROOM 2.16

Present only on the west wall, at the south end. There is no lead paint on the ceiling which has been re-plastered, or on the woodwork, which has been recently stripped.

White distemper, followed by cream-coloured oil paint on the walls.

Wallpaper or lining was used at some point in the early years. The paper has gone, but a thick layer of glue was found over the first oil paint. The paper was later removed and the repainted with oil paints.

The red seen today on the walls is not a standard house paint. It is still flexible, with a rubbery texture, and is unaffected by a range of solvents

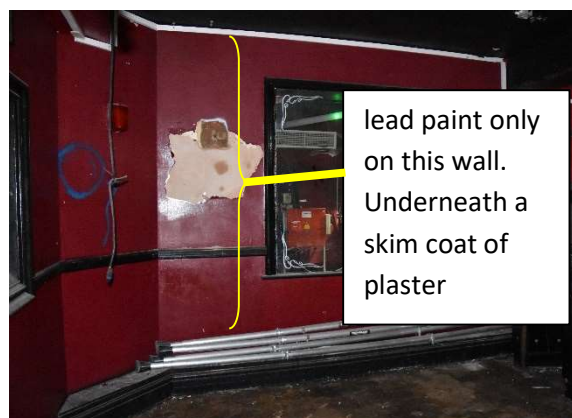
At some point in the recent past the whole room was almost completely re-plastered. A small patch of original plaster survived on the west wall, as shown above. This patch was covered over with a skim coat of the new plaster.

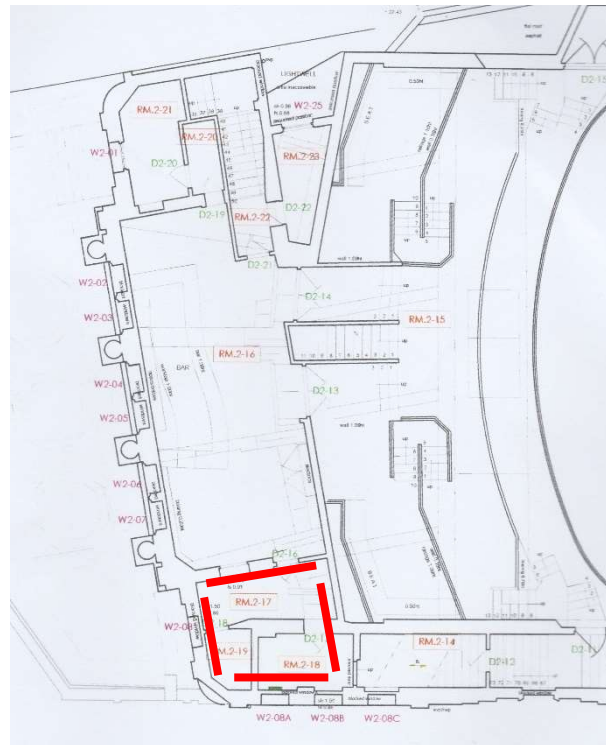
ROOMS SOUTH OF THE BAR
ROOMS 2.17, 2.18 & 2.19

Lead paint	Present on the walls of 2.17 and 2.19 Not present in 2.18
Original scheme	dark brown oil paint on all surfaces
Early C20th schemes	four lots of oil paint
Late C20th schemes	Three lots of emulsion paints followed by alkyd paints with a gloss finish.

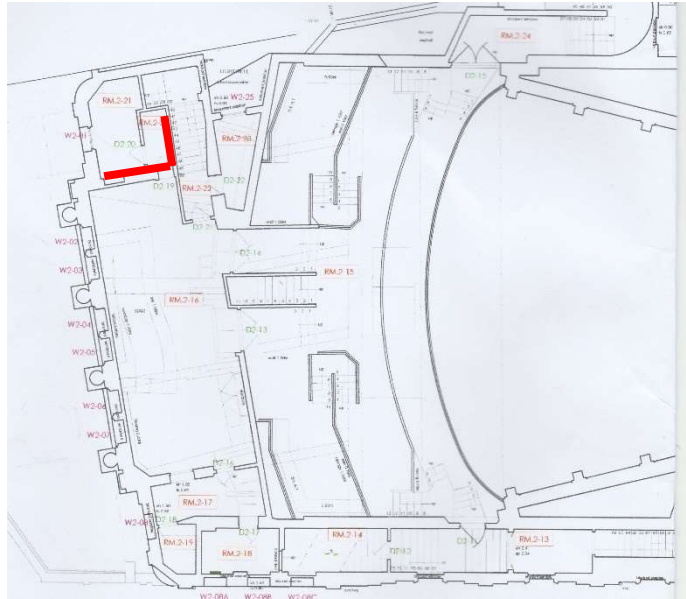
ROOMS NORTH OF THE BAR ROOMS 2.20 & 2.21

This area was probably originally a single room. The NS partition which divides it dates to the later C20th.

Lead paint	Present on the panelled walls
Original decoration	white, lead-based oil paint. This remained in place until the middle of the century.
Later decorations	In the later C20th the room was painted four times with alkyd paints

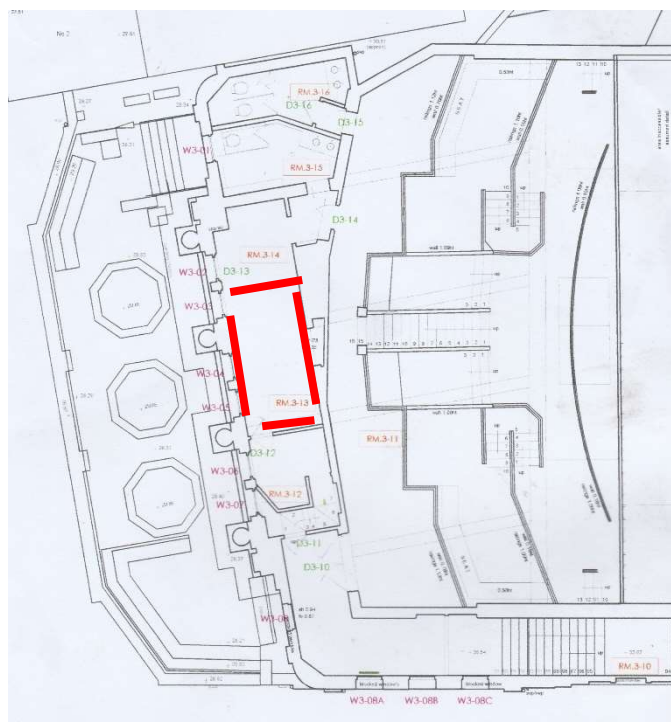
THIRD FLOOR – PROJECTION ROOM ROOM 3.13

Original lime plaster and earliest paint layers were found only on the west and east walls. The north and south partitions, which are coated in gypsum plaster, must have been built when the theatre became a cinema,

Lead paint	Present on the west, north and east walls, and on the ceiling, but not on the south wall or any of the woodwork.
Original paint	Red distemper on the walls, white distemper on the ceiling. Original paint found only on the west and east walls.
Early C20th paints	Painted with black oil paint in 1913 when the room became a projection room, then the walls and the ceiling were painted a further six times with lead based oil paints . One of these oil paint schemes was varnished.
Later C20th paints	Wall and ceiling painted twice with alkyd paints.
Most recent paint	Pale green emulsion paint on the walls, and white emulsion paint on the ceiling.

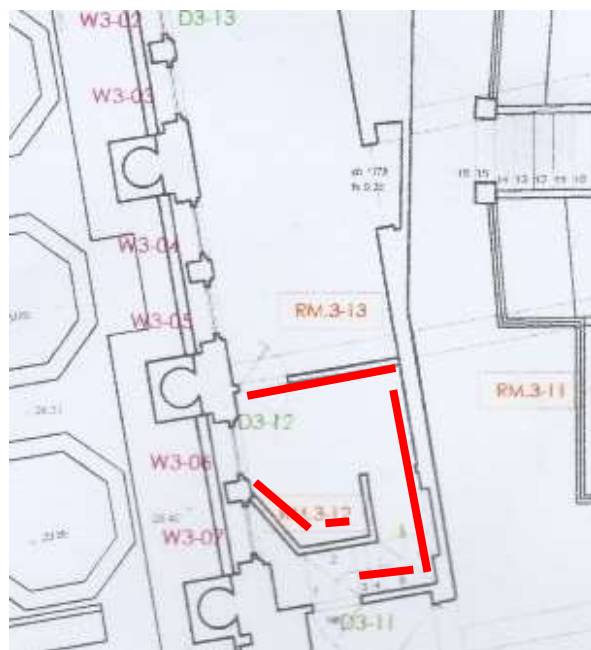
THIRD FLOOR LOBBY SOUTH OF PROJECTION ROOM - ROOM 3.12

Lead paint Found only on the south and east walls of the lobby and on a patch of older plaster on the south wall of the stairs.

Original paint Red distemper on the walls.

Early C20th paints Two lots of lead-based oil paint

Later C20th paints Fours lot of alkyd paint. The most recent ones applied over a skim of grey gypsum plaster.

Late C20th plastering The north wall of the Lobby and the south walls of the Lobby and Stairs have been recently re-plastered.

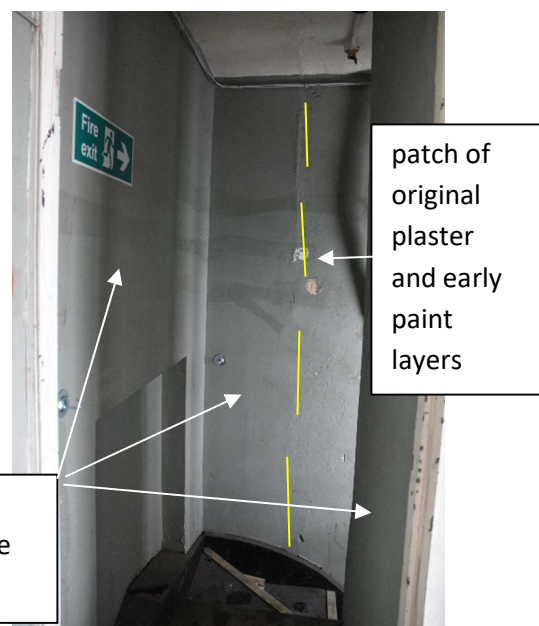
On the south wall of the Stairs this plaster was applied over a patch of original plaster and early paints.

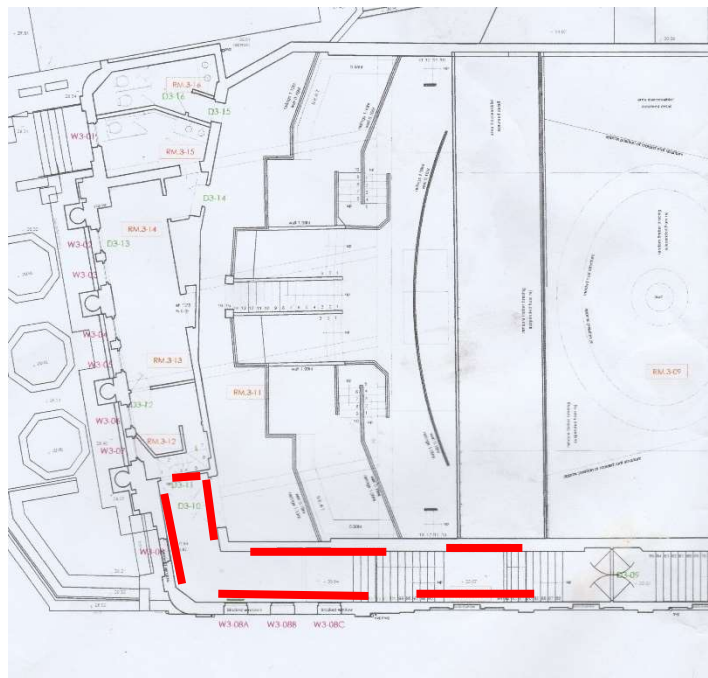
SOUTH STAIRS – THIRD FLOOR ROOM 3.10

Lead paint	Present in all samples from walls and woodwork. Not present on the ceilings which have been recently been re-plastered.
Original paint	A red soft distemper was used from floor to ceiling on the walls. The paint was applied directly to the bricks. Brown oil paints were used on the woodwork and iron window grilles
Early C20th paints	Distempers initially continued to be used, but then there was a switch to oil paints, and up to six lots of oil paint were used on the walls.
Later C20th paints	Three lots of alkyd paint and one emulsion paint
Most recent paint	Emulsion paint

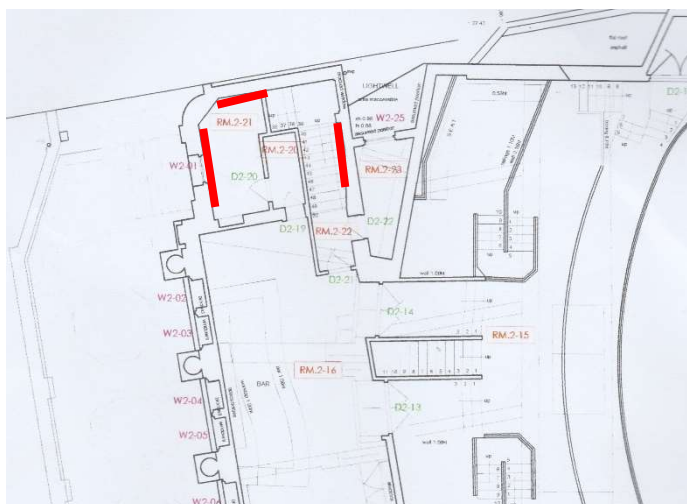
SECOND FLOOR – 2.22

Original paint on the plaster was only found in two samples and the walls of this staircase have been partly stripped and partly re-plastered on more than one occasion.

Lead paint Found in samples from the ceiling of the second floor landing and in a few samples taken from the walls between ground and first and between first and second.

Early C20th paints Embossed wallpaper with cream-coloured oil paint on the surface was used for the walls below the dado rail. Some has survived, at ground floor level, but elsewhere it appears to have all been removed.

Later C20th paints At least eight lots of alkyd paint. During this period the walls were partly stripped, and at ground floor level fresh lining paper applied.

Recent re-plastering Prior to the most recent decoration extensive repairs were carried out, including applying a fresh plaster skim to parts of the upper wall particularly between the first and second floor.

Most recent paint This paint is still flexible and has a rubbery texture. It is insoluble in acetone and is not a standard alkyd. Instrumental organic analysis would have to be carried out to identify the binder.

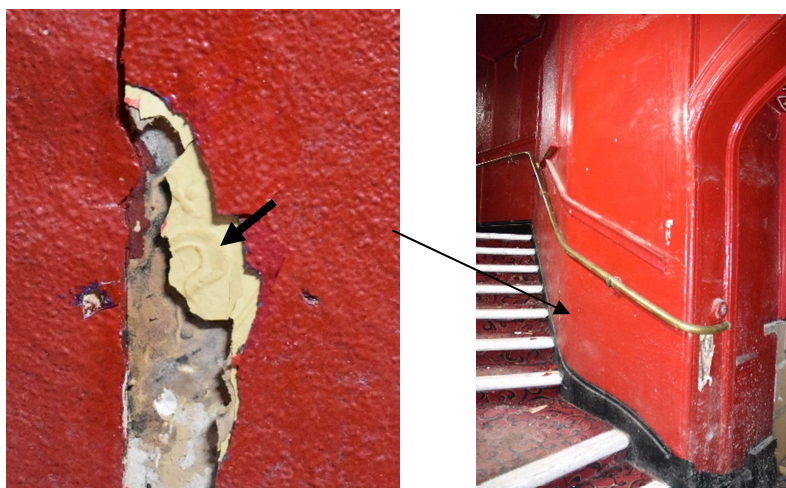
The paper was re-painted twice with lead-based oil paints
